Technical Service Information

FORD CD4E **CODE P0741 STORED, AFTER REBUILD**

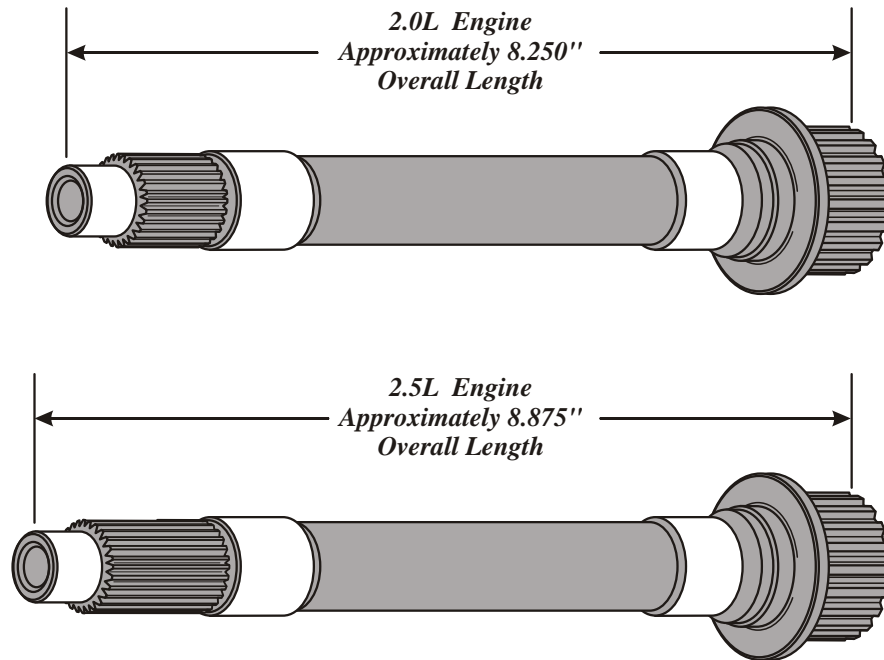
CAUSE: One cause may be, a mis-matched turbine shaft and torque converter that was mistakenly installed in the vehicle. The turbine shaft and oil pump drive shaft for the 2.0L engine are approximately 5/8" shorter than the turbine shaft and oil pump drive shaft for the 2.5L engine as shown in Figures 1 and 2. If the short turbine shaft is installed with the 2.5L engine and converter, the vehicle will exhibit the above concerns. Torque converter identification is provided for you in Figure 3, and as you can see in the height dimension chart, there is approximately 5/8" difference.

CD4E TURBINE SHAFT DIFFERENCES

CORRECTION: Remove transaxle and ensure that the proper turbine shaft and oil pump drive shaft have been installed for the engine size that you have. Refer to Figure 1 to identify the turbine shaft, Figure 2 to identify oil pump drive shaft and Figure 3 for converter identification.

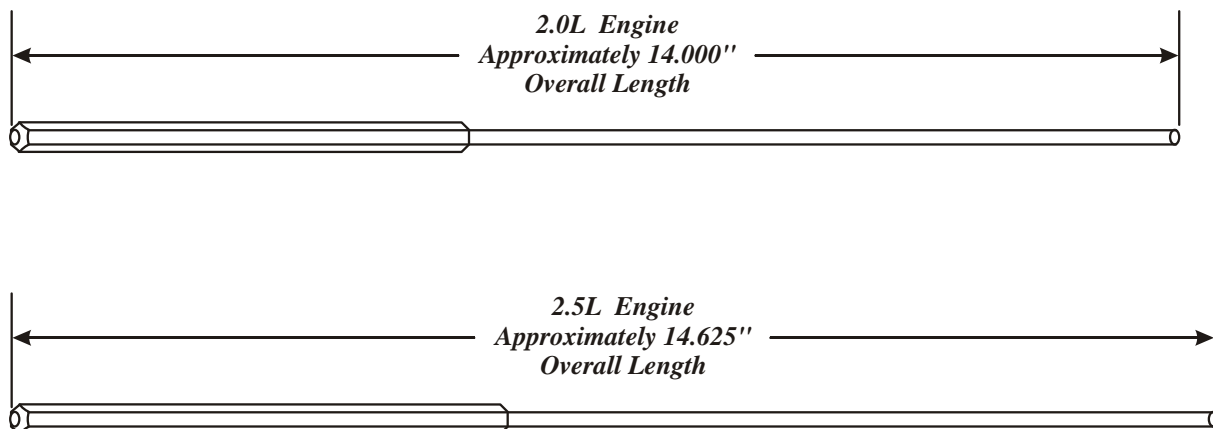
Figure 2

CD4E PUMP DRIVE SHAFT DIFFERENCES
