Technical Service Information

THM 4T80-E TURBINE SHAFT SPEED SENSOR CHANGES

CHANGE: Beginning in the 1996 model year, on Julian Date 113, all THM 4T80-E transaxles were produced with a new design case casting, manual shaft and turbine shaft speed sensor.

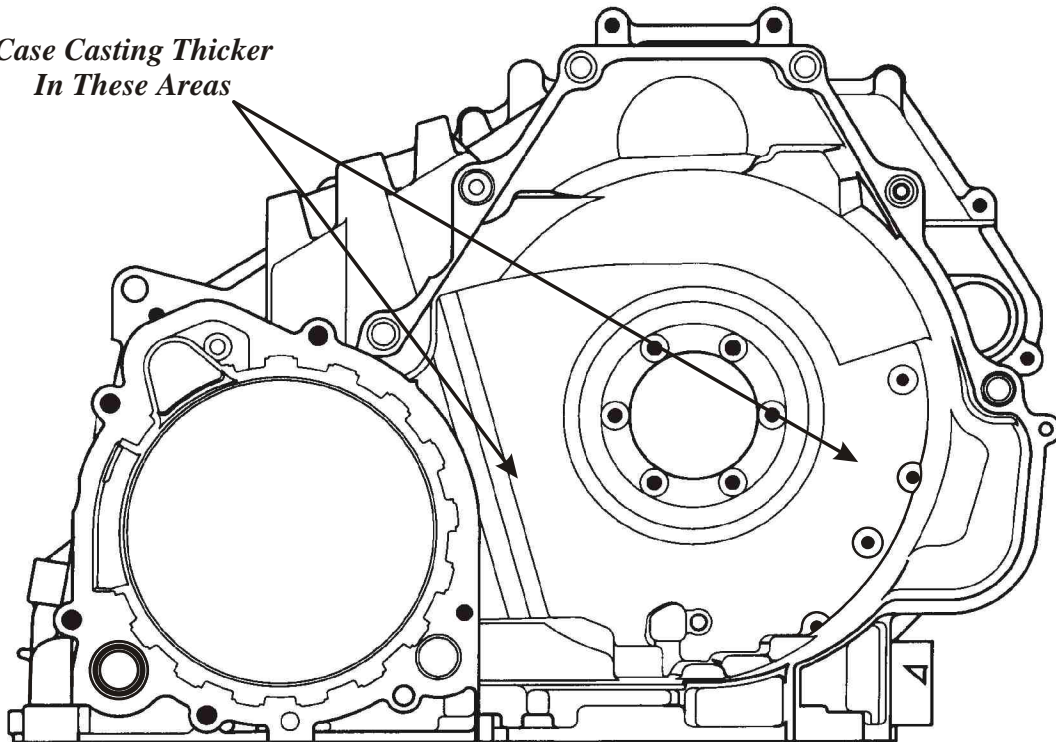
Figure 1

- (1) TRANSAXLE CASE - Thicker casting in the front seal area to help eliminate possible cracks and leakage and revised machining in the manual shaft seal bore area (See Figure 1).
- (2) MANUAL SHAFT - New design manual shaft has groove cut in shaft, to accept the bump on bottom of the turbine speed sensor wiring bracket, to locate and hold the manual shaft in the proper location in case (See Figure 1).
- (3) TURBINE SPEED SENSOR - Now manufactured with the bump on the bottom of turbine speed sensor wiring harness bracket, to position and retain manual shaft. The 1st design parts are shown in Figure 2 and the 2nd design parts are shown in Figure 3.

*Case Casting Thicker
In These Areas*

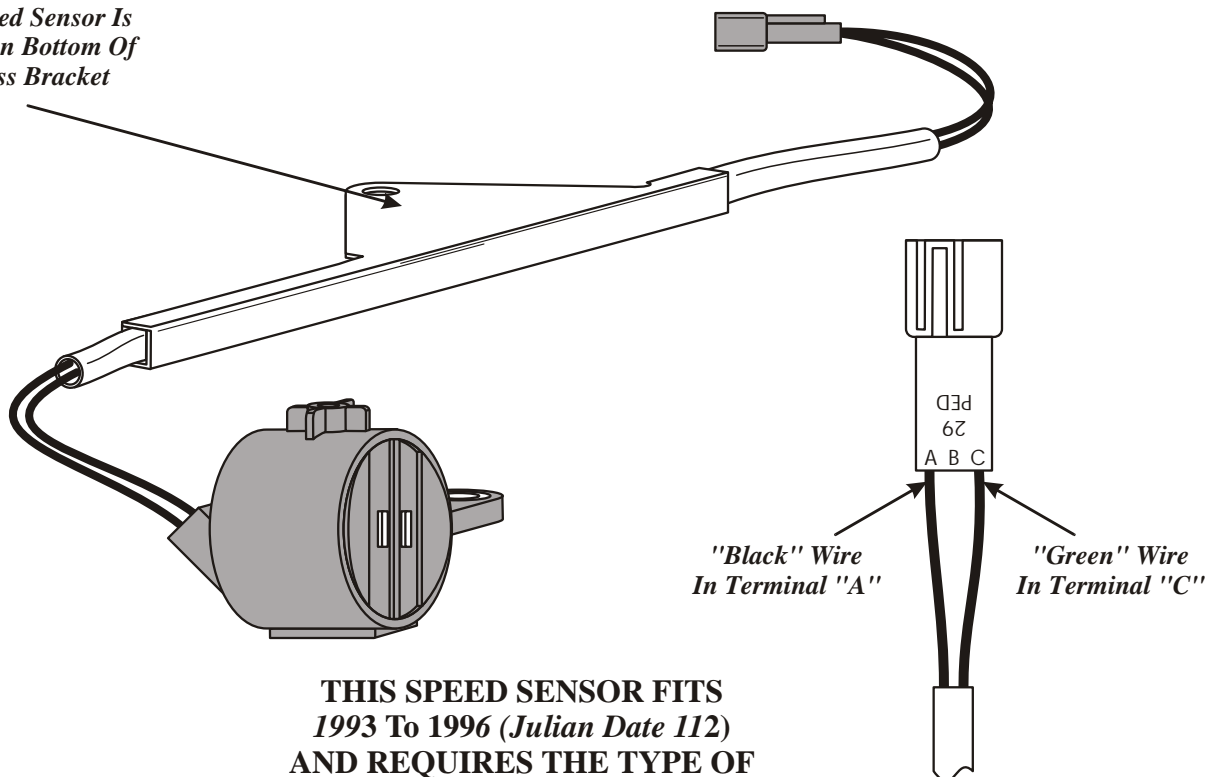
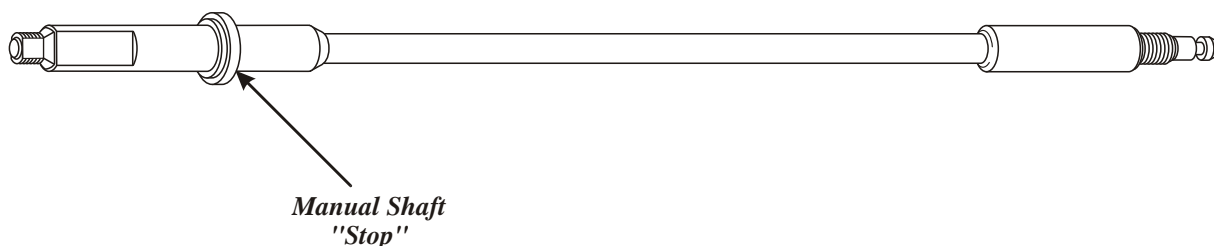
Figure 2

THM 4T80-E 1ST DESIGN TURBINE SHAFT SPEED SENSOR OEM PART NUMBER 24209654

*This Speed Sensor Is
"Flat" On Bottom Of
Harness Bracket*

**THIS SPEED SENSOR FITS
1993 To 1996 (Julian Date 112)
AND REQUIRES THE TYPE OF
MANUAL SHAFT SHOWN BELOW**

If it becomes necessary to replace the turbine speed sensor, ensure that your new sensor has the wires in terminals "A" and "C", as shown here. We have had some reports that the new sensor came with the green wire in terminal "B" and had to be moved to terminal "C". We have also had some reports of the black wire being in terminal "A" and the green wire being in terminal "B" on both sides of the connecting harness. Ensure that your wires match on both sides of connector, regardless of where they are located.

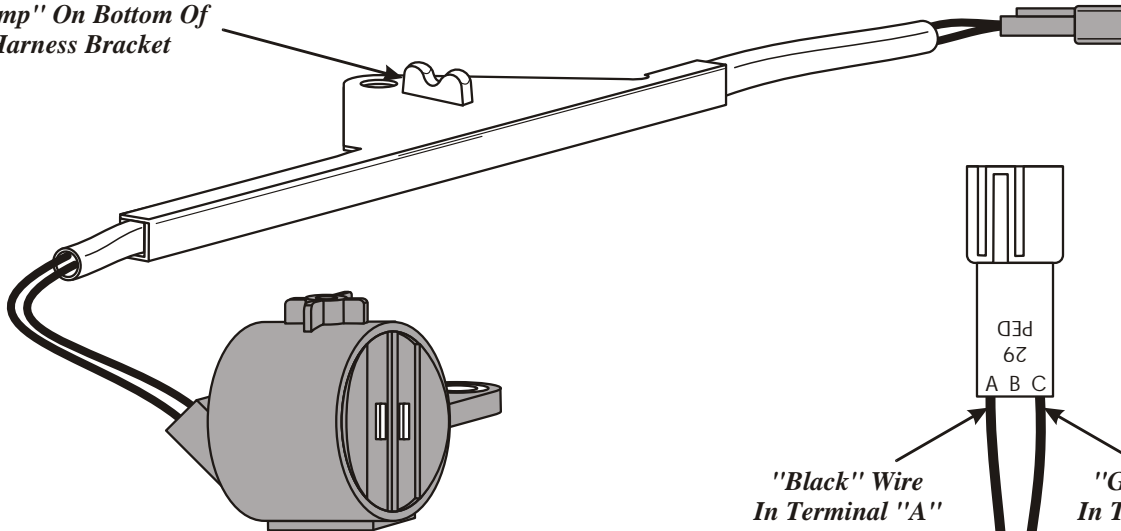
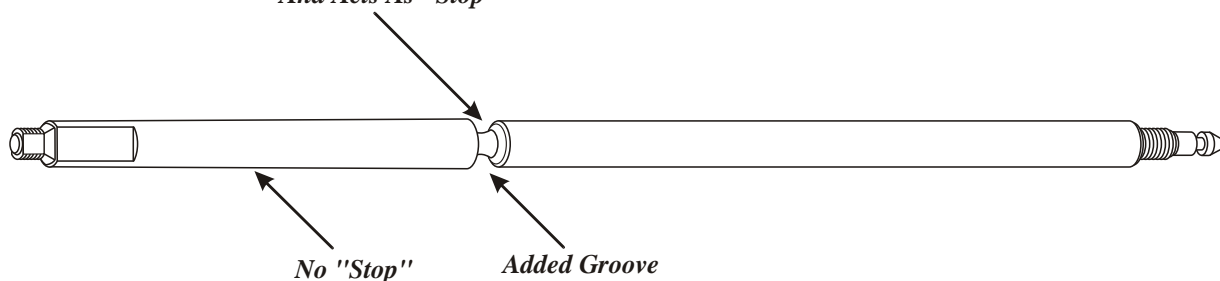
Figure 3

THM 4T80-E 2ND DESIGN TURBINE SHAFT SPEED SENSOR OEM PART NUMBER 24207491

*This Speed Sensor Has
"Bump" On Bottom Of
Harness Bracket*

**THIS SPEED SENSOR FITS
1996 (Julian Date 113) TO CURRENT
AND IS "MANDATORY" FOR
THESE MODELS AS TRANSAXLE
IS EQUIPPED WITH THE MANUAL
SHAFT SHOWN BELOW**

*"Bump" On Bottom Of Harness Bracket
Fits Into Groove In Manual Shaft And
Positions Manual Shaft In Case
And Acts As "Stop"*

If it becomes necessary to replace the turbine speed sensor, ensure that your new sensor has the wires in terminals "A" and "C", as shown here. We have had some reports that the new sensor came with the green wire in terminal "B" and had to be moved to terminal "C". We have also had some reports of the black wire being in terminal "A" and the green wire being in terminal "B" on both sides of the connecting harness. Ensure that your wires match on both sides of connector, regardless of where they are located.
