# Technical Service Information

## FORD 5R55N NO 4TH OR 5TH GEAR

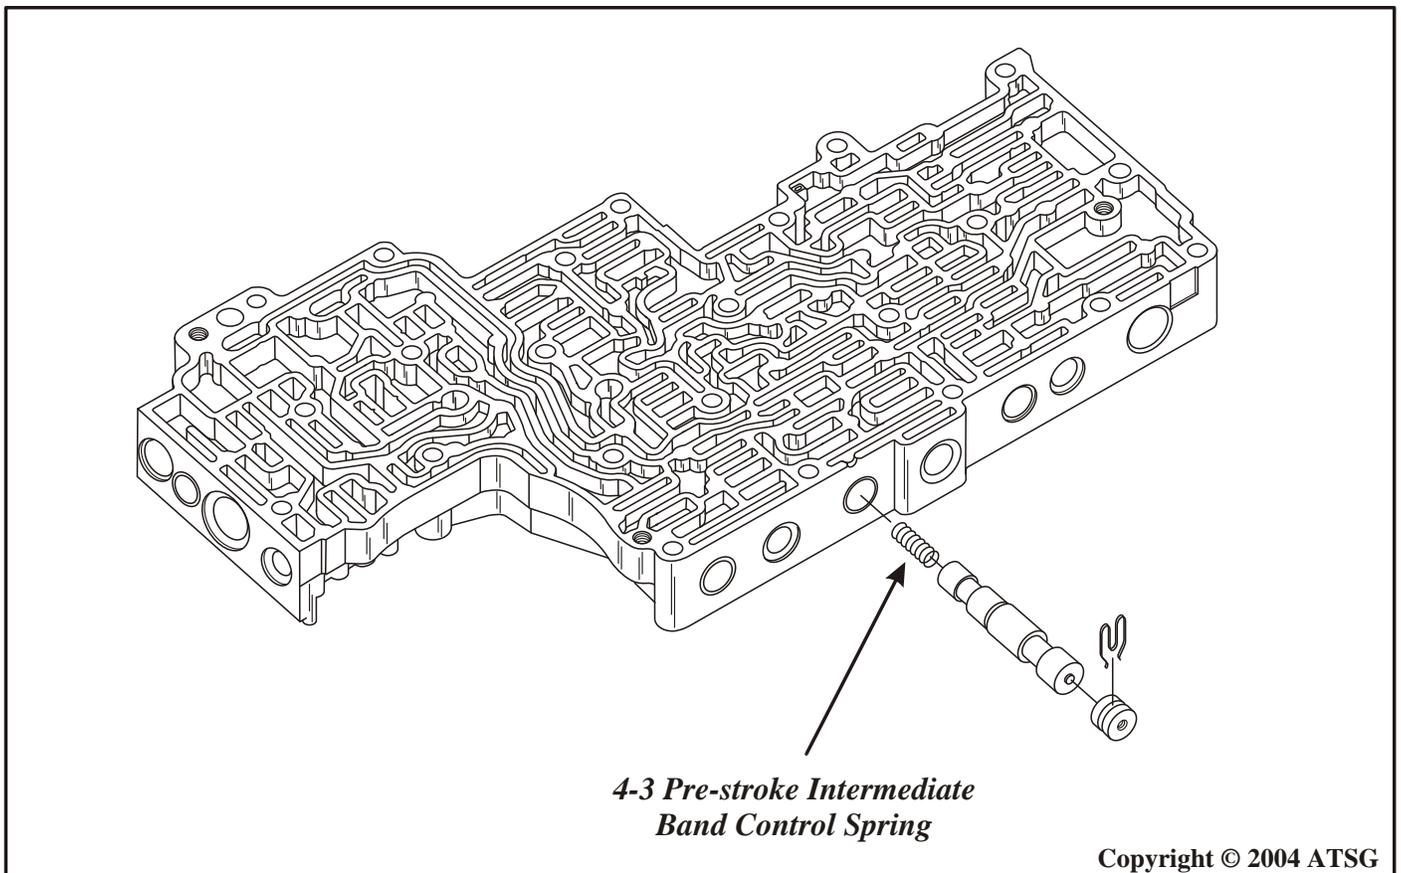
Figure 1

**CAUSE:** One possible cause is a broken 4-3 Pre-stroke Intermediate Band Control Spring, as shown in Figure 1.

**CORRECTION:** Replace spring from another 5R55N valve body or find a spring that is as close to the original spring, dimension listed below. Sonnax® will have one available soon under part number 56947J-S1

FREE LENGTH	.880"
DIAMETER	.294"
WIRE DIAMETER	.033"
APPROX. COILS	8

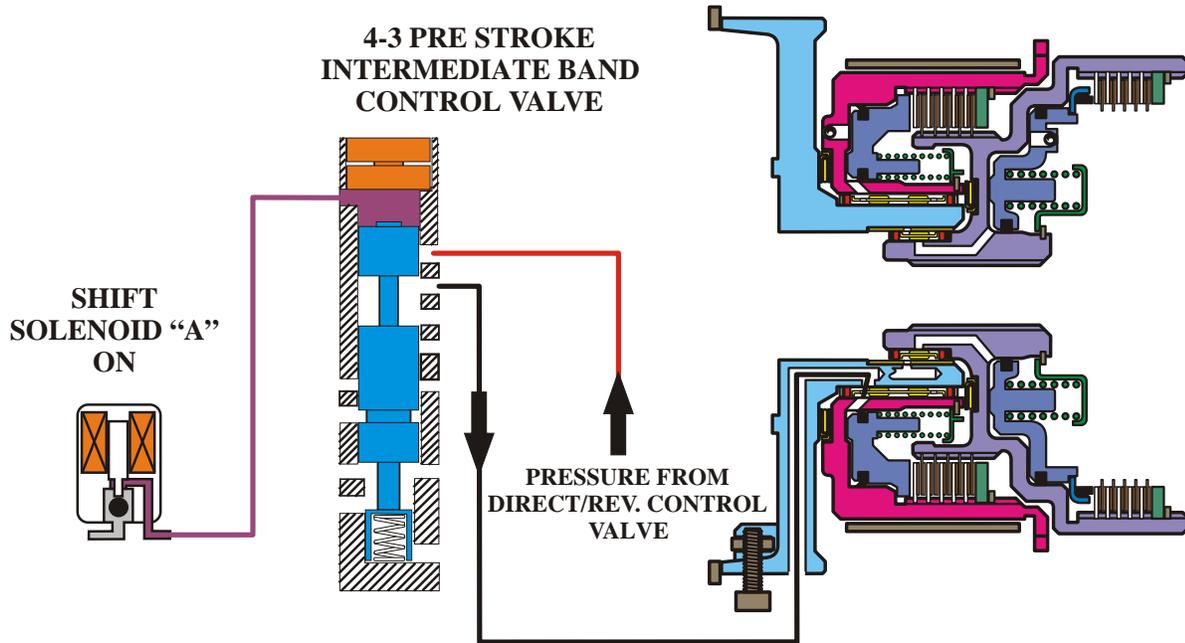
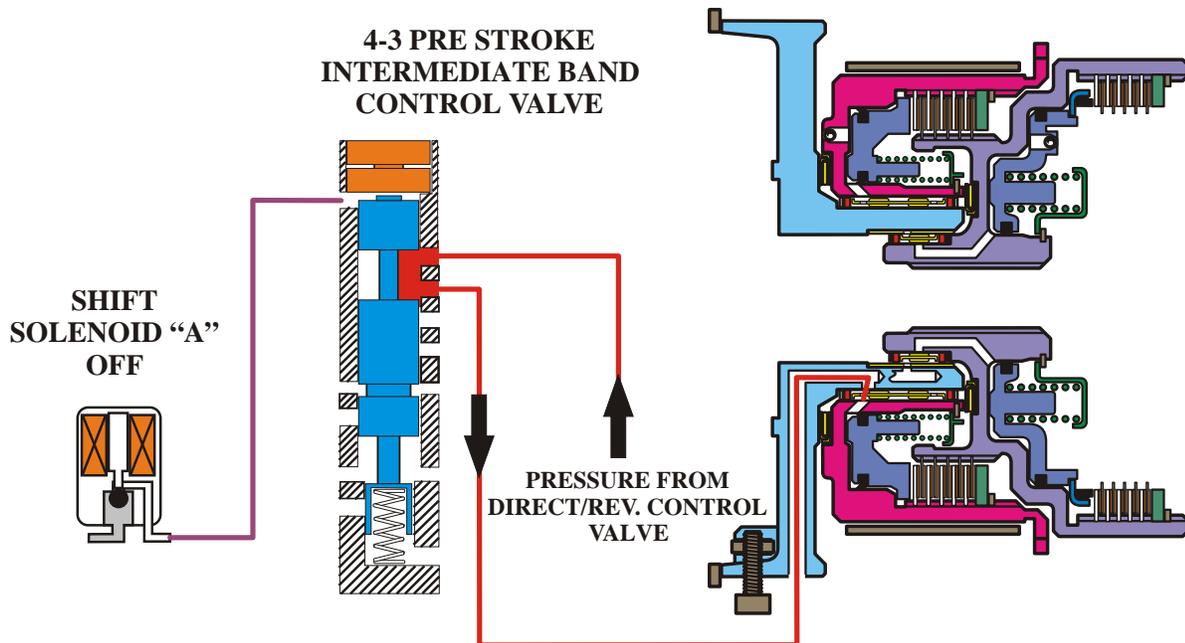
Figure 2

### 4-3 PRE STROKE INTERMEDIATE BAND CONTROL VALVE POSITION IN 3rd GEAR

### 4-3 PRE STROKE INTERMEDIATE BAND CONTROL VALVE POSITION IN 4th AND 5th GEAR

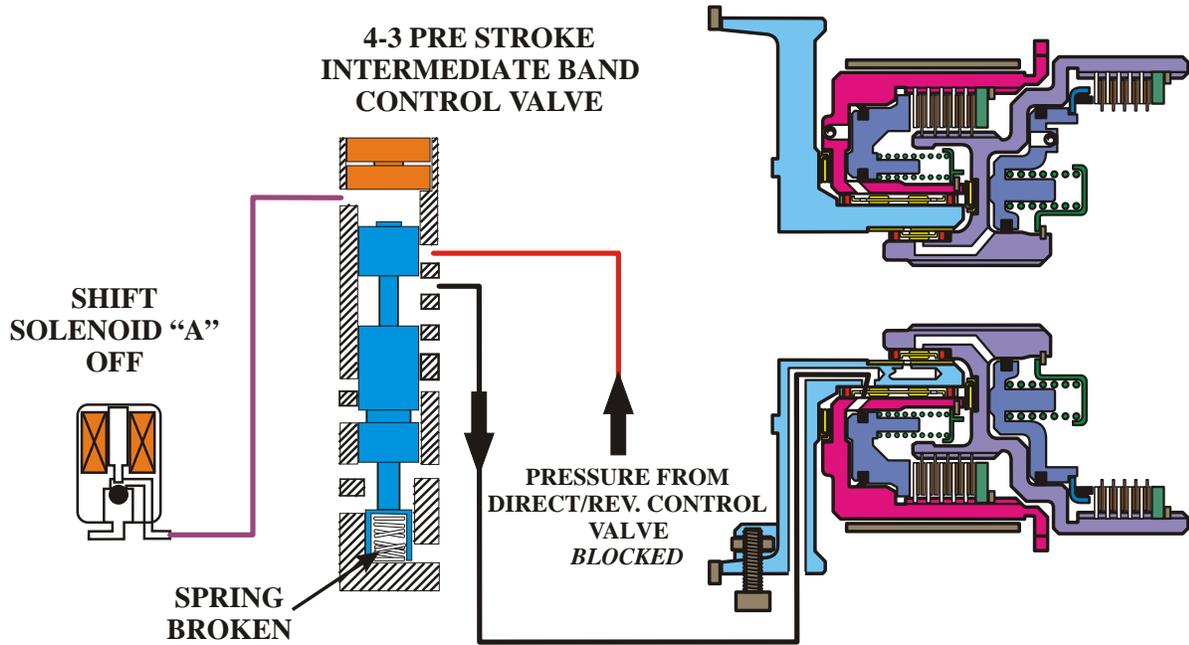
Figure 3

**REASON:** When the 4-3 Pre-stroke Intermediate Band control spring breaks, the passage to the Direct Clutch is blocked by the valve as shown in partial schematic in Figure 3. See Figure 2 for a partial schematic showing the function of the 4-3 Pre-stroke Intermediate Band Control Valve.

### 4-3 PRE STROKE INTERMEDIATE BAND CONTROL VALVE POSITION IN 4th AND 5th GEAR SPRING BROKEN
