Technical Service Information

ALLISON 1000/2000 SERIES

3RD OR 5TH GEAR STARTS DTC P0705, P0706, P0708

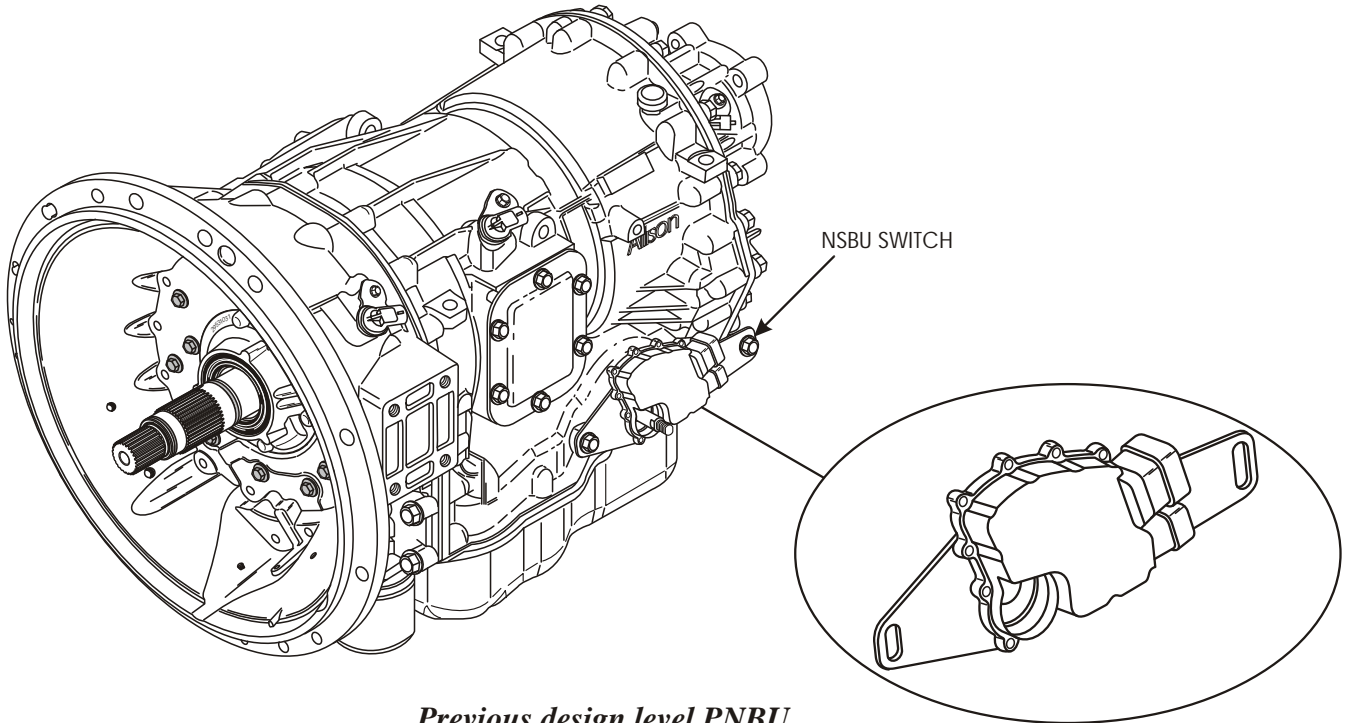
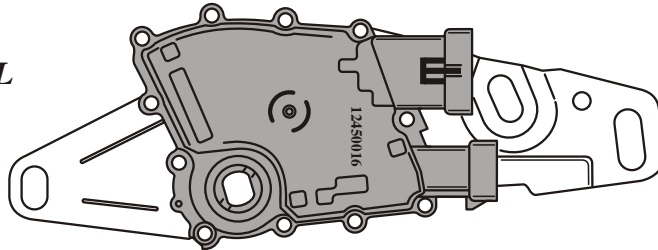
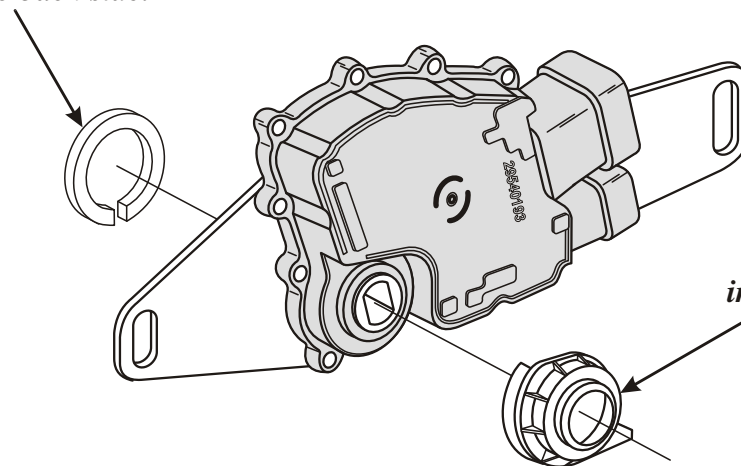
Figure 1

CAUSE: The cause may be, a defective Neutral Start Back-Up (NSBU) switch, created by weather intrusion. The NSBU switch is mounted on the exterior of the transmission and rotated by the manual shaft, as shown in Figure 1.

*Previous design level PNB
Switch is "Black" in color.*

*New PNB Switch has
seal glued to back side.*

*New service package
includes cover for front
side of new switch.*

*New design level PNB Switch is "Tan" in color,
and is available under OEM part number 29540479.*

CORRECTION: There is now available from OEM parts sources, a revised NSBU switch that has improved sealing capabilities to help prevent water intrusion, and is available under OEM part number 29540479. (See Figure 1) Since the original switch is the same part number as the 4L60-E switch, high ambient heat may have caused the sealing compound in the switch to melt and flow into the connectors, sealing the connectors to the switch. There is now available from OEM sources, service repair connectors for both the 7-way and the 4-way connectors under part numbers 15305887 and 15305925 (See Figure 3).

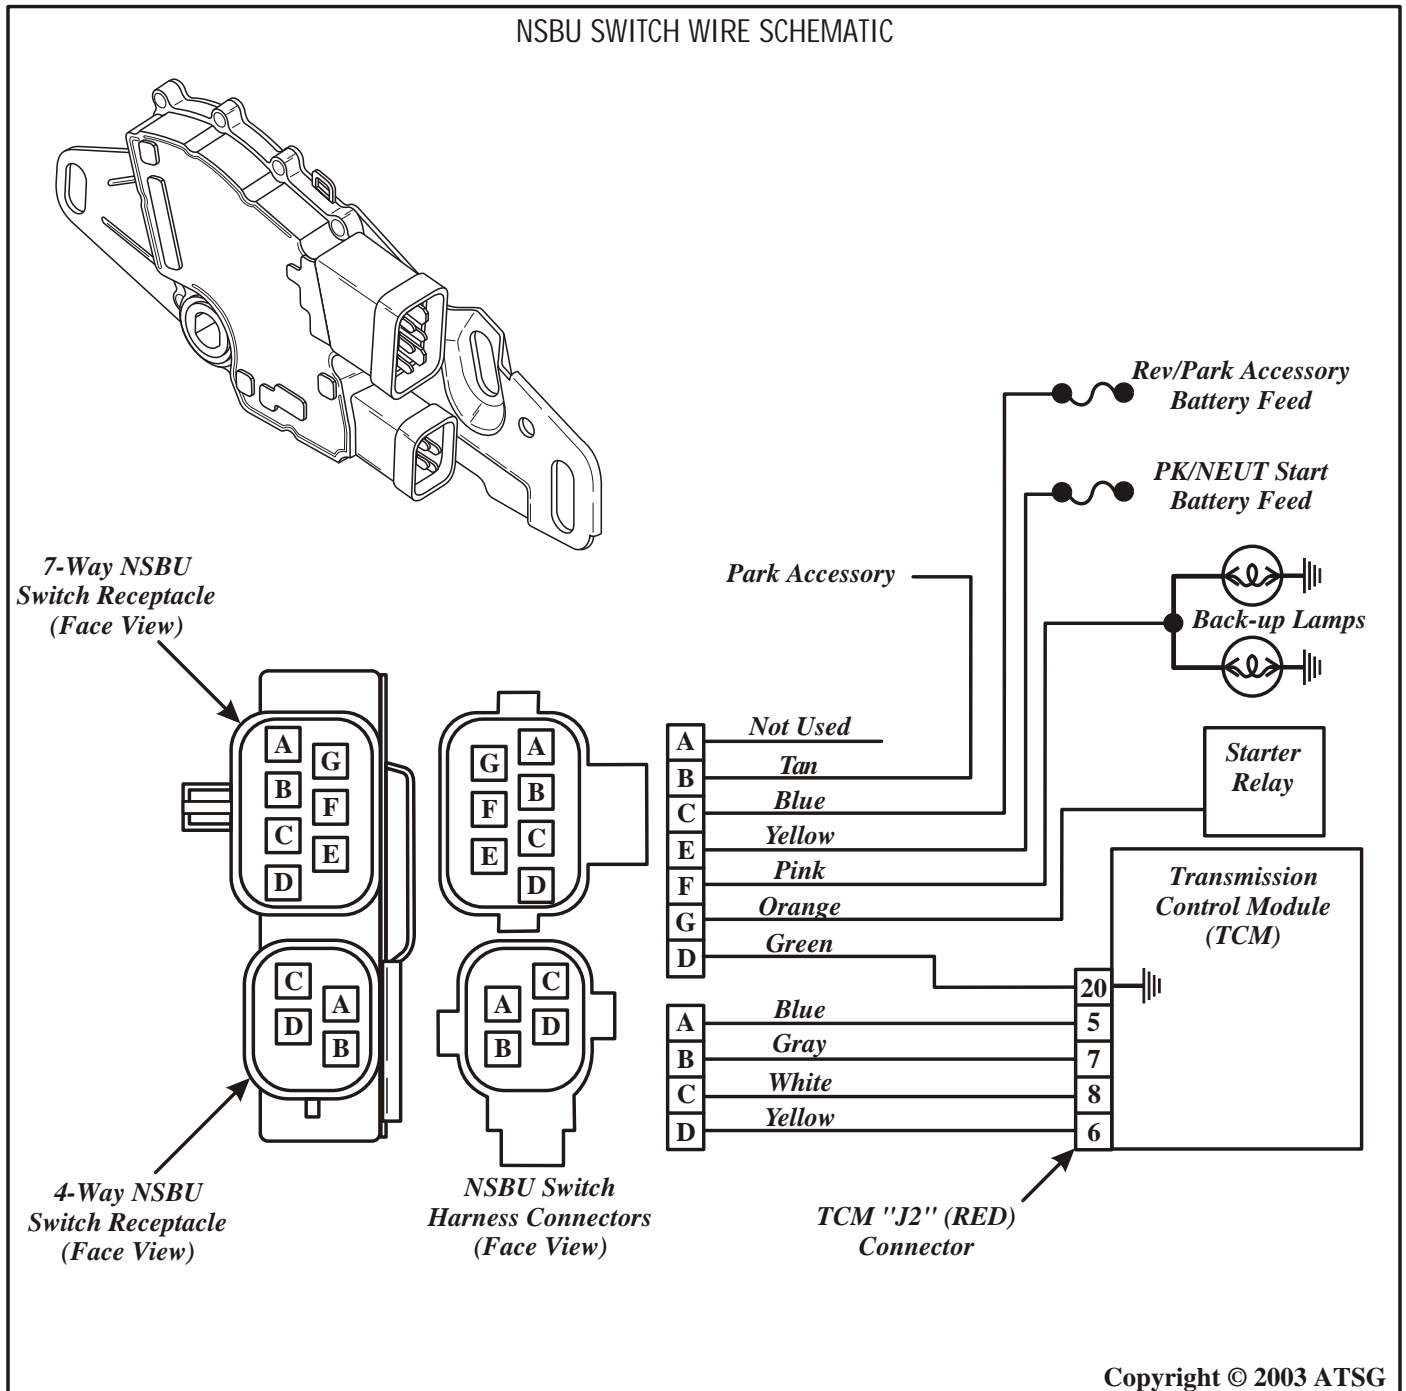
The installation of a transmission mounted Neutral Start/ Reverse Signal switch is required. This switch commonly referred to as an "NSBU Switch", mounts directly onto the transmission case from the outside and detects the angular position of the manual shift selector shaft. This position is relayed to the TCM so that certain vehicle control functions can be coordinated with the position of the shift controls. The NSBU Switch has redundant circuitry to alert the TCM in the event of a single wire or switch failure. The switch is interfaced to the starter circuit, and the reverse signal provision may be used to activate vehicle back-up lights and/or reverse warning devices.

Note: The service connector pigtails use wires that are all the same color. Use the old connector as a pattern to ensure that the new wires are connected to the vehicle harness correctly. This switch is in a wet area, and it is *imperative* that the wires be soldered and heat-shrink tubing be used to insure water-tight connections. Refer to Figure 1 for the location of the Park/Neutral Position Switch. Refer to Figure 2 for a full wiring schematic of the Park/Neutral Position Switch circuit for diagnostic purposes.

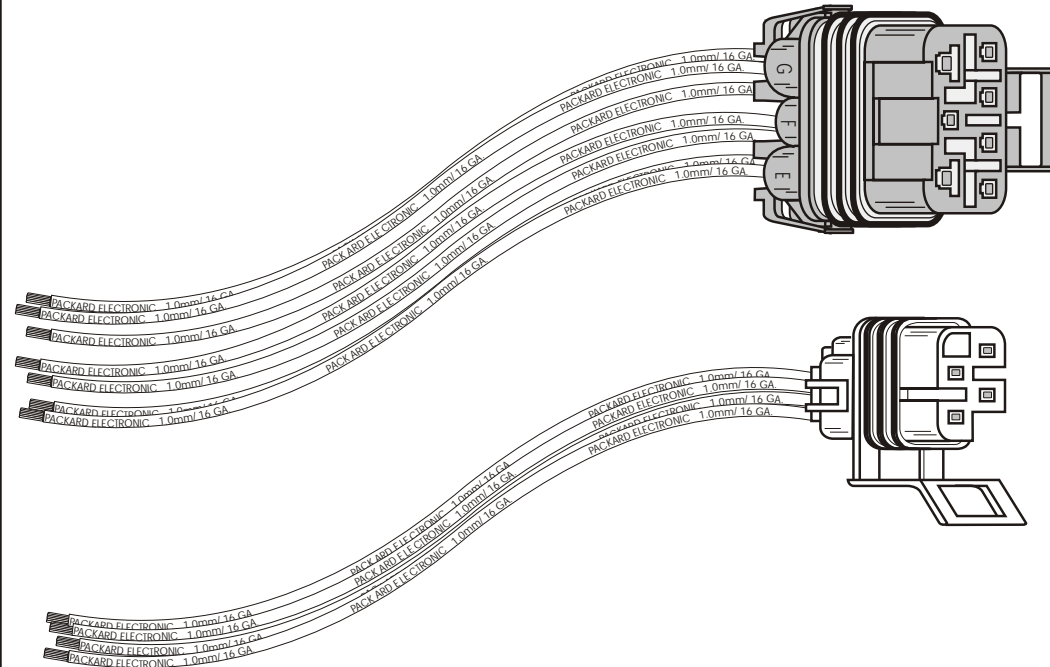
Figure 3

NSBU SWITCH REPAIR CONNECTORS

**PART NUMBER
15305887**

**PART NUMBER
15305925**
