THM 4T65-E NO 3-4 SHIFT

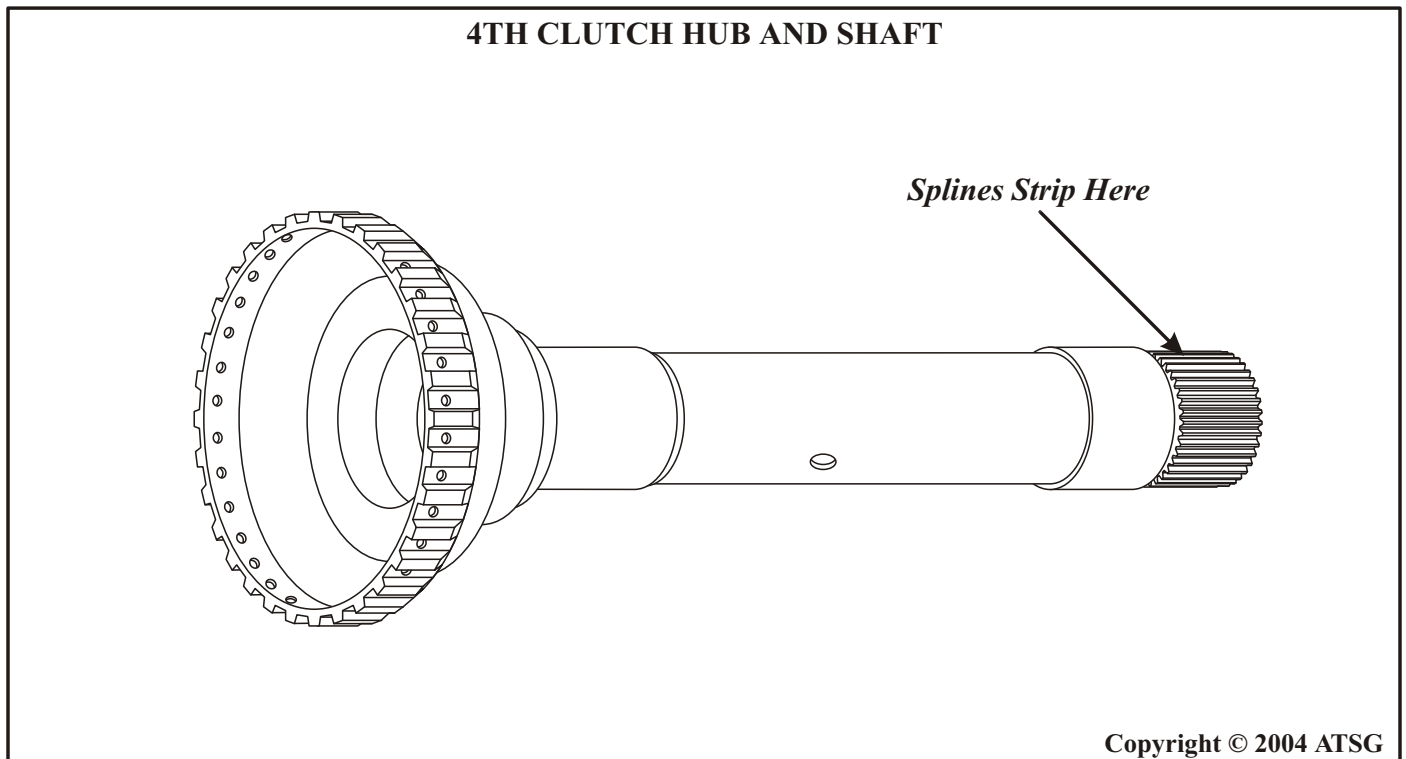
Figure 1

CAUSE: The cause may be, stripped splines on the 4th clutch hub and shaft where it splines into the input sun gear, as shown in Figure 1.

CORRECTION: Replace the 4th clutch hub and shaft assembly with a new one. Extra care should be exercised when inspecting this area on your normal overhaul, as this is a very common wear area on higher mileage units.

4th Clutch Hub and Shaft 24205603
