Technical Service Information

ZF 4HP-18 FLE/FLA NEUTRAL AFTER A 3-4 UPSHIFT

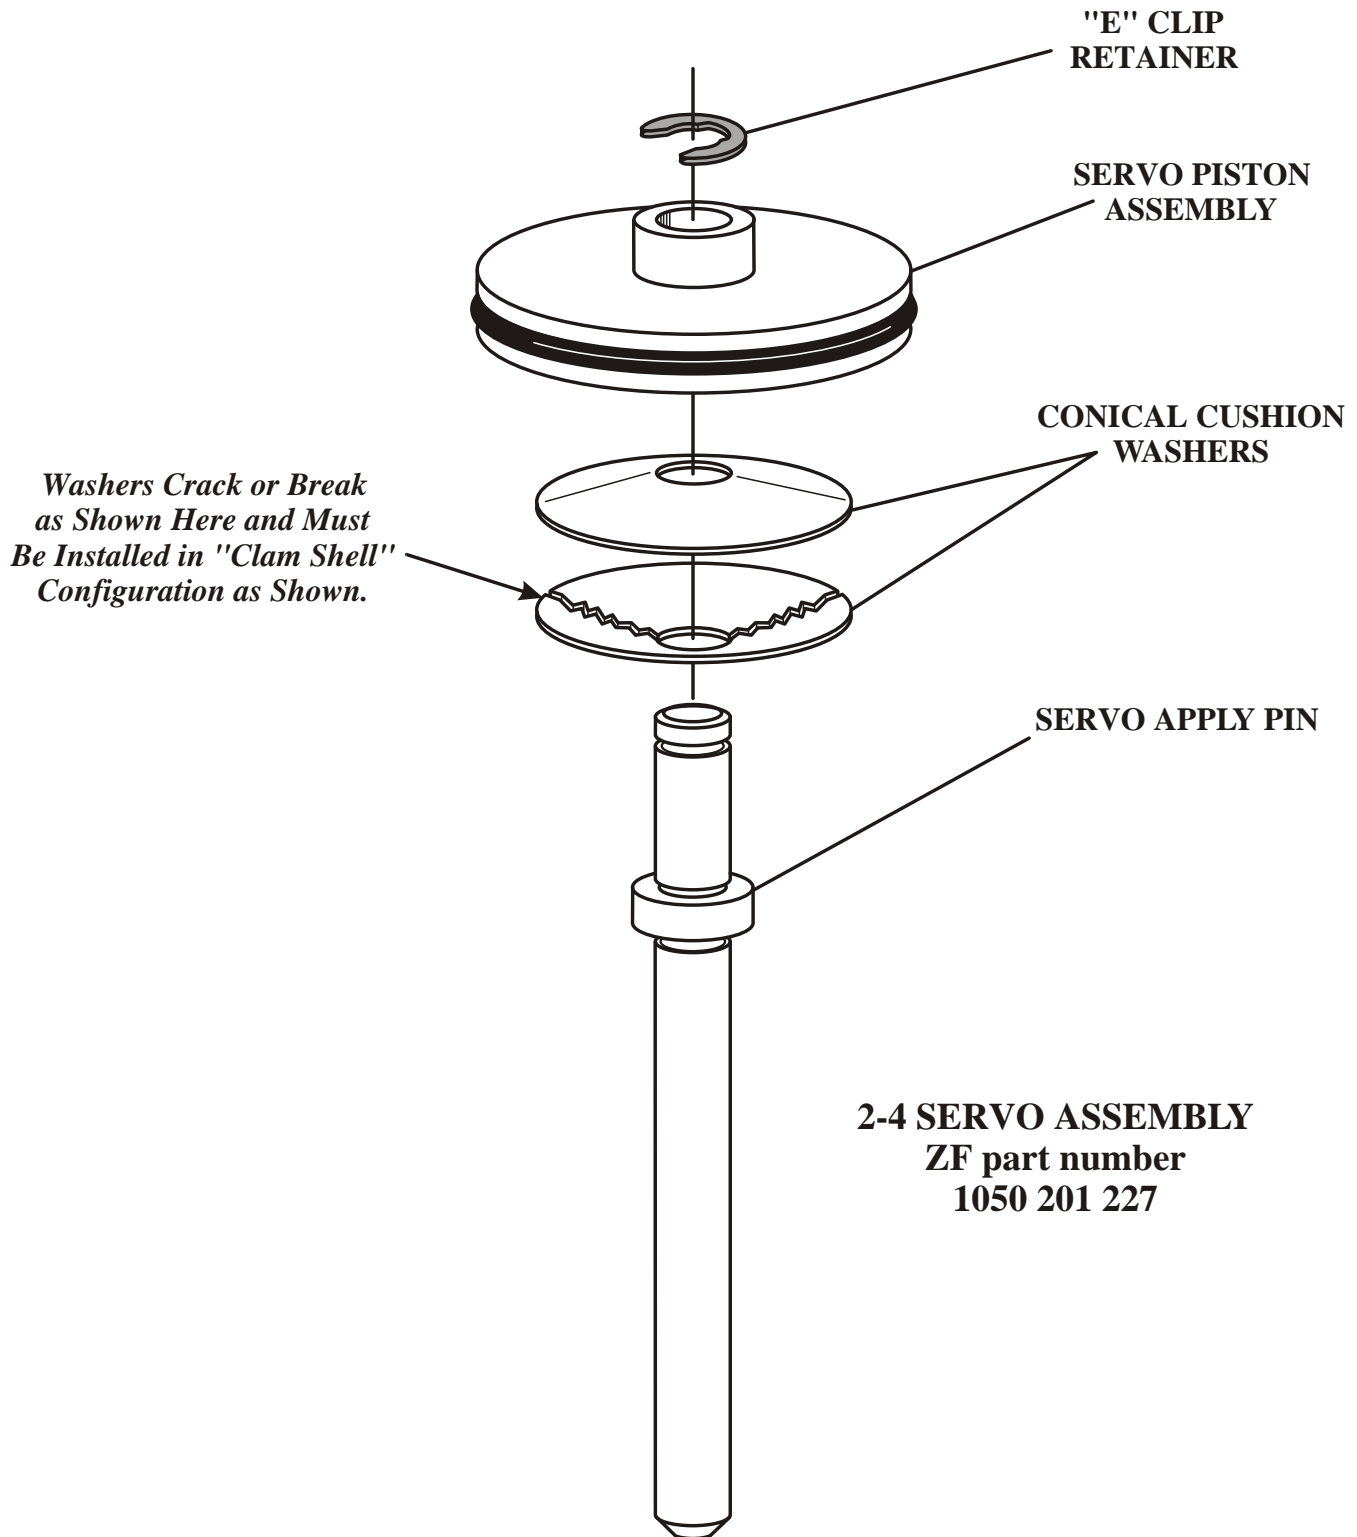
Figure 1

CAUSE: The cause may be split conical cushion washers in the 2-4 servo assembly as shown in Figure 1. This will create a neutral condition when the band is re-applied in 4th gear, because of the broken cushion washers limiting the travel of the servo. **NOTE: The 2-4 servo is also applied in 2nd gear but only provides engine braking because of the application of the "C" clutch in 2nd gear. See Figure 2 for the Clutch and Band application chart.** The Transmission Control Module will put the transmission in a "Fail Safe Mode" when it neutrals out in 4th. In this situation, this is a 4th gear command (all solenoids OFF), which is now Neutral. The driver of the vehicle will have to cycle the ignition switch to regain forward application.

CORRECTION: Replace the conical washers, as shown in Figure 1. The entire 2-4 servo assembly can be purchased through an authorized ZF parts distributor, as the conical washers are not sold separately. If good used conical washers are found, ensure that the washers are assembled in a "clam shell" configuration, as shown in Figure 1.

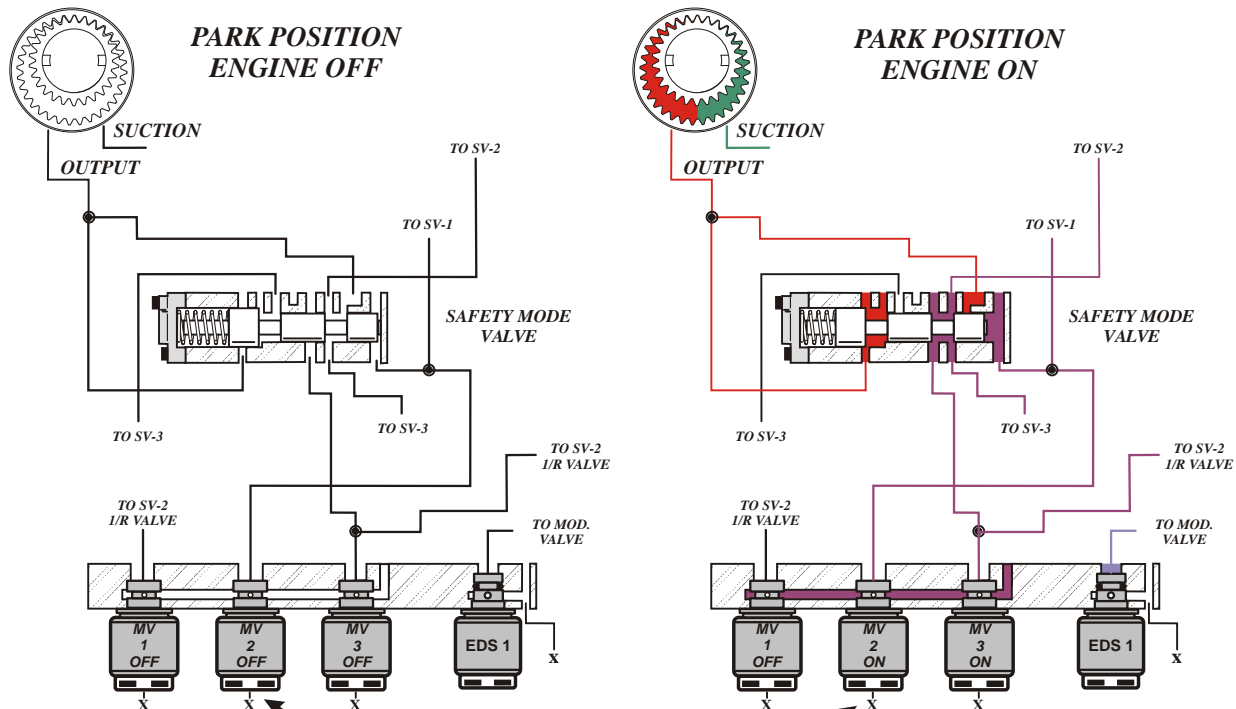
Figure 3

MV-2 IS TURNED "ON" ONLY TO STROKE THE SAFETY MODE VALVE. PUMP PRESSURE WILL KEEP THE SAFETY MODE VALVE STROKED AS LONG AS THE ENGINE IS RUNNING
