## FORD MOTOR COMPANY TRUCKS 1996 AND LATER

### NO TORQUE CONVERTER CLUTCH APPLICATION AT LESS THAN 30 PERCENT THROTTLE

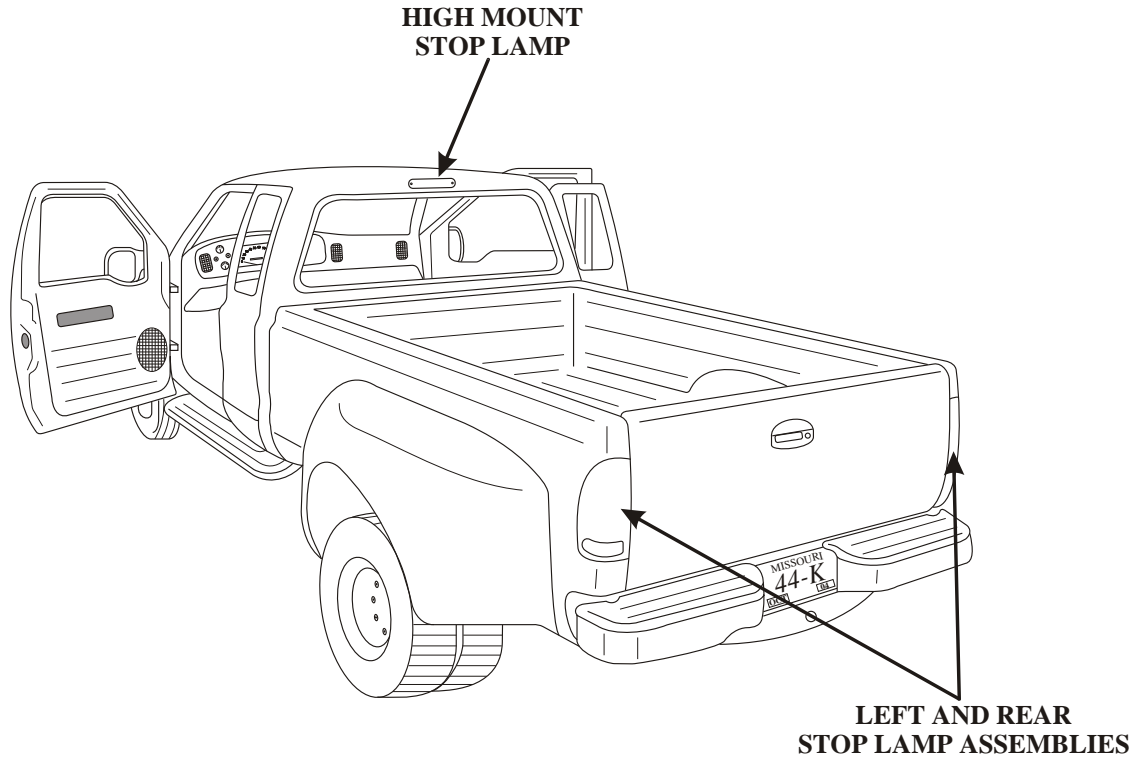
Figure 1

**CAUSE NO. 1:** One cause for this condition may be that one or more of the vehicle brake light bulbs, including the High Mount brake light may be burned out, or have a damaged filament (See Figure 1). When this condition is present, the PCM will detect an open in the brake lamp circuit, and due to a pull-up resistor in the PCM, will output voltage from PCM terminal 92 to the brake on-off switch (See Figure 2). As a result, the Torque Converter Clutch will not be applied at less than 30 percent throttle.

Replace any burned out brake lamp bulbs, including the High Mount brake lamp bulb, as shown in Figure 1. It is also important to note, that a bad ground for the rear lamp assembly, has also been known to cause the identical symptom. Refer to Figure 5 for the rear lamp assemblies ground location.

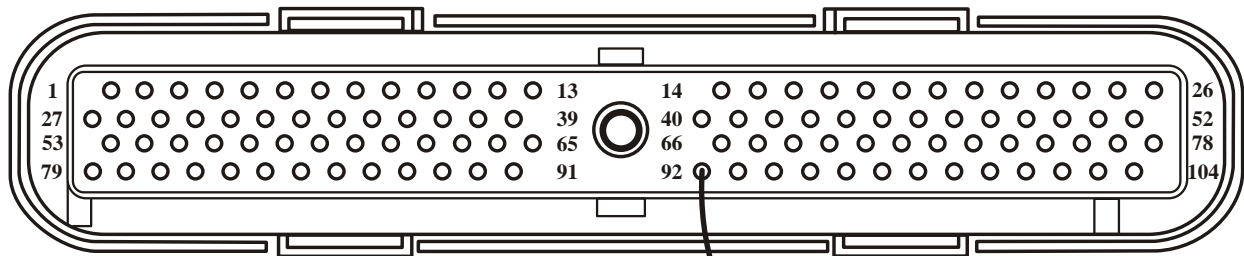
Figure 2

**Malfunction:** Check for 5 to 8 volts DC at PCM pin 92  
or at the Light Green wire at the Brake On-Off Switch

**Normal Operation:** 0 volts DC brake off  
12 volts DC brake on

Prior to any part replacement or modifications, it would be recommended to check for a 5 to 8 volt DC signal coming out of the PCM at terminal 92 using a volt meter set to read DC voltage. Voltage may also be checked at the Light Green wire located at the back of the Brake On-Off Switch. **Note:** *The example given is for a 1996 F-Series 7.3 Diesel.* This test will help to confirm that a circuit fault has been detected by the PCM. Refer to Figure 2. **Normal operation will be 0 volts DC, brake off, and 12 volts DC, brake on.**

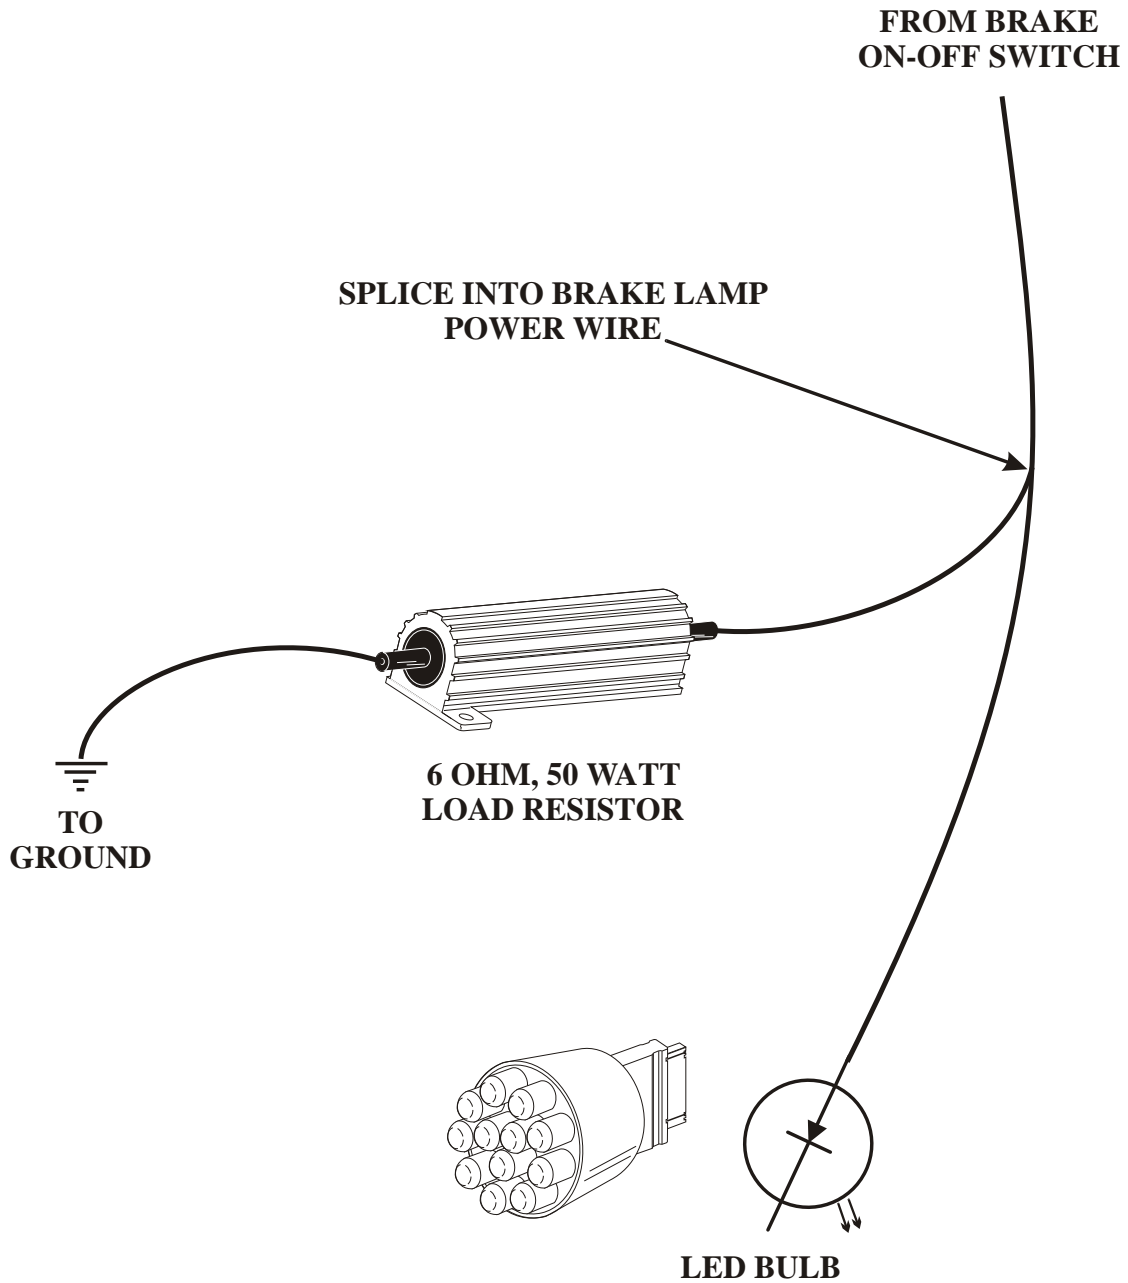
Figure 6

**CAUSE NO. 2:** Recently there has been an increase in the popularity of replacing the stock incandescent brake lamp bulbs, with aftermarket LED lamp assemblies. Refer to Figures 3 and 4. The main advantages of switching to LED lamp assemblies is that there are no fragile filaments to burn out or break, which means that the LED lamp assemblies may possibly last for the entire life of the vehicle, and LED lamps consume much less energy than the stock incandescent bulbs. Due to the low power consumption, the PCM *may* view this reduced current draw as being a burned out bulb, resulting in a no Torque Converter Clutch apply at less than 30 percent throttle.

For those vehicles that have had the stock incandescent bulbs replaced with aftermarket LED bulb assemblies, it *may* be necessary to install a 6 ohm- 50 watt Load Resistor across the brake light power wire to simulate the load of the regular stock incandescent bulb (See Figure 6). **Note:** *One resistor is required for use on each LED bulb assembly.*
