# Technical Service Information

## ZF 5HP-24

### SLIPPING OR NO FORWARD ENGAGEMENT

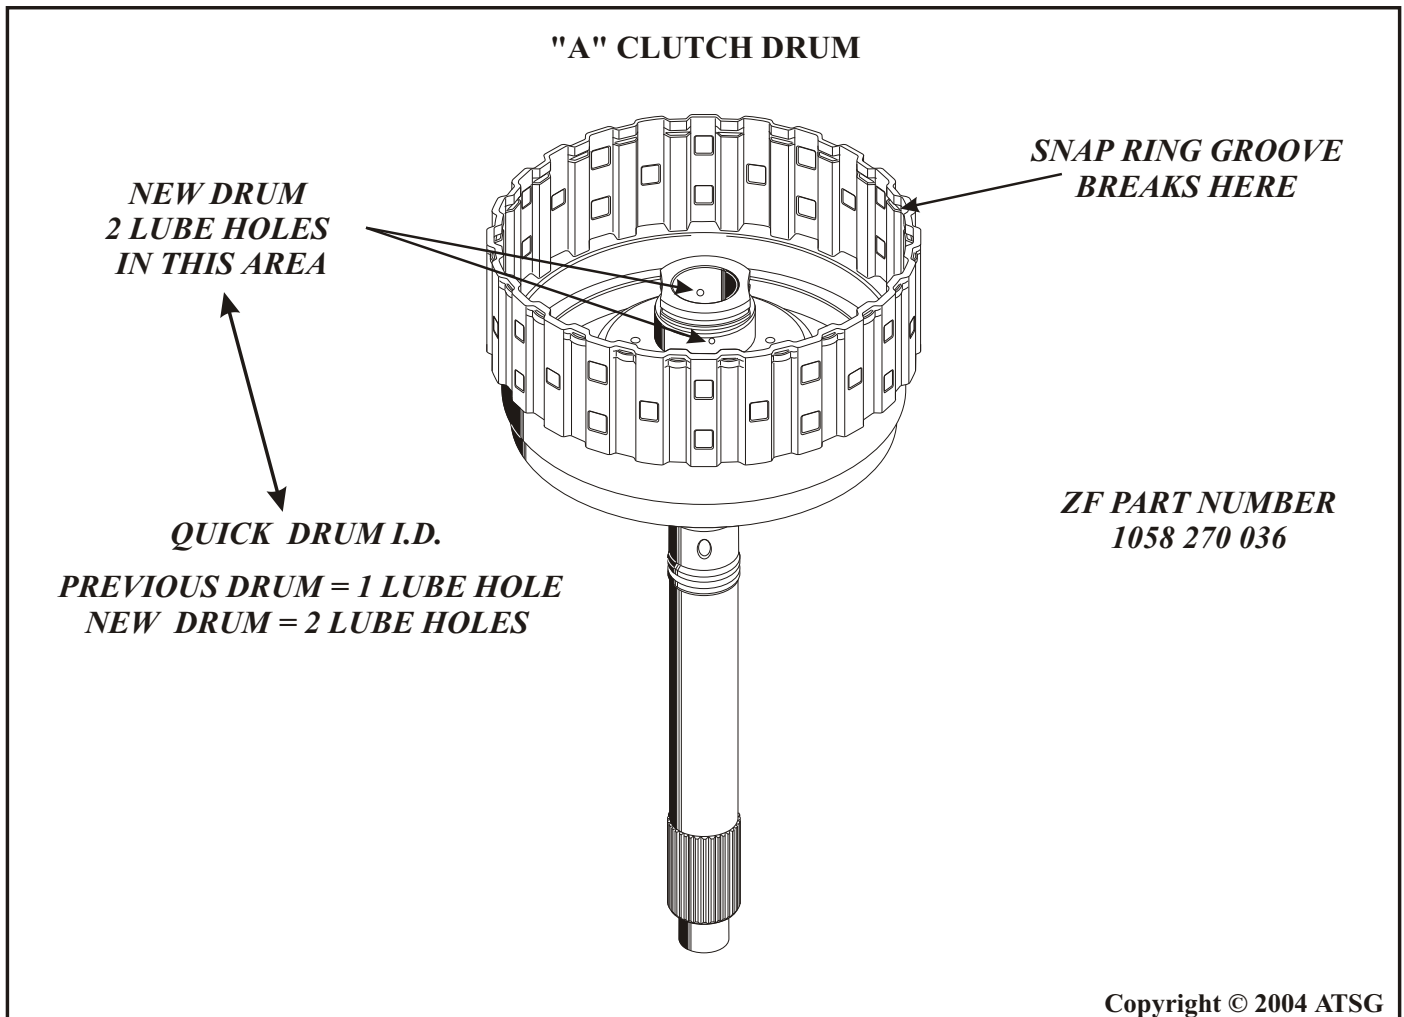
Figure 1

**COMPLAINT:** Vehicles equipped with the ZF 5HP-24 transmission may exhibit a Slipping or no Forward engagement.

**CAUSE:** The cause may be, a broken snap ring groove in the "A" Clutch Drum allowing the "A" Clutch to slip, as shown in Figure 1.

**CORRECTION:** Replace the "A" Clutch Drum with the updated drum available from ZF.

A CLUTCH DRUM (ZF part number).....1058 270 036
