Technical Service Information

MITSUBISHI F4A40/50 SERIES SHUDDERING ENGAGEMENTS OR HARSH SHIFTS

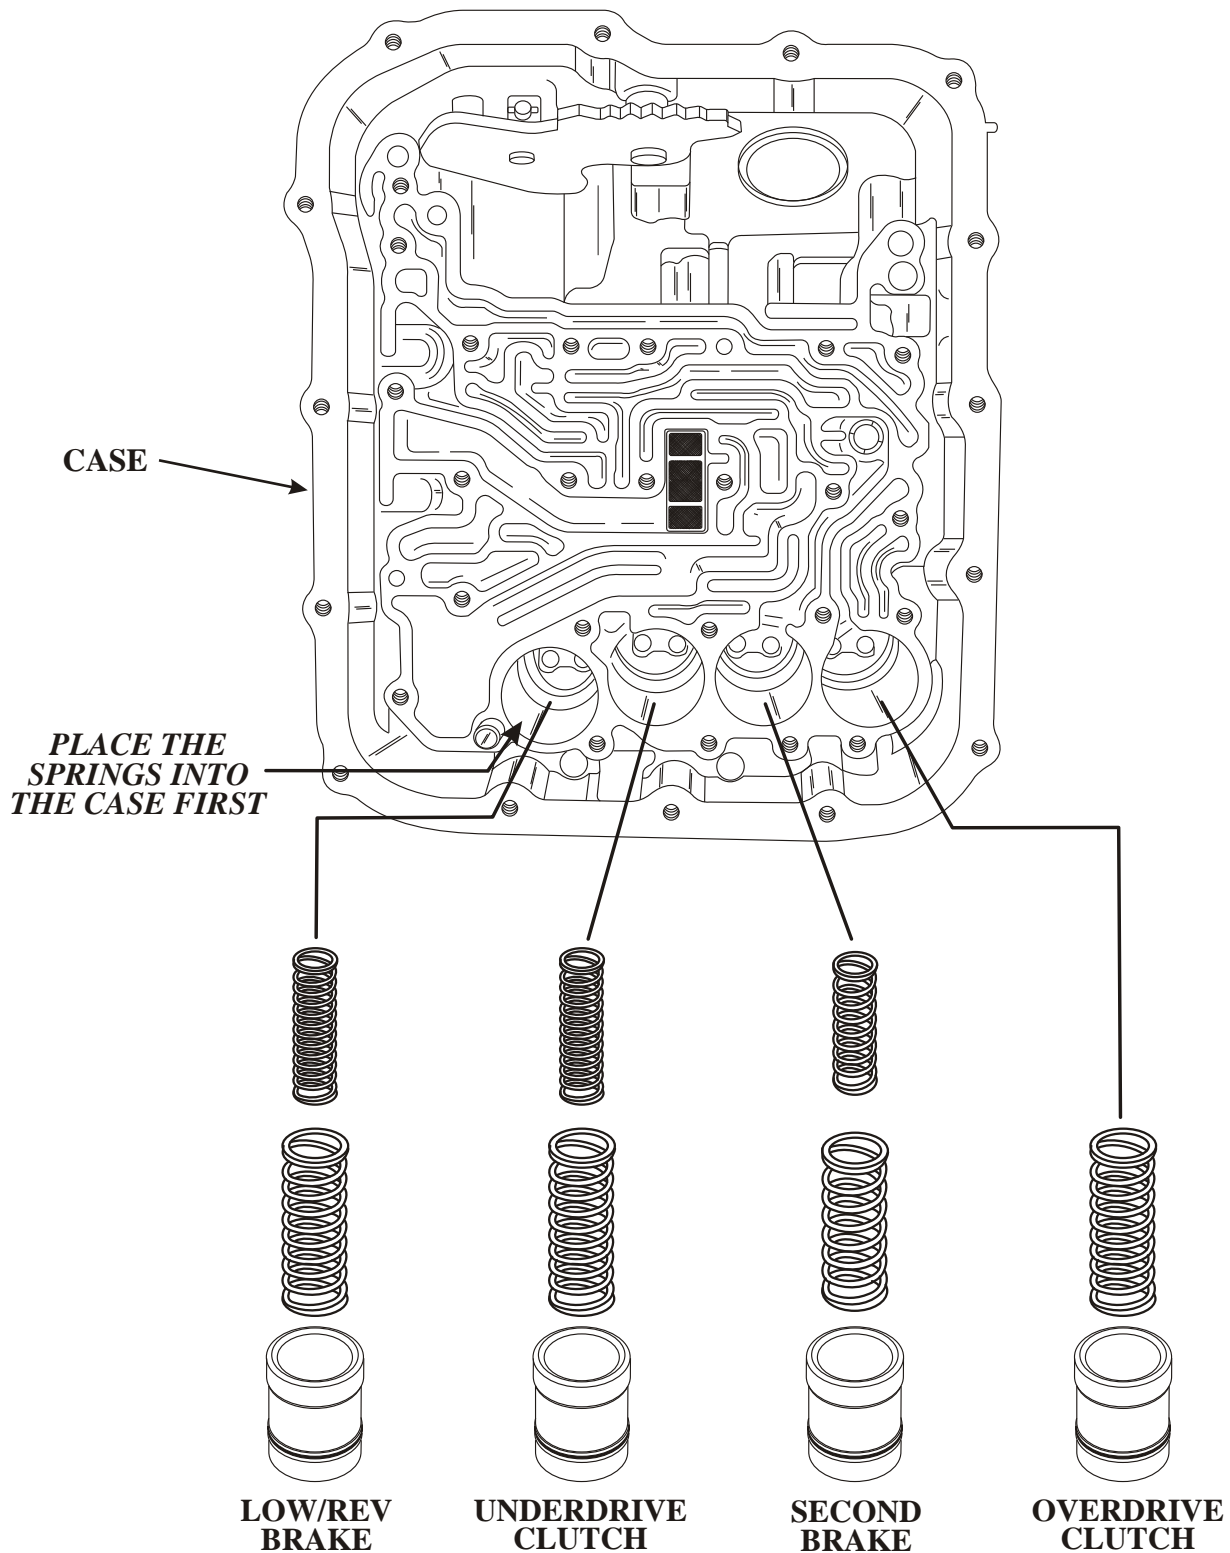
CAUSE: The cause may be, during overhaul, the Accumulator Pistons and springs were installed backwards into the case or the springs were mis-assembled in the Accumulator Pistons.

ACCUMULATOR PISTON AND SPRING PLACEMENT IN THE CASE

CORRECTION: Refer to Figure 1 for the spring dimensions for each Accumulator piston, and to Figure 2 for the correct accumulator identification and placement.

NOTE: *Ensure that each Accumulator line-up is placed into the case springs first.*
