FORD/MAZDA 4F27E/FN4A-EL DELAY IN "D" OR PREMATURE FORWARD CLUTCH FAILURE

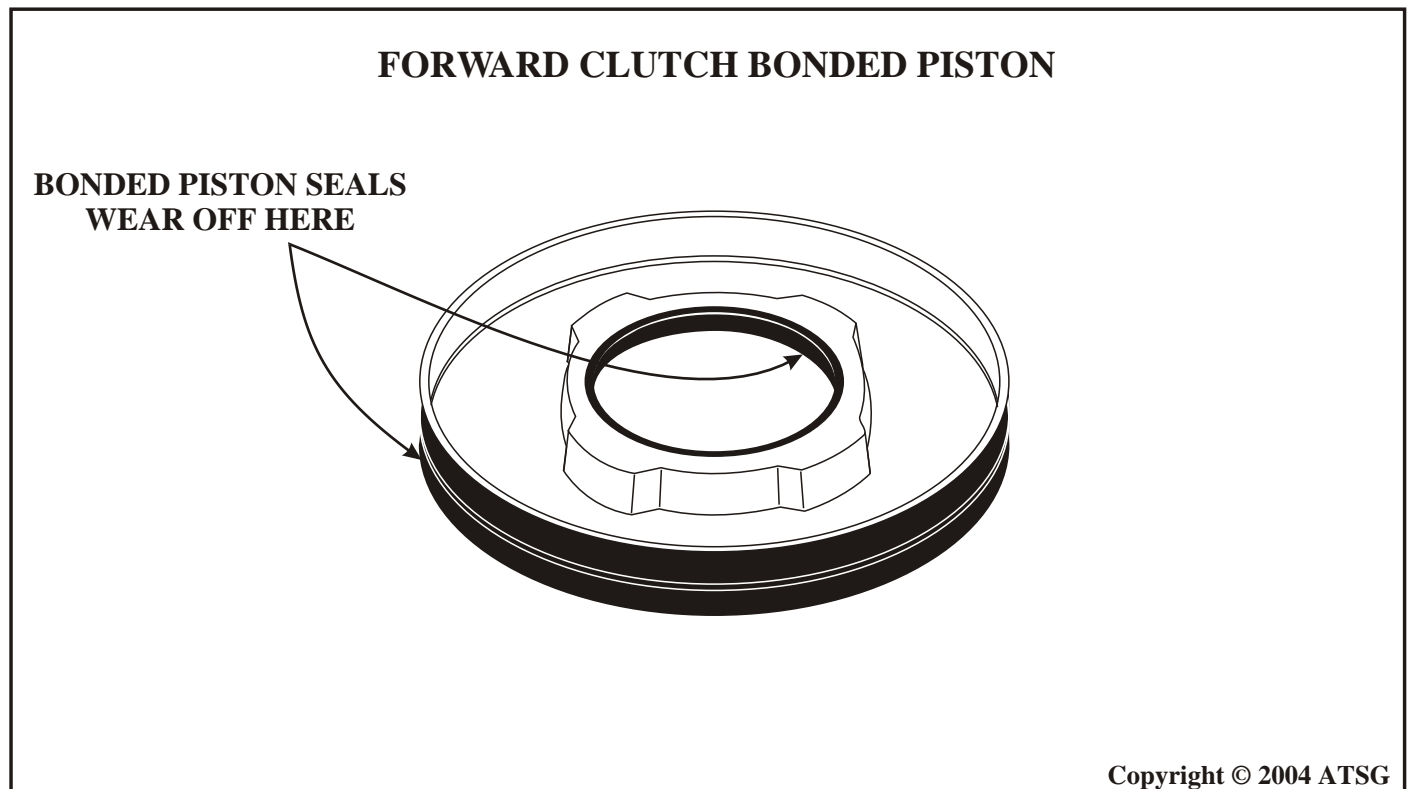
Figure 1

FORWARD CLUTCH BONDED PISTON (Ford Part No.)XS4P-7A262-CC

CORRECTION: To correct this condition, polish the inside of the Forward Clutch drum with Scotchbrite® or fine Emery paper to smooth the bonded piston seal contact surfaces, and then replace the Forward Piston, as shown in Figure 1.

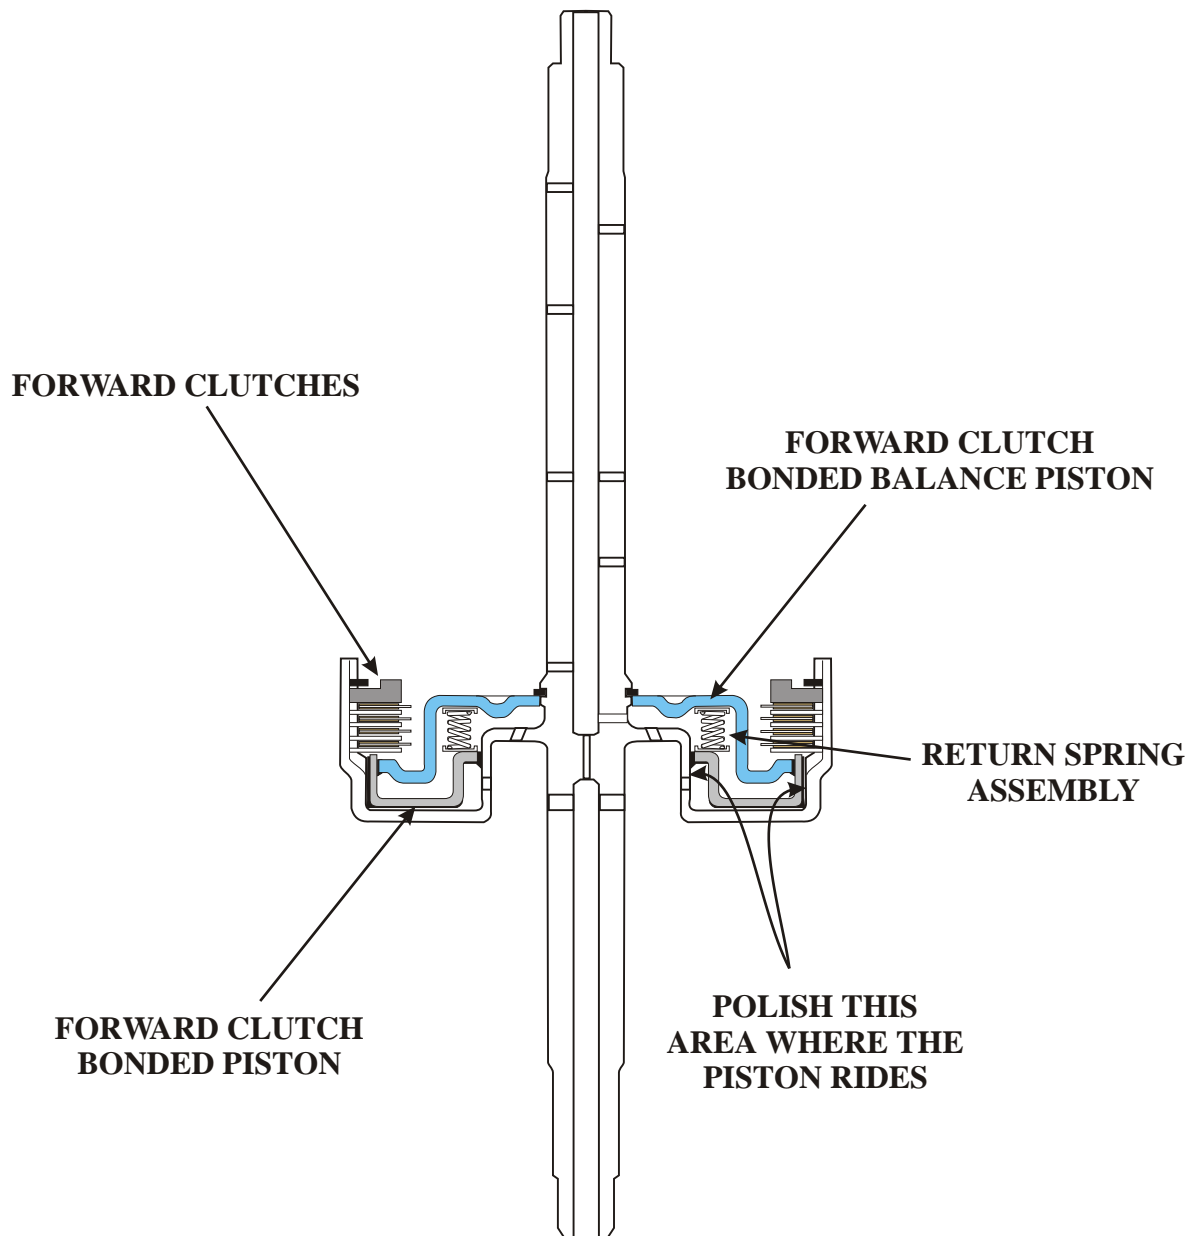
FORWARD DRUM ASSEMBLY

CAUSE: The cause may be, a rough finish inside of the Forward Clutch Drum surface, as shown in Figure 2, wearing the bonded piston seals down, creating a leak in the Forward Clutch circuit.
