MITSUBISHI F4A40/50 SERIES HARSH OR FLARED 3RD GEAR UPSHIFT

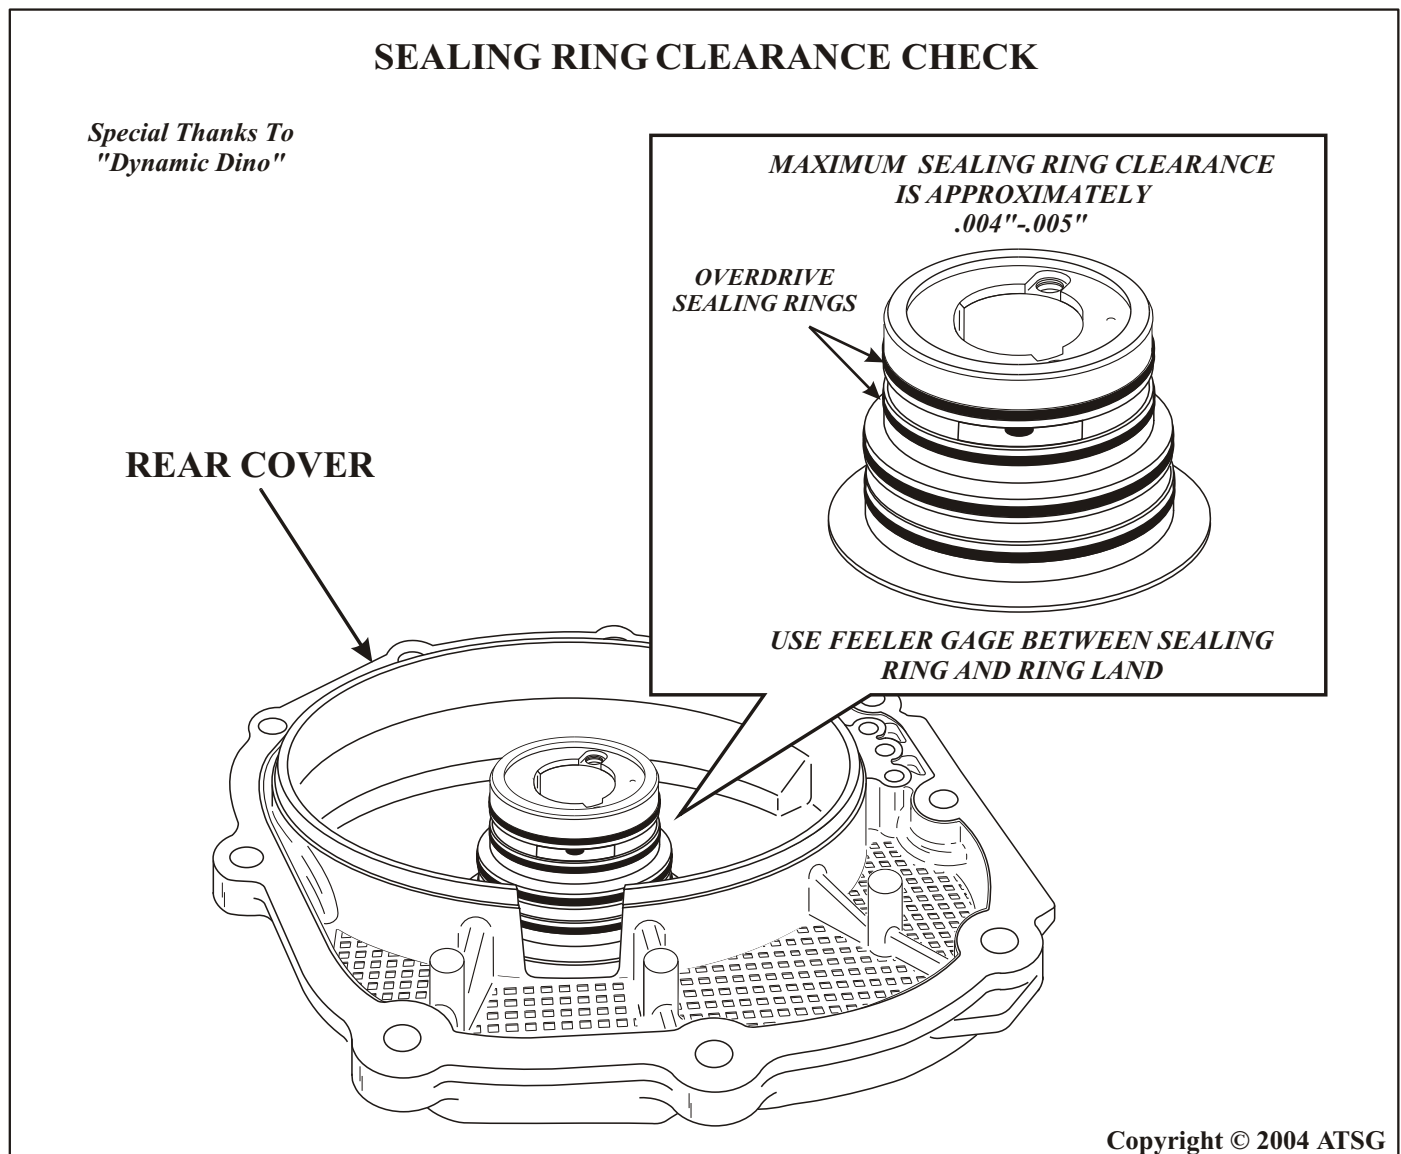
COMPLAINT: Before or after overhaul, vehicles equipped with the F4A40 or F4A50 series transaxles may exhibit a Flared or Harsh upshift into 3rd gear.

CAUSE: The cause may be, worn sealing ring lands where the Overdrive Clutch sealing rings ride, creating leakage in the Overdrive Clutch circuit.

CORRECTION: Refer to Figure 1 to identify the Overdrive Clutch Sealing Rings. Using a feeler gage ensure that there is no more than .005" clearance between the sealing ring and the sealing ring groove. Replace Rear Cover as necessary.
