# Technical Service Information

## AISIN SEIKI 450-43LE NO THIRD OR REVERSE

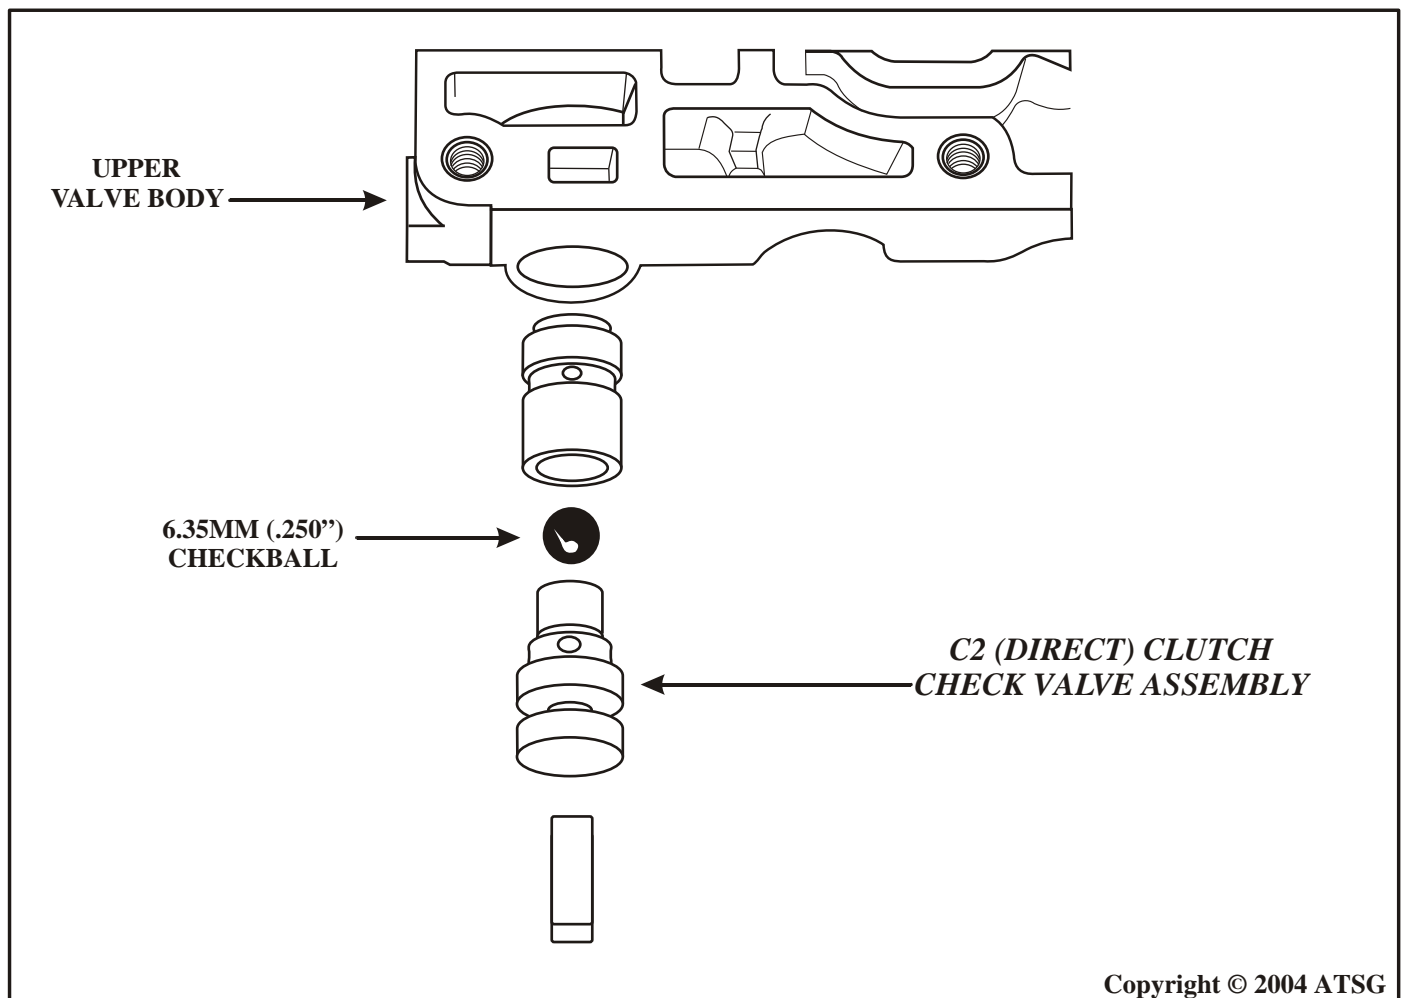
Figure 1

**COMPLAINT:** After rebuild, the transmission exhibits no movement in reverse and no third gear.

**CAUSE:** The cause may be, the C2 (Direct) Clutch check valve missing. This check valve is actually a 6.35mm (.250") checkball, as shown in Figure 1, and switches C2 (Direct) Clutch apply oil between the 3rd gear circuit and reverse circuit. If left out both circuits are exhausted.

**CORRECTION:** Install the correct C2 (Direct) Clutch check valve line-up, as shown in Figure 1. The steel checkball in the C2 Clutch check valve assembly is 6.35mm (.250") in diameter. We have also provided you with the other checkball locations for both the upper and lower valve bodies in Figure 2 and 3.

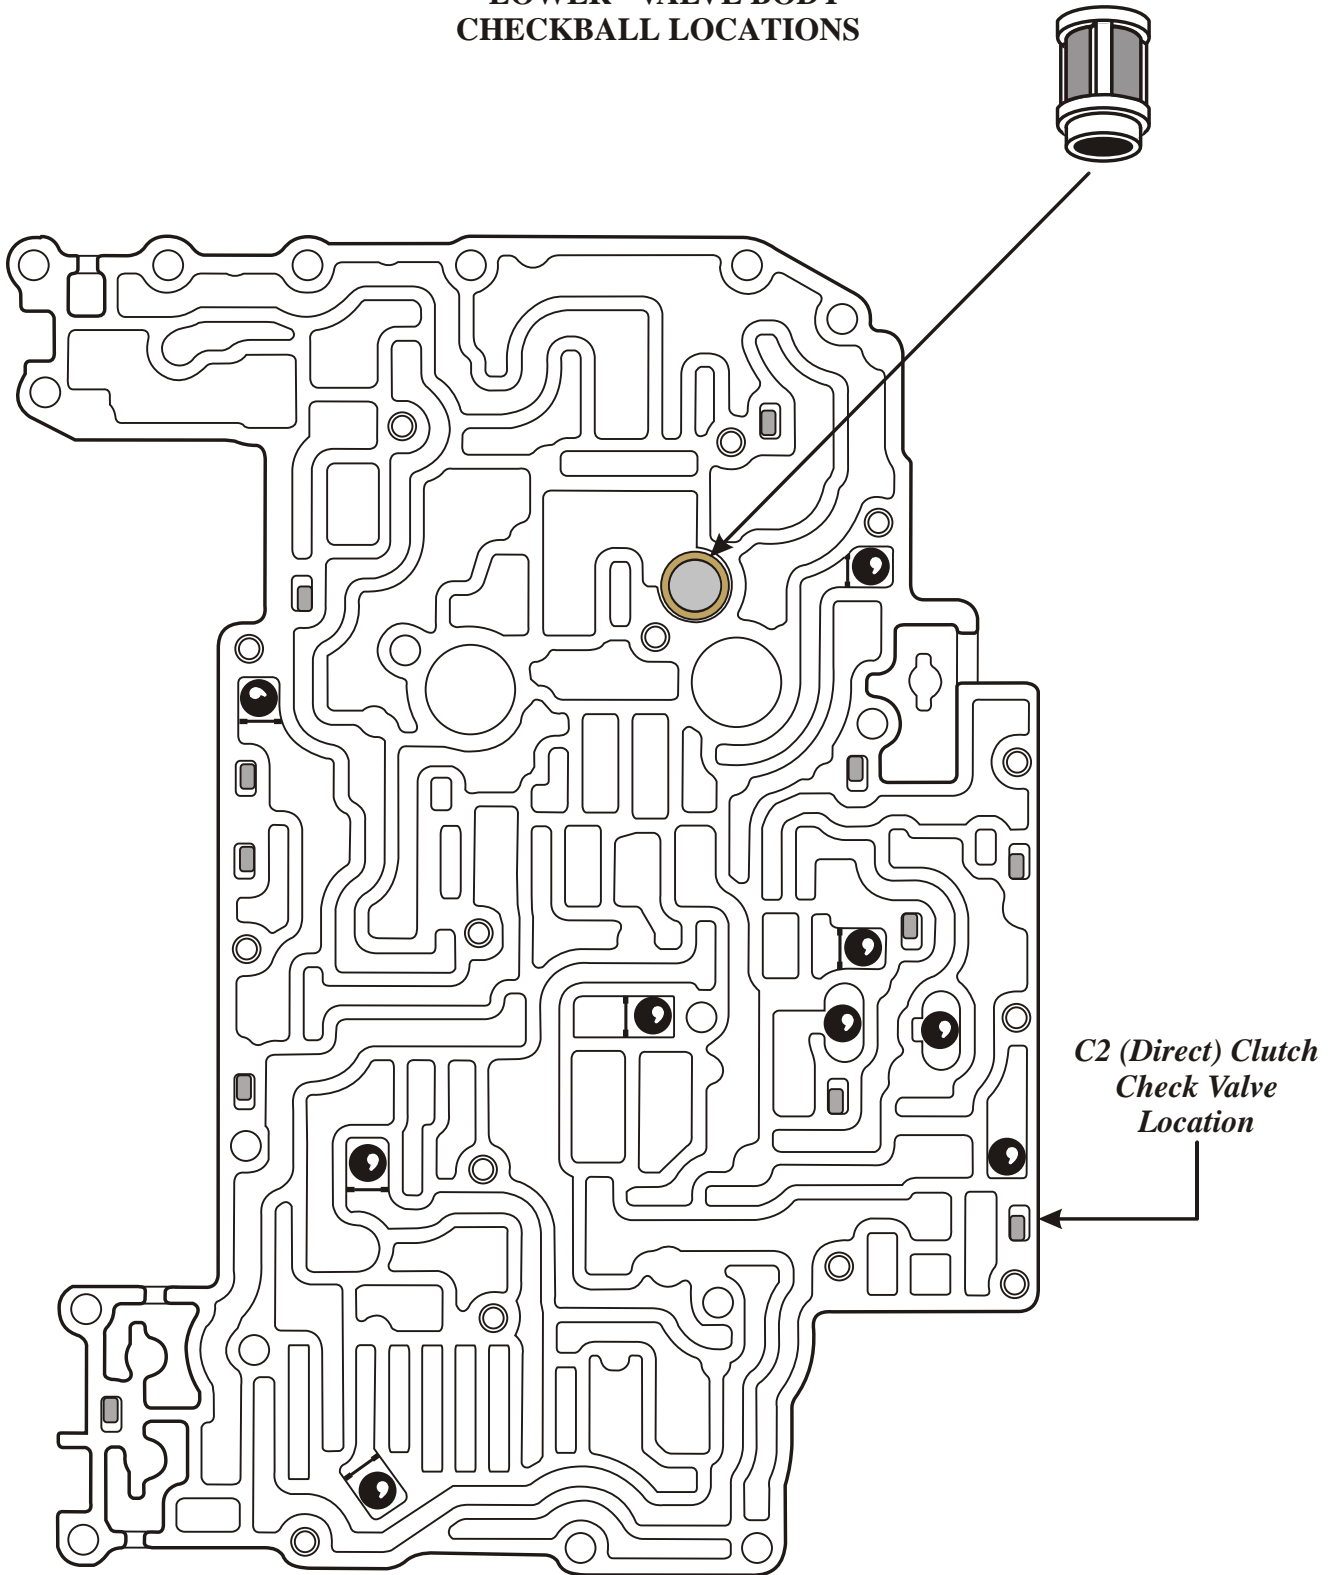
Figure 2

**THE UPPER VALVE BODY REQUIRES NINE 6.35MM (.250") STEEL CHECKBALLS IN THE WORM TRACK AREA, PLUS THE "C2" CLUTCH CHECK VALVE ASSEMBLY.**

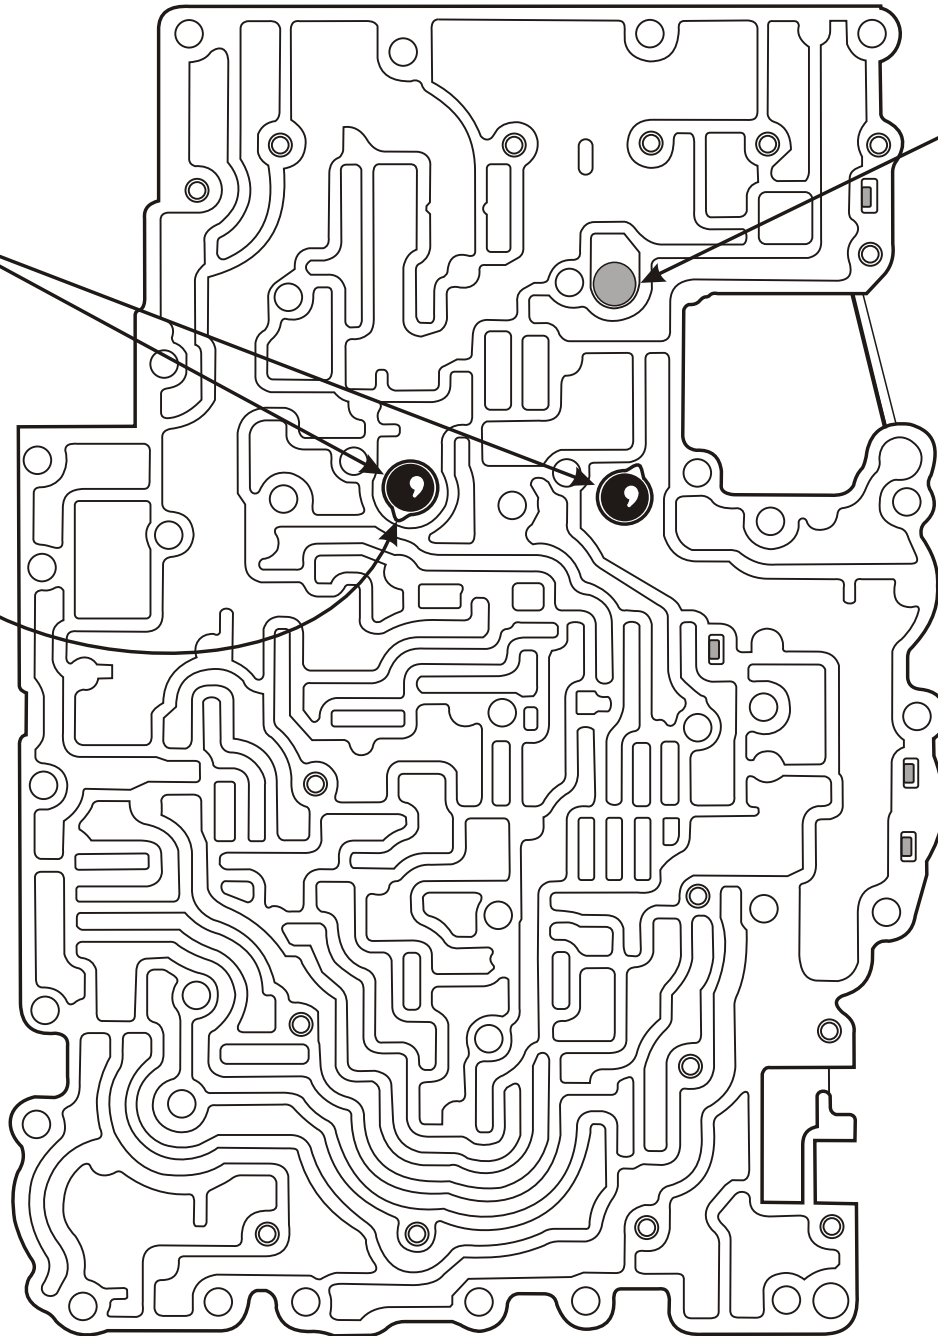
Figure 3

*Make Certain  
This Raised Leg  
Fits Into The  
Notch In The  
Valve Body*

**THE LOWER VALVE BODY HAS TWO 10.00MM (.394")  
STEEL CHECKBALLS ON BARREL SPRINGS AND CAPSULES**
