# Technical Service Information

## THM 4L80-E CENTER GEAR BOX CHANGES FOR 1999 MODELS ("REVISED INFORMATION")

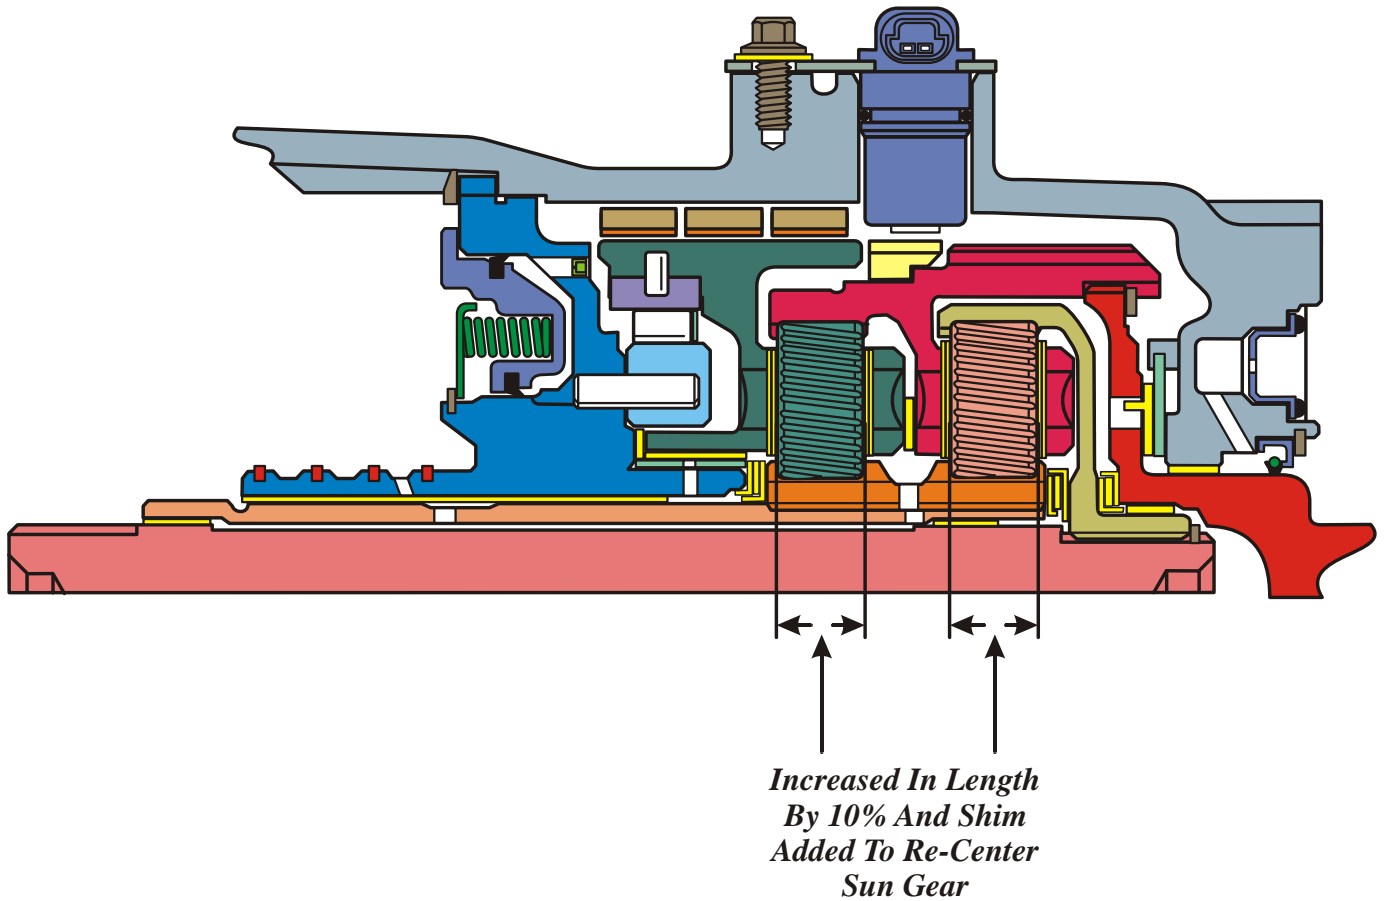
Figure 1

**CHANGE:** Beginning at the start of production for all 1999 model THM 4L80E transmissions, the planetary pinions on both carriers were produced 10% thicker than the previous models, as shown in Figure 1. This engineering change required the addition of a .041" shim in the gear train to re-center the sun gear in the new planetary pinions and affected several internal parts, that may create some confusion, and thus some mis-assembly concerns.

- (1) PLANETARY PINION GEARS - Were increased in length by approximately .075" in both front and rear carriers, as shown in Figure 1, for increased durability.
- (2) ADDED .041" SHIM - There was a .041" shim added between the thrust bearing and the rear internal ring gear, to re-center the sun gear in the revised planetary pinion gears, as shown in Figure 2.
- (3) CENTER SUPPORT - Required a .041" recess to be machined into the center support bearing surface, to accommodate the sun gear being re-centered in the revised planetary pinion gears, as shown in Figure 3.

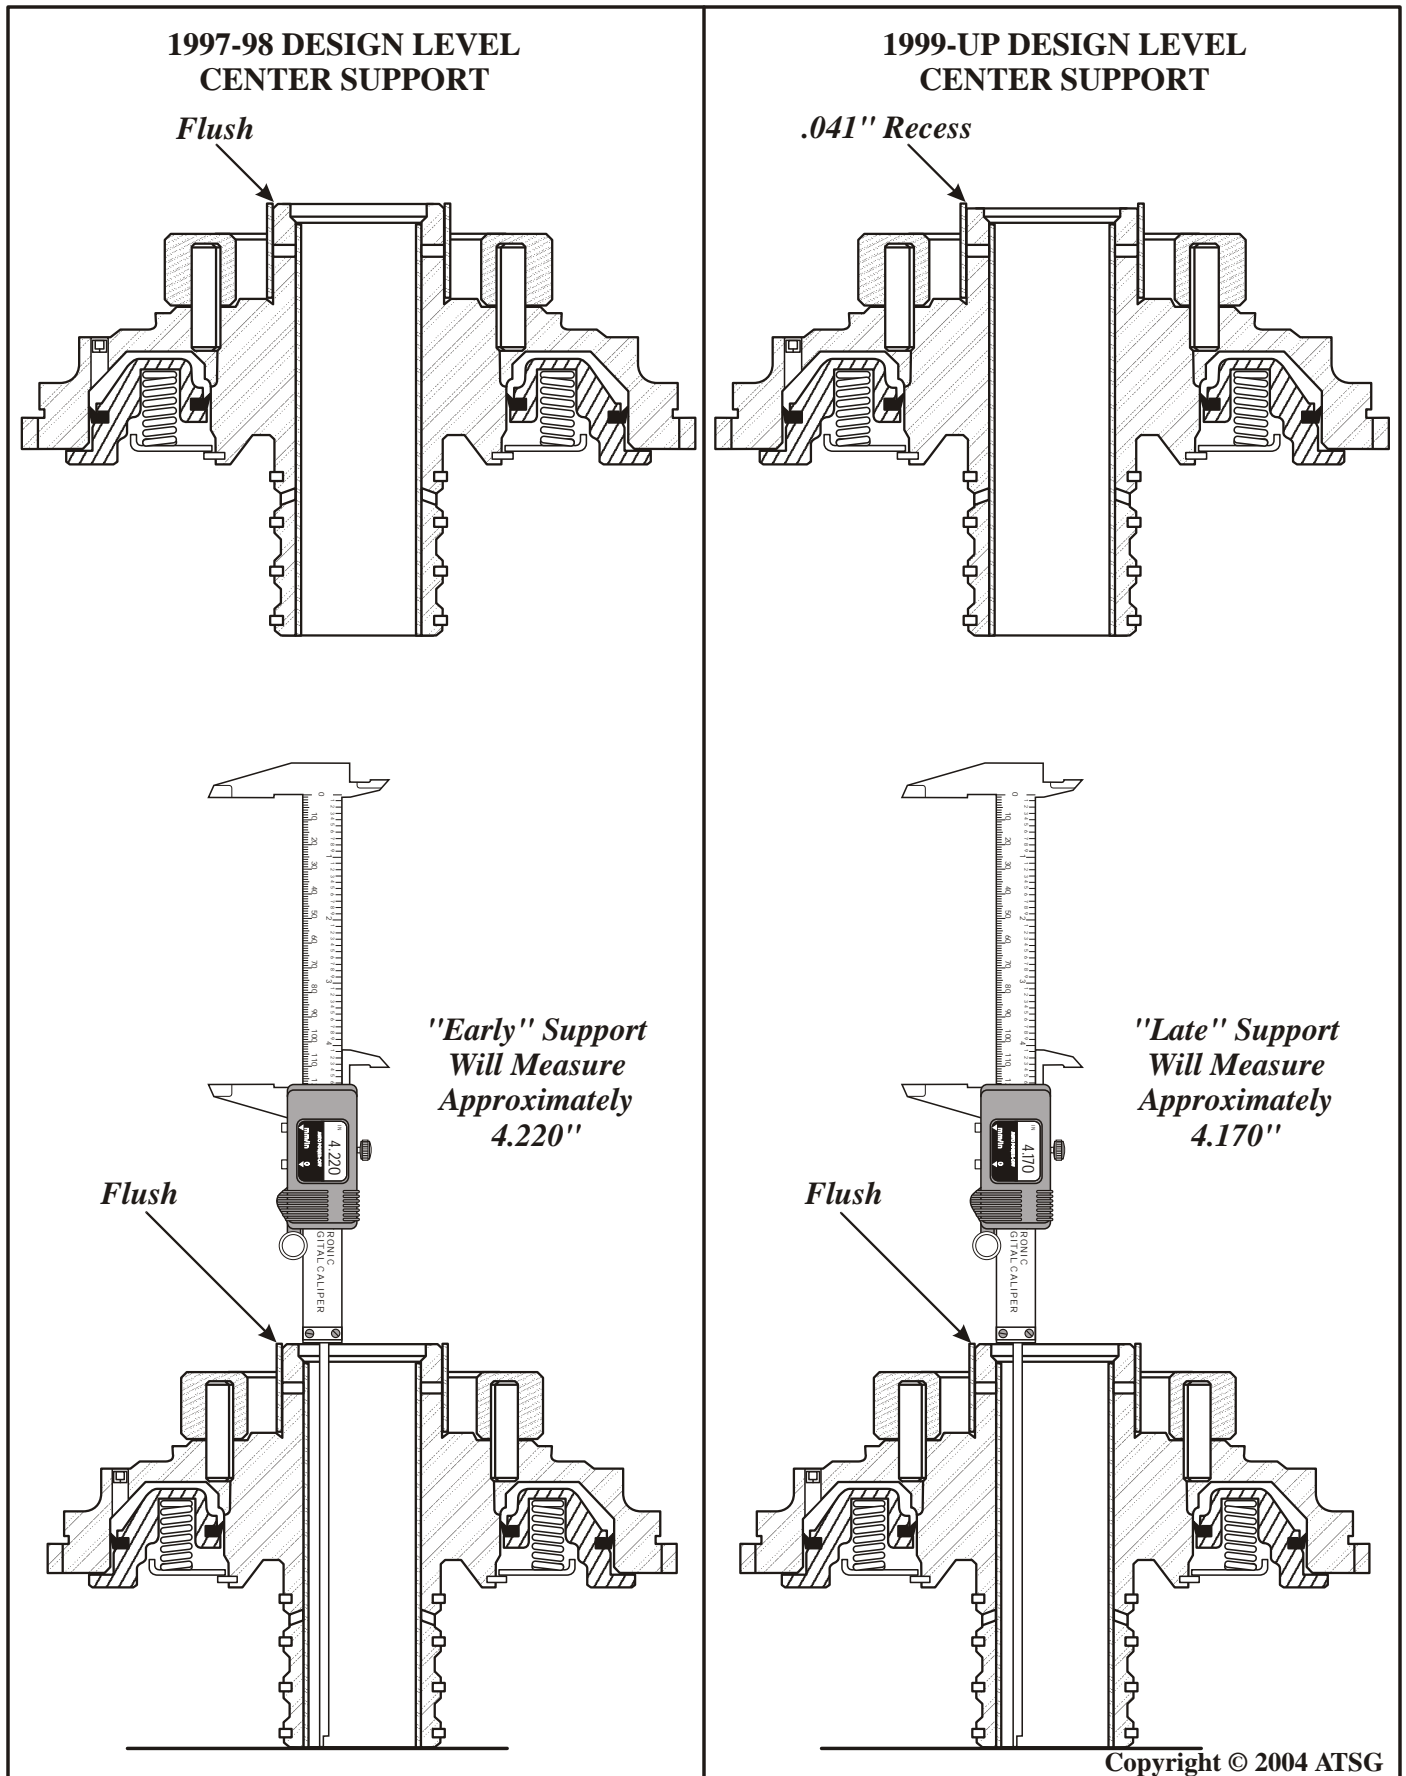
Figure 3

**SPECIAL NOTE:** *Sometime in 2000 GM. eliminated the only visual identification from the updated center support and it now "Requires" measurement for identification, as shown Figure 3.*

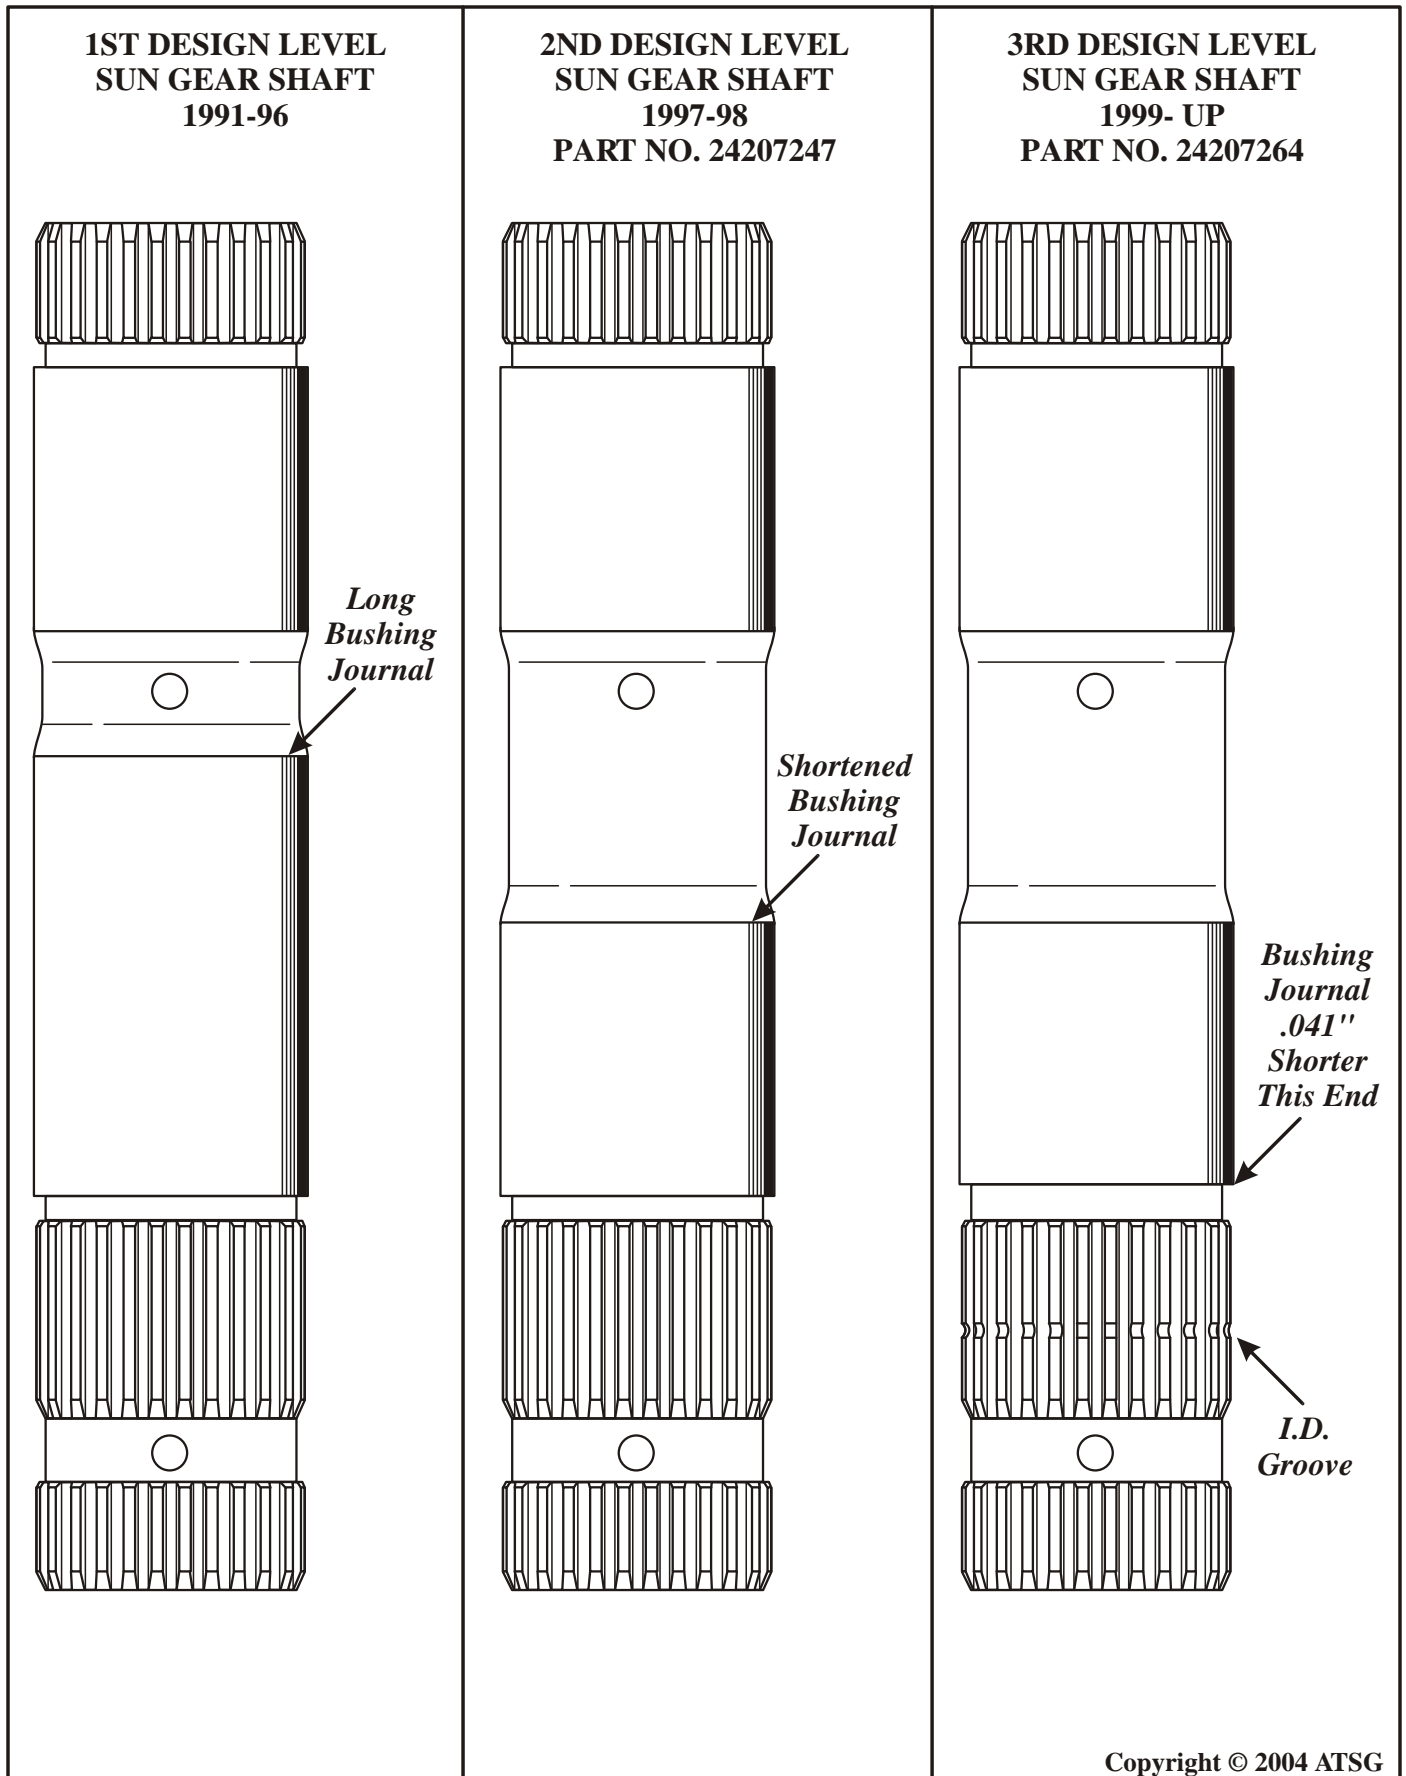
Figure 4

- (4) SUN GEAR SHAFT - Required that .041" be removed from the bottom of the rear bushing journal, to accommodate the re-centering of the sun gear in the revised planetary pinion gears, as shown in Figure 4. Notice that revised sun gear shaft can be identified with a groove cut into the shaft splines, as shown in Figure 4.

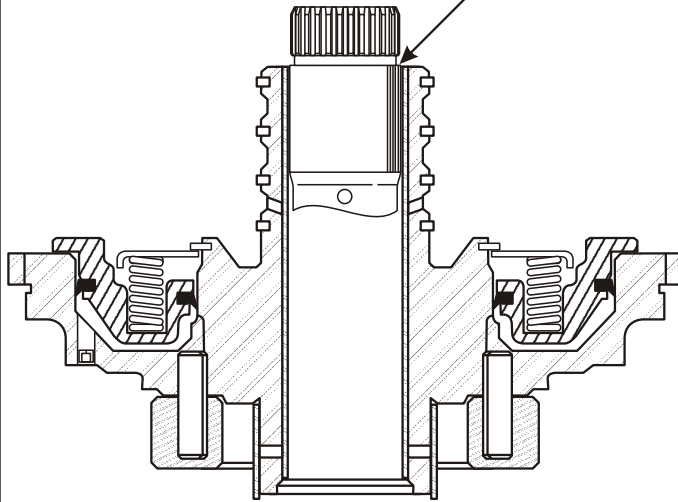
1999 SUN GEAR SHAFT  
WITH 1997-98 CENTER SUPPORT  
AND NO .041" SHIM

*Shaft Journal  
Approximately  
Flush With Support*

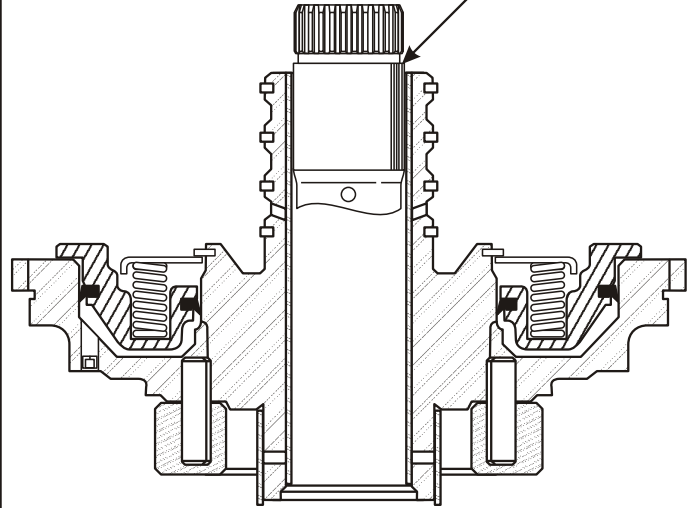
1997-98 SUN GEAR SHAFT  
WITH 1999 CENTER SUPPORT  
AND WITH .041" SHIM

*Shaft Journal  
Approximately  
.090" Above Support*

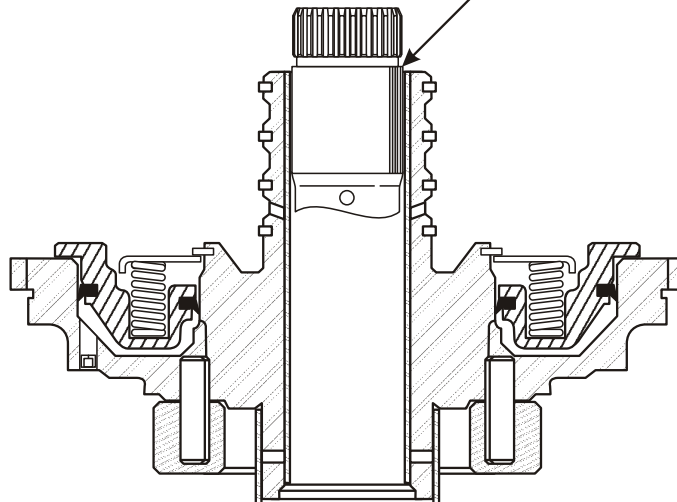
"CORRECT ASSEMBLY"  
WITH PROPER  
SUN GEAR SHAFT  
AND CENTER SUPPORT

*Shaft Journal  
Approximately  
.050" Above Support*
