FORD 5R110W "TorqShift" HARSH FORWARD ENGAGEMENT

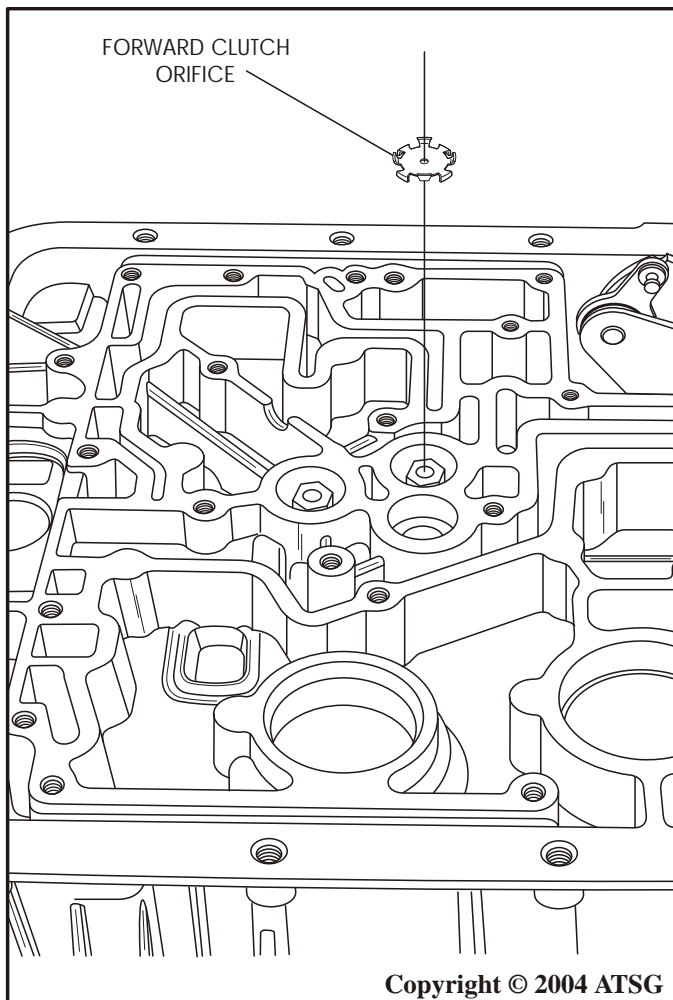
CAUSE: The cause may be, the forward clutch orifice missing, or misplaced into the intermediate clutch feed instead of the forward clutch feed. (See Figure 1 and 2).
