## FORD 5R110W "Torqshift"

### INTERNAL HARNESS OR SOLENOID BODY SERVICE

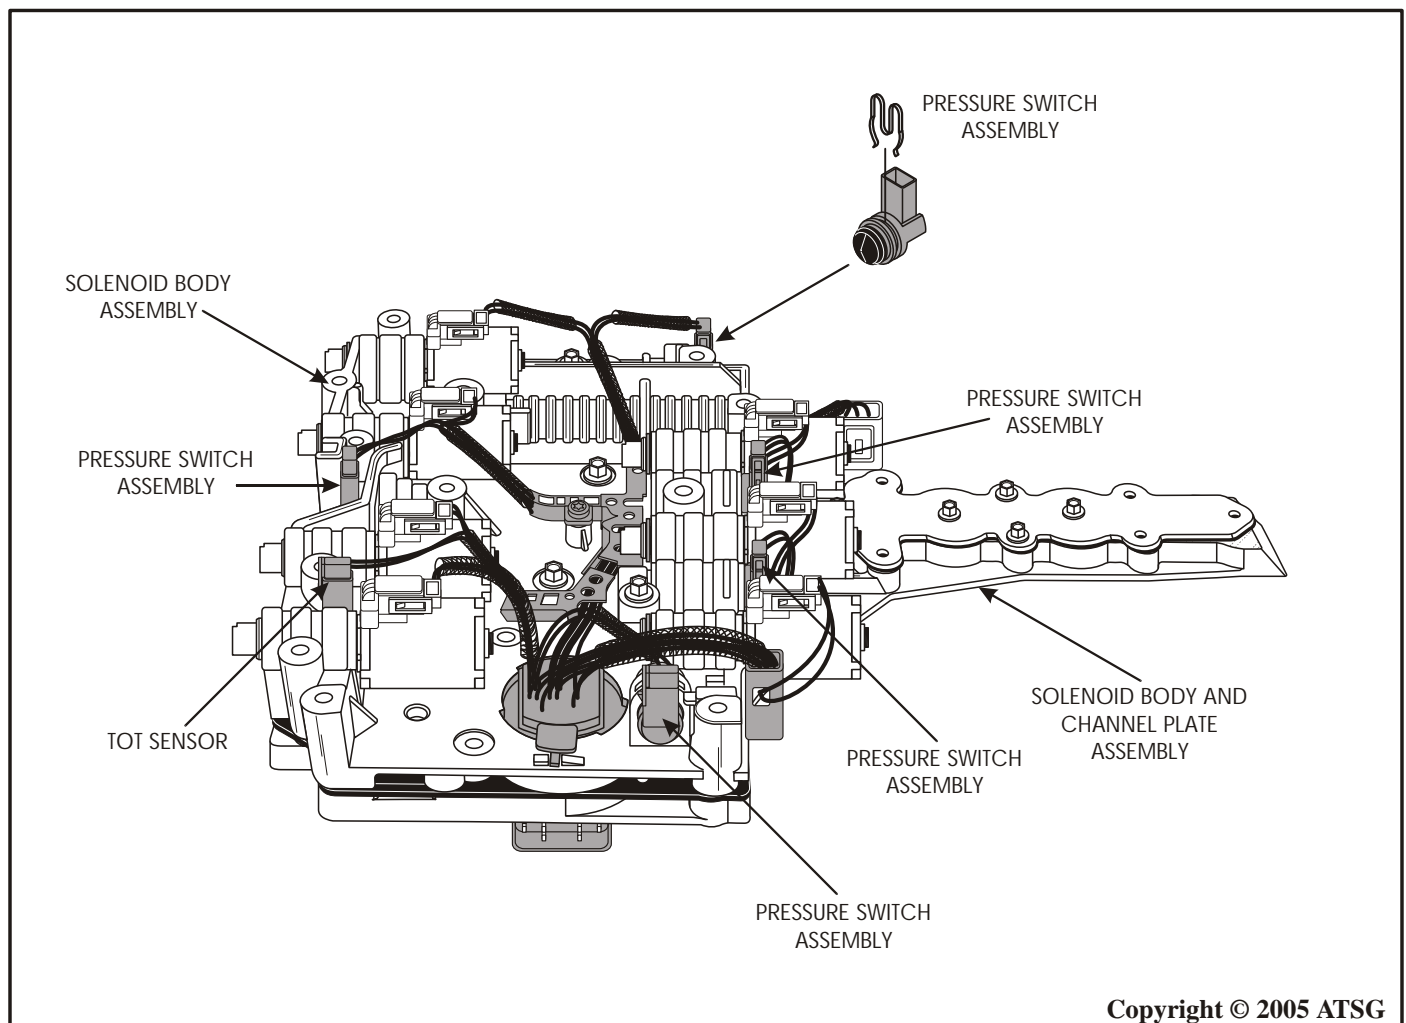
1. You may have to install a new service harness, without pressure switch connectors, into a unit that has pressure switches in the solenoid body. (See Figure 1 for locations)
2. You may have to install a new service solenoid body, without pressure switches, into a unit that has the original internal harness with pressure switch connectors. (See Figure 1 for locations)

**Note:** *These are both acceptable repairs and will not affect the function or operation of the transmission. Use of the pressure switch input was dropped from the vehicle calibration before the 2003 model year went into production.*
