FORD MOTOR COMPANY AX4N 1999 - UP MOMENTARY NEUTRAL ON ACCELERATION SHIFT SELECTOR IN OD POSITION ONLY

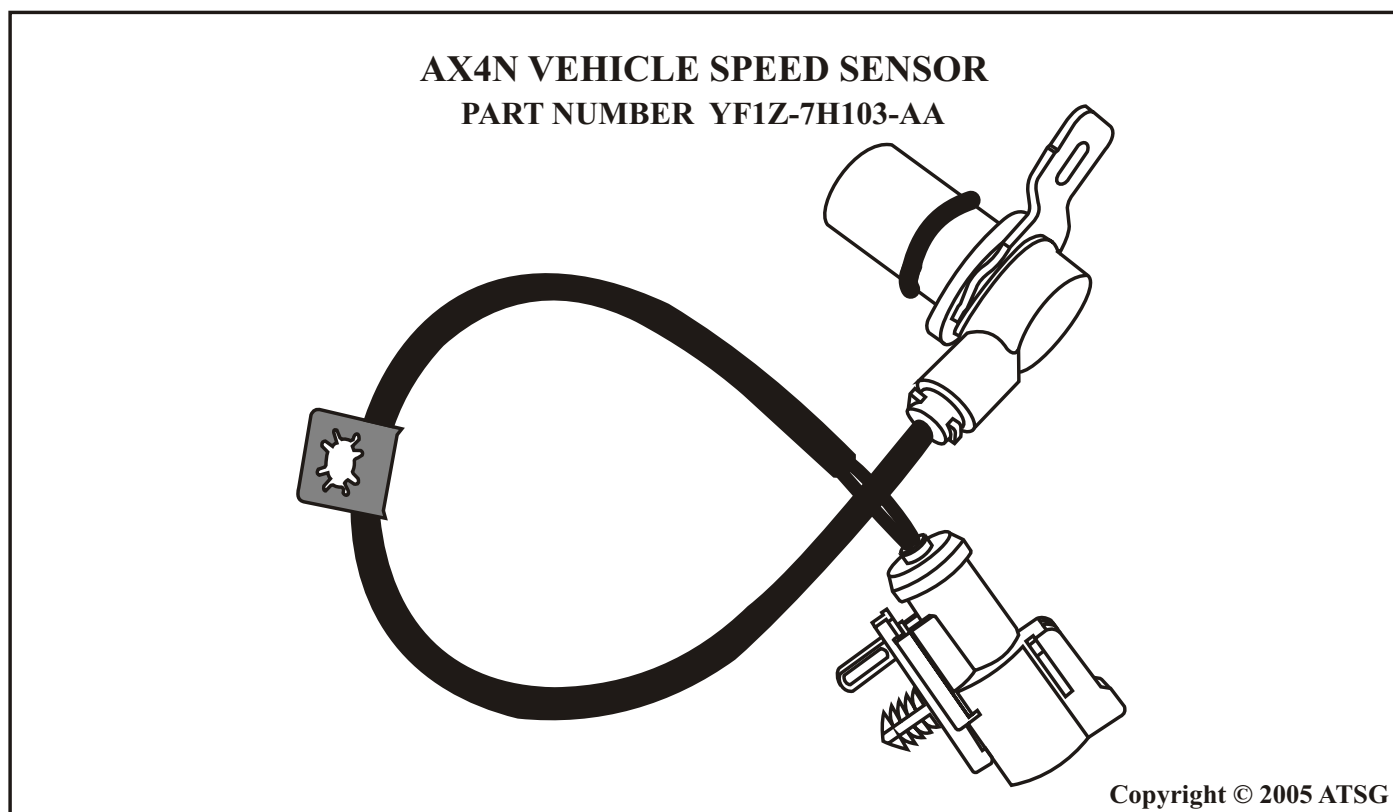
Figure 1

CAUSE: The cause may be that a faulty Vehicle Speed Sensor is causing this complaint. See Figure 1. It is a new design Vehicle Speed Sensor that is a Permanent Magnet Sensor that reads off the park gear. See figure 2. **Reason:** when the neutral feeling occurs it is a fault in the signal that is sent to the PCM, telling it that the vehicle speed has just increased from approximately 15 mph to approximately 35 to 40 mph. When this happens the trans is still in first gear, the PCM turns on Shift Solenoid 3 momentarily and then turns it back off again. At the time that Shift Solenoid 3 is on it allows the Forward Clutch Control Valve to move to a downshifted position, at which time the Forward Clutch exhausts causing the trans to slip into a neutral condition. Figure 3 shows Shift Solenoid 3 off, and the Forward Clutch applied. Figure 4 shows Shift Solenoid 3 on, and the Forward Clutch off.

CORRECTION: Replace the Vehicle Speed Sensor with Ford Part Number YF1Z-7H103-AA
