JR403E ELECTROMATIC

ATF LEAKING FROM THE VENT

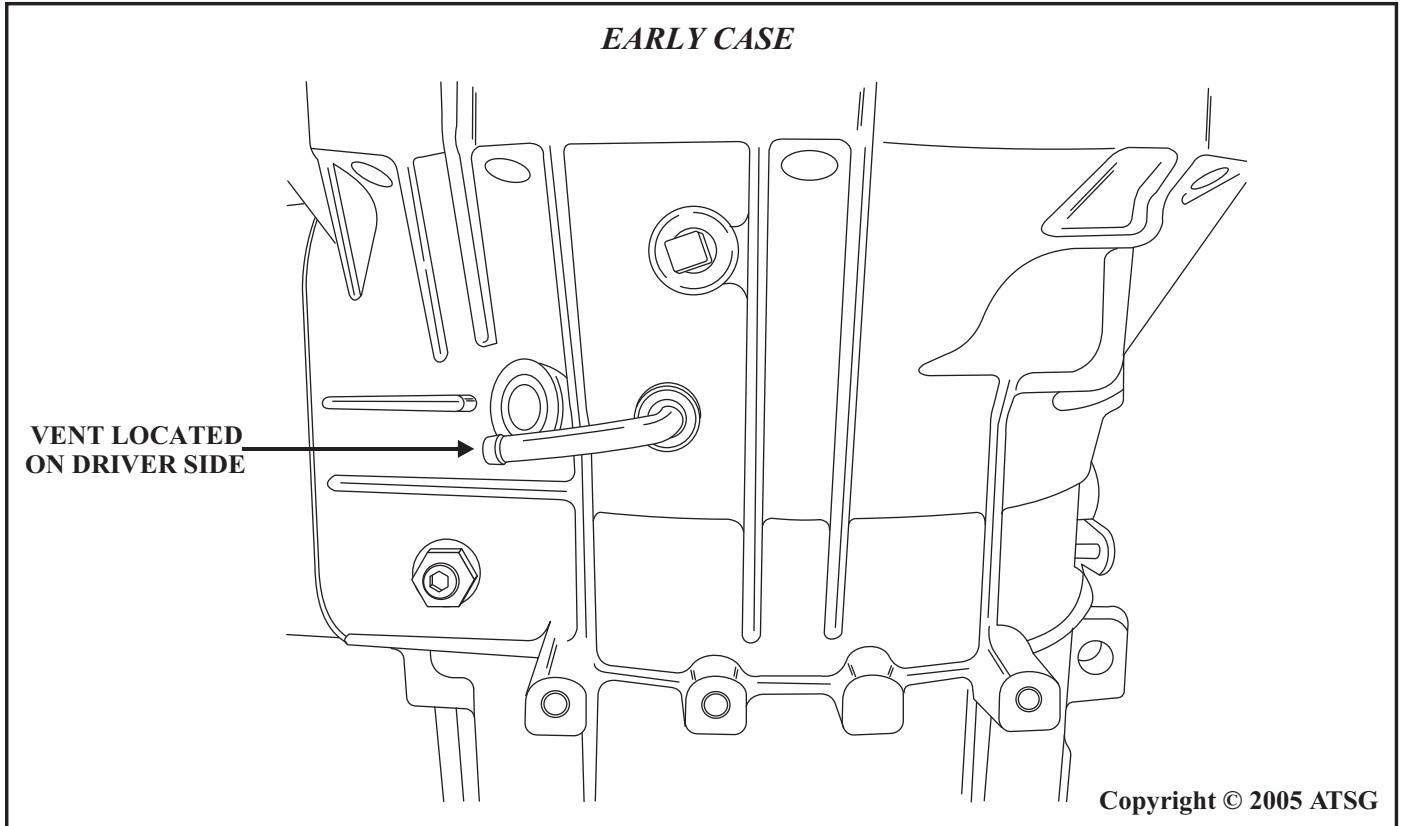
Figure 1

CAUSE: The replacement pump did not match the case that it went into which is the cause of the above complaint. There are two (2) different pump and case designs and they vent differently.

CORRECTION: The case in figure 1 is an *early* case, *notice* that the vent tube is located on the driver side. The case in figure 2 is a *late* case, *notice* that the vent tube is located on the passenger side and the driver side location is cast shut. The vent hose on the late case runs through the case mounting area as seen in figure 3.

The early and late pumps and cases cannot be interchanged, doing so will result in the above mentioned complaints.

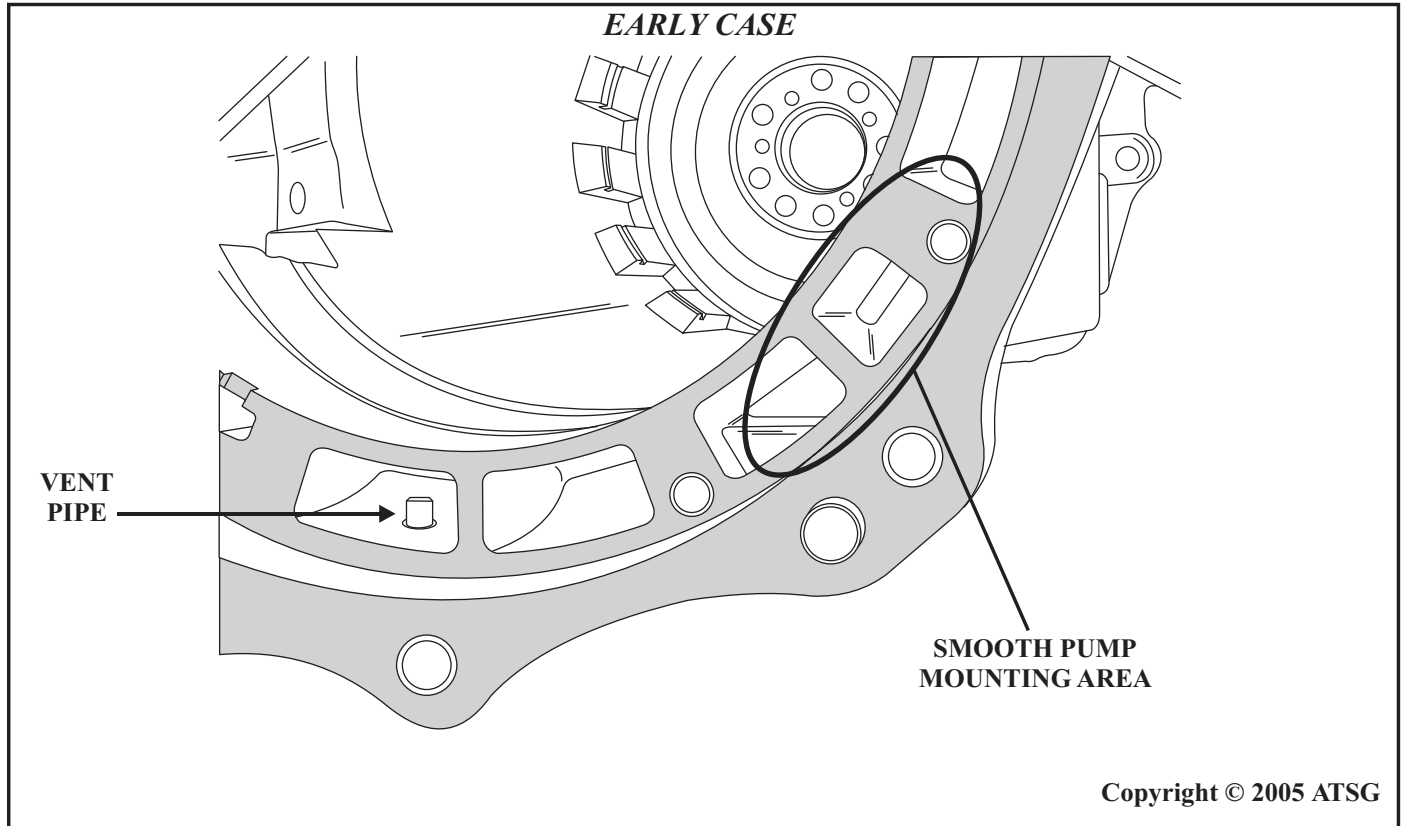
Figure 4

The pump mounting area in the case shown in figure 4 is a smooth mounting area encompassing the vent pipe, this is the *early* case. The pump mounting area in the case shown in figure 5 has channels cut in the pump mounting surface with the vent pipe on the opposite side of the case, this is the *late* case.

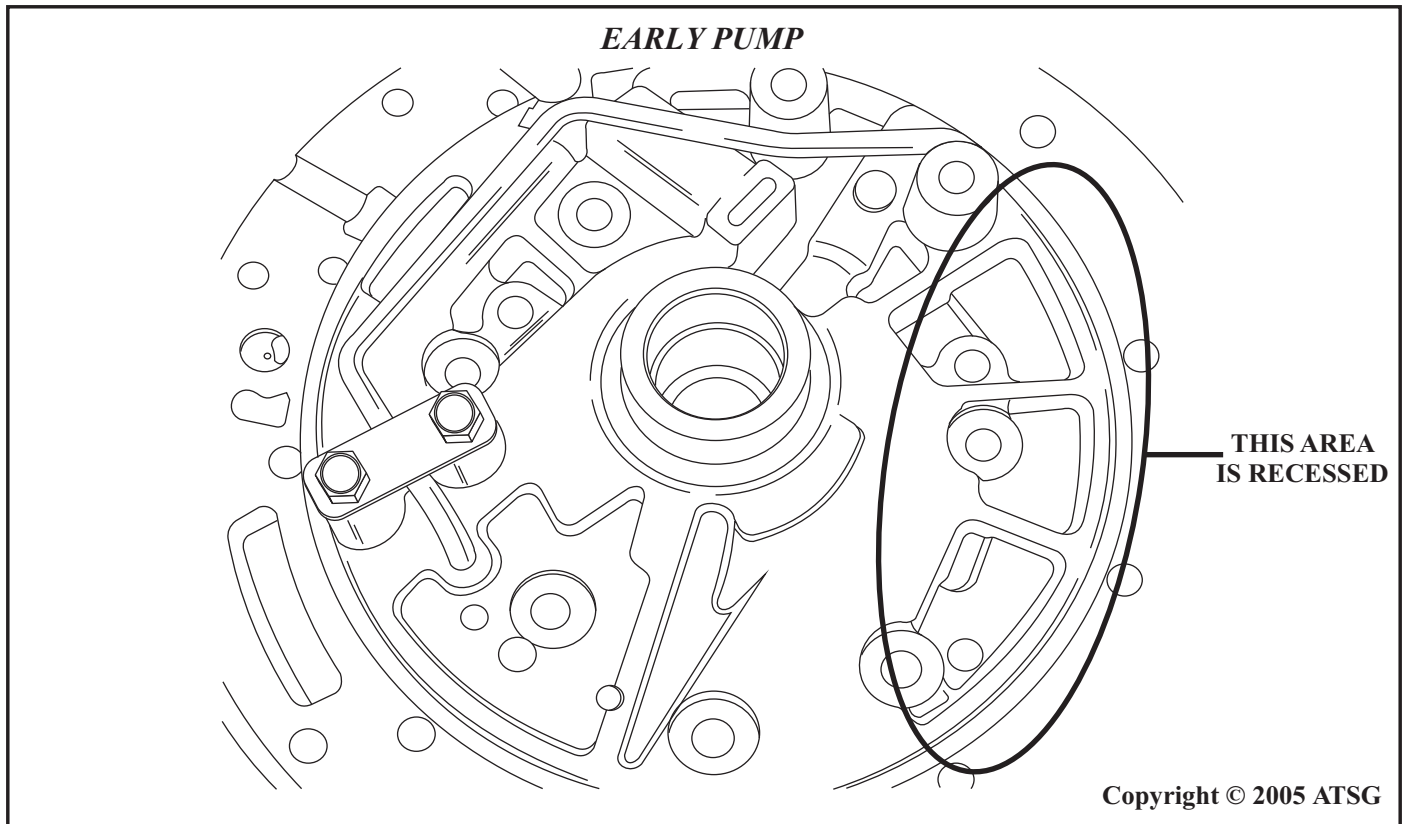
Figure 6

The pump shown in figure 6 is an *early* pump and goes with the *early* case, *notice* the highlighted area, it is recessed. The pump shown in figure 7 is a *late* pump and goes with the *late* case, *notice* the highlighted area, it is raised and contains air bleed holes.
