FORD EXPLORER; MOUNTAINEER; TAURUS; SABLE; WINDSTAR & LINCOLN CONTINENTAL

WHINNING NOISE FROM THE TORQUE CONVERTER AREA

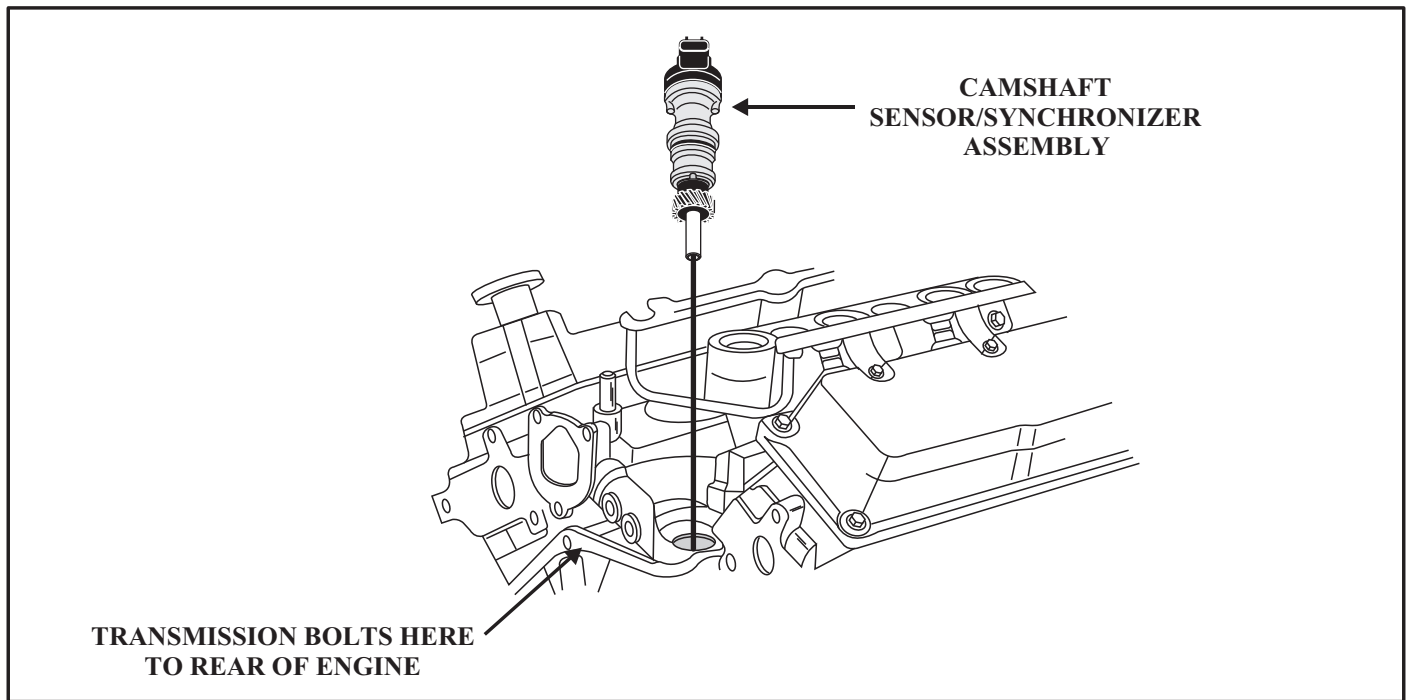
Figure 1

CAUSE: Camshaft Position Sensor/Synchronizer assembly bearing failure due to lack of lubrication. The synchronizer assembly lube hole becomes clogged cutting off oil to the area between the synchronizer body and shaft causing it to run dry.

CORRECTION: Replace with an OE assembly from Ford Motor Co. The Camshaft Position sensor is located on top of the Camshaft Synchronizer in the back of the engine block centered just in front the of the transmission bell housing held in by two bolts (See Figure 1). The PCM uses this sensor to control Fuel Injector timing. When this sensor begins to fail it can cause a loud whining or buzzing noise. Because of its location you may think the converter is the problem on an Explorer or Mountaineer. On a Taurus, Sable or Windstar it is easily mistaken for a bad EPC. This one has tricked several technicians into spending countless man-hours changing torque converters or EPC solenoids trying to correct the source of the noise. Line pressure should be checked before changing the EPC solenoid. A steady pressure gauge needle with a reading of 60 to 75 psi will verify that the solenoid is working correctly. If the gauge is reading low and the needle is very erratic verify that the correct filter is being used. There are three different length filter neck seals for an AX4S and AX4N transmission. You may or may not notice any engine performance problems or find any codes stored. ***A good test is to place your finger on top of the sensor with the engine running to feel if the vibration or buzz is coming from a bad sensor.*** Remove the sensor/synchronizer assembly and dis-assemble it. Check for signs of rust and scoring, (Refer to Figures 2 and 3). Replacing this sensor/synchronizer assembly on an Explorer or Mountaineer is much easier with the transmission removed because of the tight area in which the sensor is located. Other wise the Intake Manifold will have to be removed.
