Technical Service Information

FORD AX4S OVERDRIVE BAND FAILURE

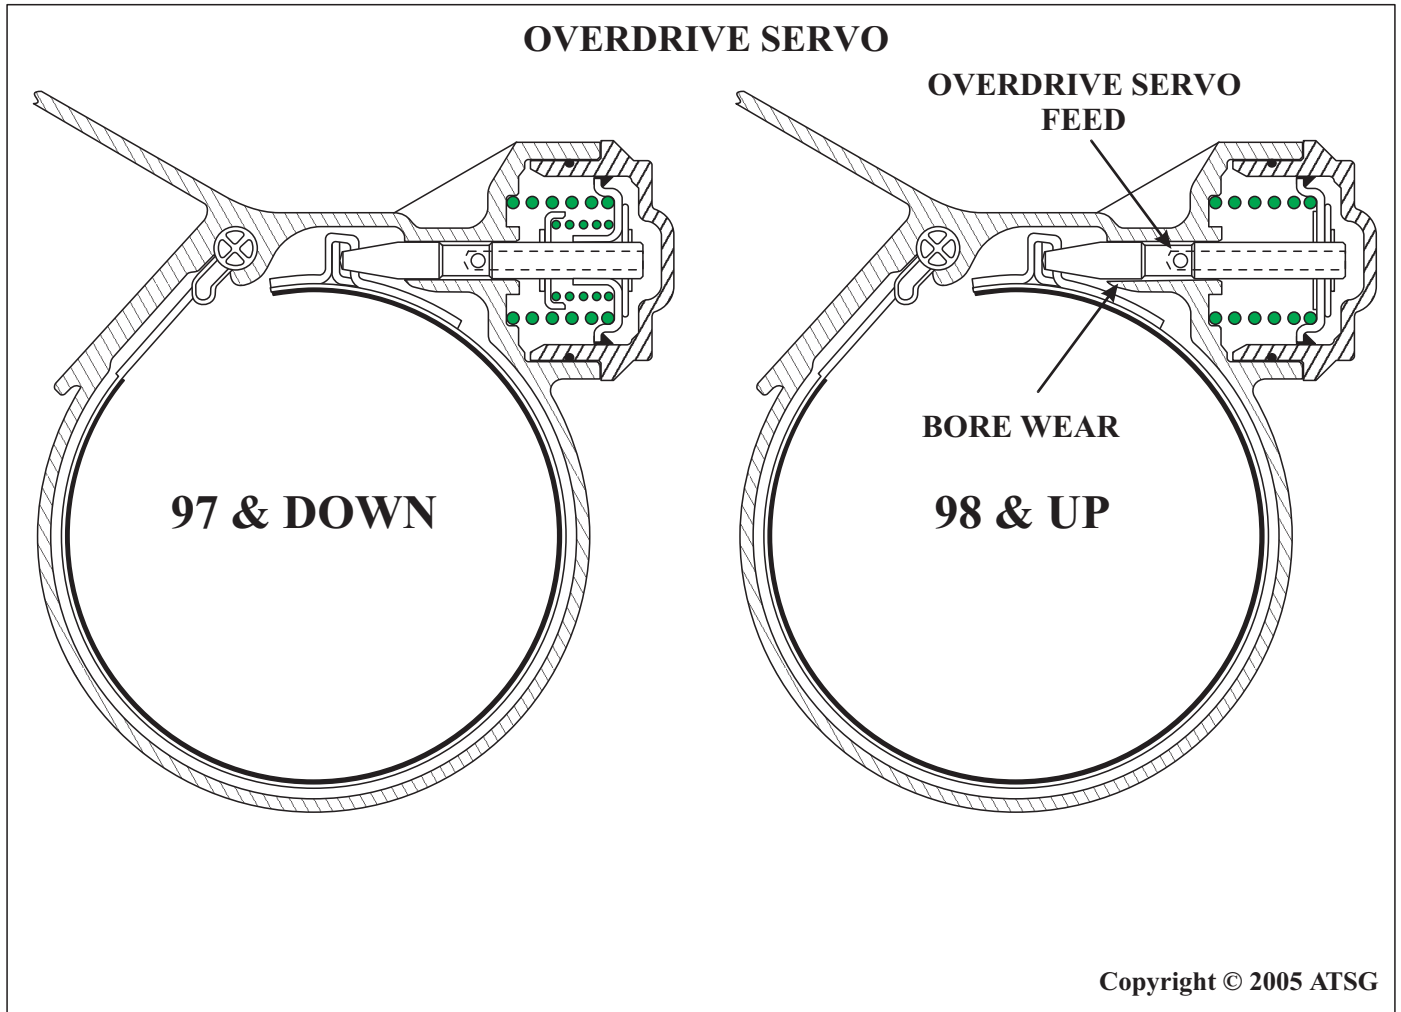
Figure 1

COMPLAINT: Vehicles equipped with the AX4S transaxle may exhibit premature Overdrive band failure.

CAUSE: The cause may be, a worn servo bore. The Overdrive servo is fed thru the center of the apply pin. Wear in the case, where the servo pin rides, may cause a pressure loss, creating the band failure. See Figure 1. ***NOTE: ATSG has found that this is very common on 98&up models.***

CORRECTION: To correct this condition there are currently two options, replace the case or re-sleeve the case where the pin rides and install a bushing for a new sealing surface. ***Northland transmission Inc. has a Re-boring kit available to repair the case bore, with a bushing, to fix the leak.***
Phone: 715-458-2617
