# Technical Service Information

## FORD 5R55W

### NO 2nd OR 5th

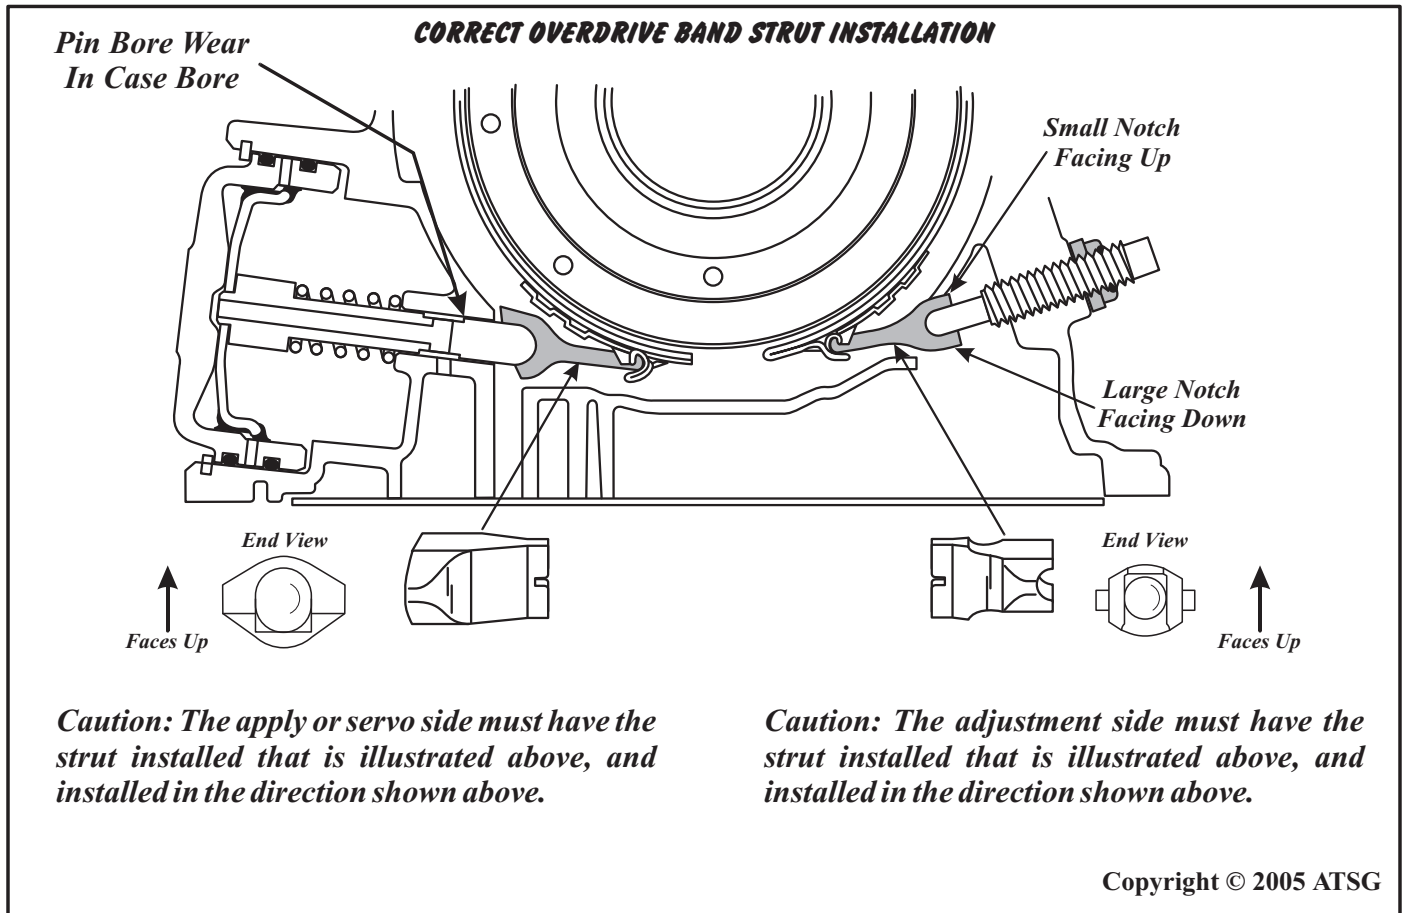
**CAUSE:** The cause may be, that the band struts were installed upside down, or the servo bore is worn. The Overdrive servo is fed thru the center of the apply pin. Wear in the case, where the servo pin rides, may cause a pressure loss, creating the band failure. See Figure 1.

**CORRECTION:** To correct this condition, refer to Figure 1 for the correct assembly of the band struts. Replace the case or re-sleeve the case where the pin rides and install a bushing for a new sealing surface. *Northland transmission Inc. has a Re-boring kit available to repair the case bore, with a bushing, to fix the leak.*  
*Phone: 715-458-2617*
