# Technical Service Information

## GM 5L40E / BMW A5S360R

### DELAYED FORWARD ENGAGEMENT

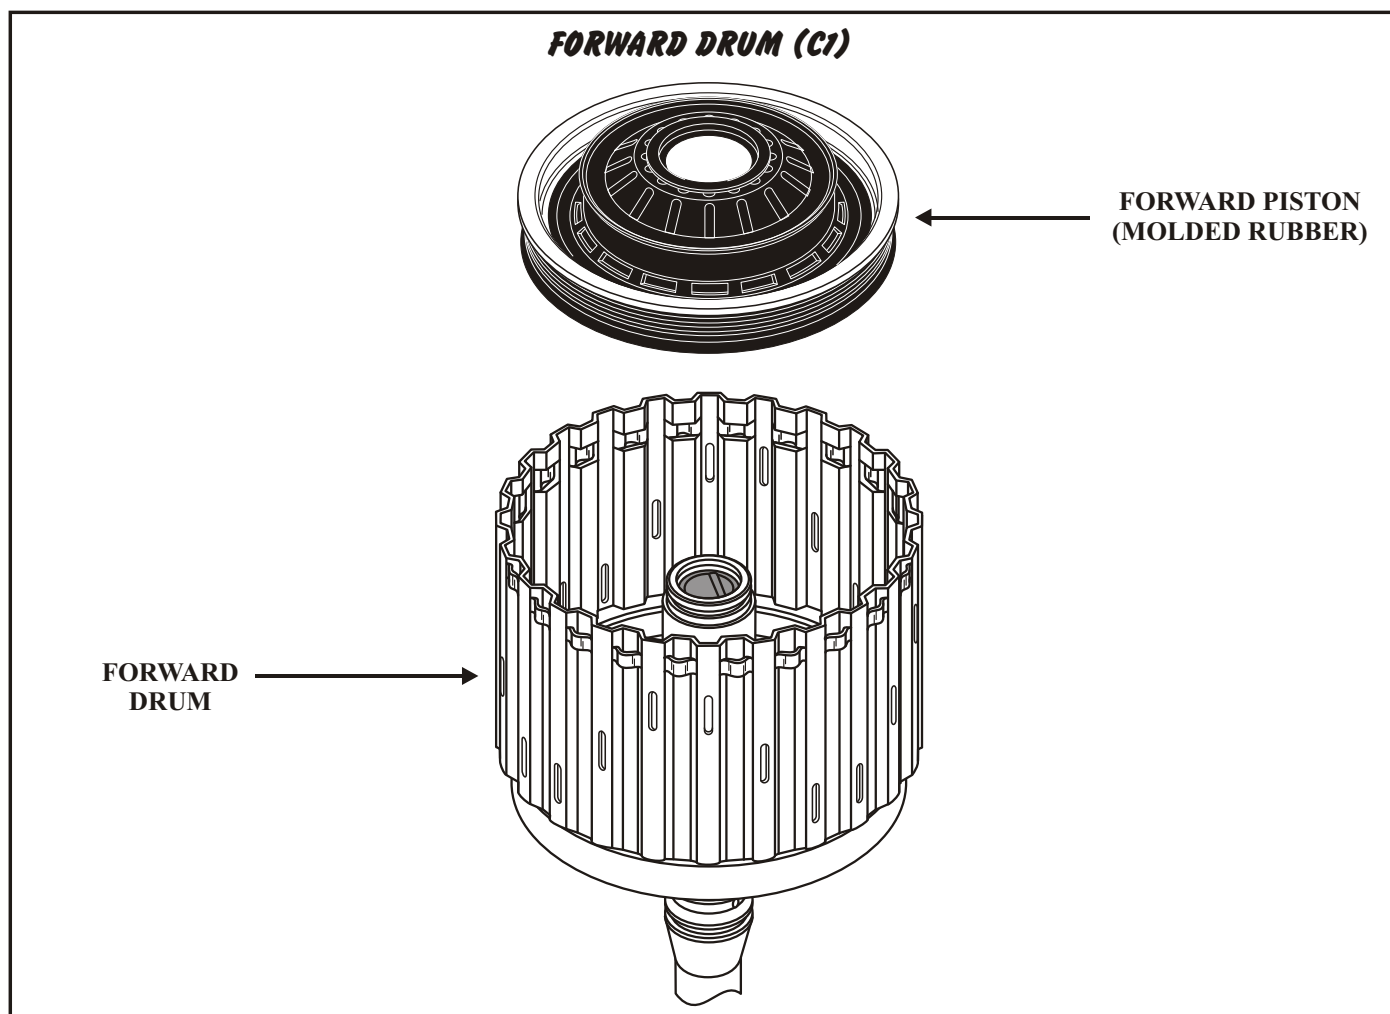
Figure 1

- COMPLAINT:** Some BMW “E” series and Cadillac CTS models built from 09/02 to 12/03 may exhibit a delayed engagement from park to drive when cold. The delay may last anywhere from two to thirty seconds.
- CAUSE:** The forward drum (C1) was manufactured with improper tolerances that cause the clutch piston to not make a good seal between it and the clutch housing when the vehicle is parked for a prolonged period of time, such as overnight. Therefore on the initial start, the forward clutch does not apply.
- CORRECTION:** Since internal parts are not available, a reman transmission will be necessary. Because the manufacturer does not disclose any build code information, it is impossible to tell which drum would be a good one if used parts are acquired.
