## FORD WINDSTAR

### CODE P0743, TCC SOLENOID ELECTRICAL CIRCUIT FAULT

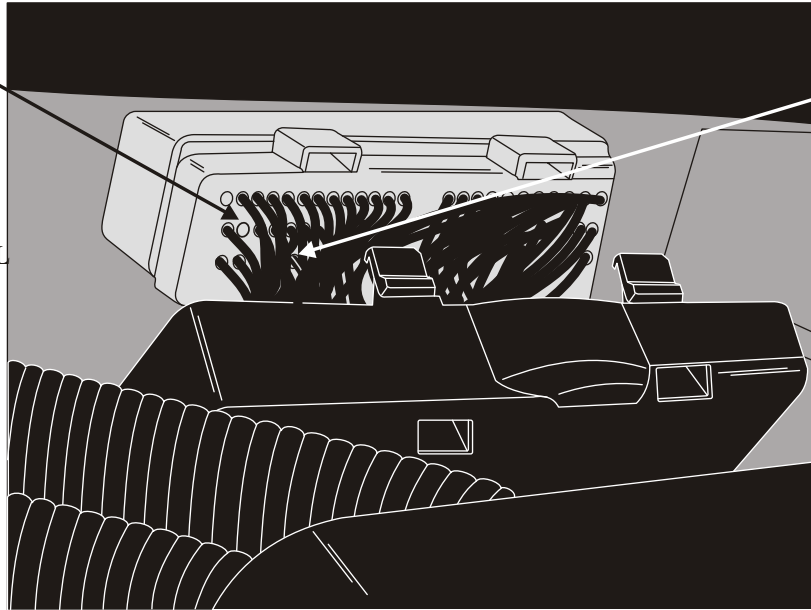
Figure 1

## *WINDSTARS BUILT BEFORE 9/8/97*

HAS THE WHITE CONNECTOR TCC SOLENOID AND WILL HAVE TERMINAL 54 MOLDED SHUT AND THIS PCM TERMINAL WILL BE NON-FUNCTIONAL

TERMINAL 82 WILL BE THE FUNCTIONAL TERMINAL FOR THE TCC GROUND CONTROLLED CIRCUIT

The fix was to drill the terminal 54 location open and move the TCC ground controlled wire from the pin 82 location to terminal 54.

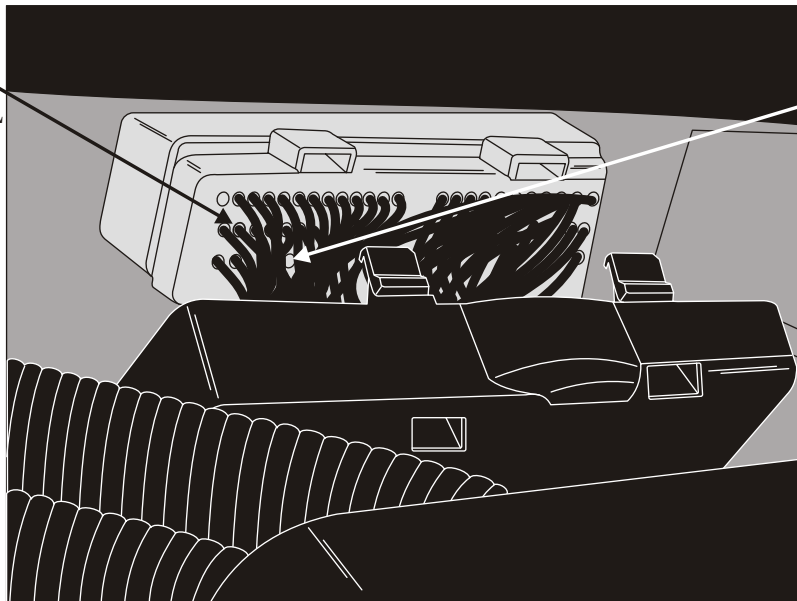
Figure 2

## *WINDSTARS BUILT AFTER 9/8/97*

TERMINAL 54 WILL BE THE FUNCTIONAL TERMINAL FOR THE TCC GROUND CONTROLLED CIRCUIT

HAS THE BLUE CONNECTOR TCC SOLENOID AND WILL HAVE TERMINAL 82 MOLDED SHUT AND THIS PCM TERMINAL WILL BE NON-FUNCTIONAL
