Technical Service Information

CHRYSLER 46RE

REOCCURRING P1740 OR P0740 WHEN HOT

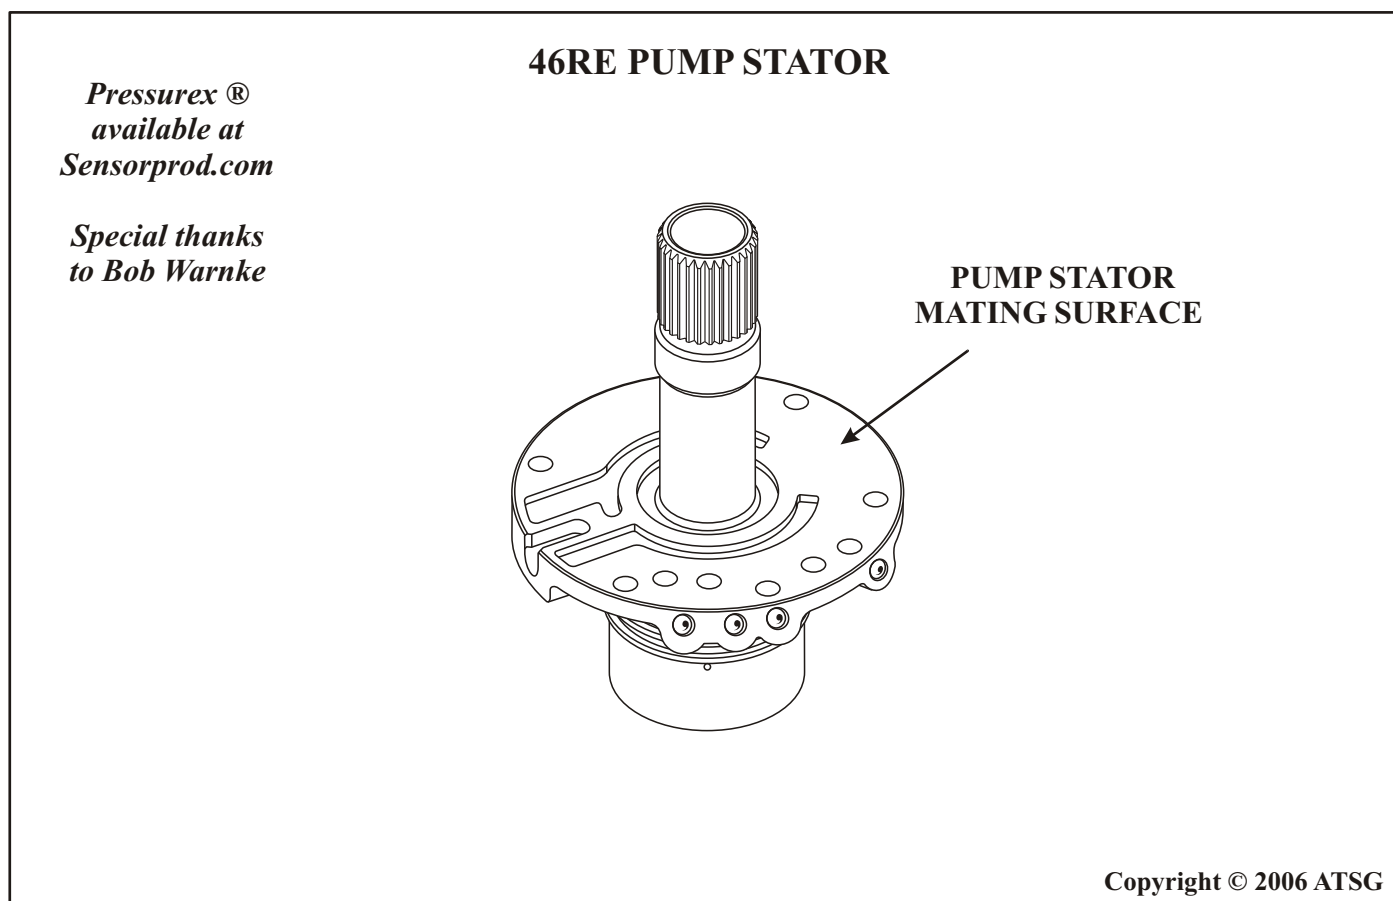
Figure 1

CAUSE : The cause may be, that the mating surface, as shown in Figure 1, between the Pump Body and the Pump Stator is not flat, causing a loss of line pressure and Torque Converter apply pressure. Refer to Figure 2 for port identification of the Pump Body and Pump Stator.

CORRECTION: To verify that the stator surface is flat, Pressurex[®] Film may be used. This is a product from Sensor Products Inc., which uses microcapsules of a paint like substance that changes color intensity depending on pounds per square inch. The higher the psi., the brighter the color. To repair this condition, have the face of the stator machined so that it is flat.

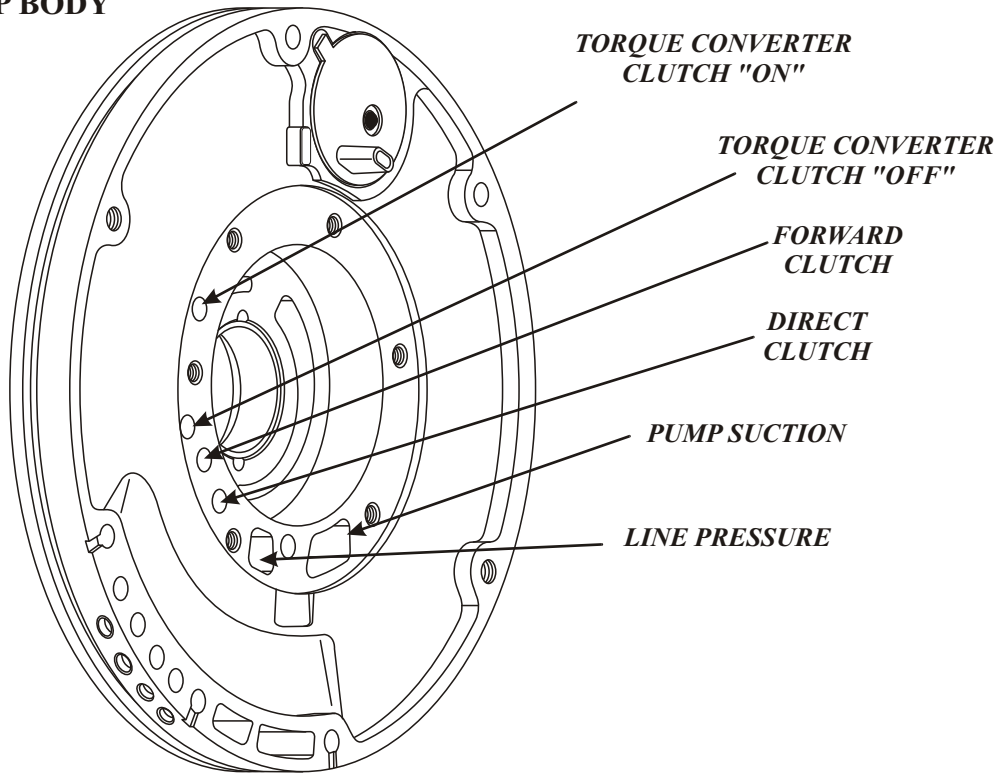
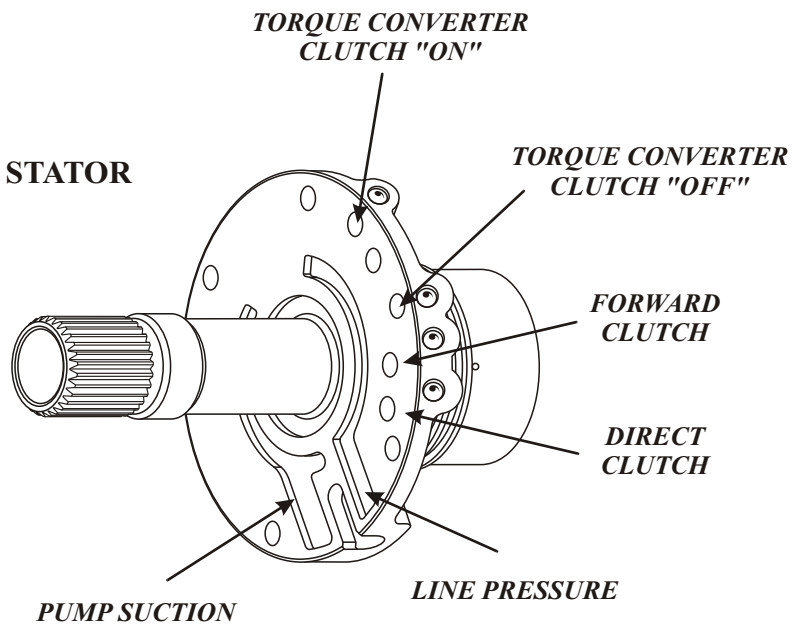
Figure 2

46RE PUMP BODY AND STATOR PASSAGE IDENTIFICATION
