# Technical Service Information

## SATURN TAAT DELAYED AND OR NO REVERSE

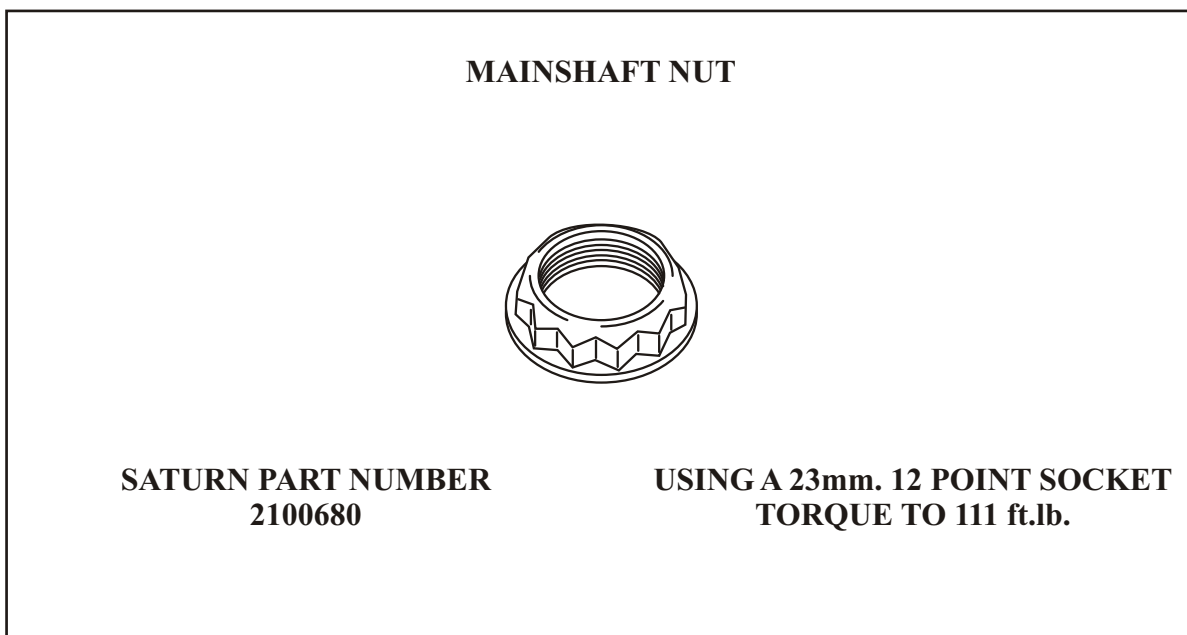
Figure 1

**CAUSE:** The cause may be, a loose Mainshaft Nut, as shown in Figure 1, causing a leak in the 2nd clutch circuit. When the nut loosens the mainshaft tends to walk back and forth in the mid case. This causes a gap between the 1st Clutch and the nut, which is where the leak in the 2nd Clutch circuit appears. In Figure 2 the cutaway shows how the 2nd Clutch is fed around the outside of the feed pipe for the 3rd clutch. **Notice** that the area over and under the nut are all part of the 2nd Clutch circuit.

**CORRECTION:** Install a new Mainshaft nut, which has a factory thread locker, as part of every repair. Using a 23mm. 12 point socket torque the new nut to 111 ft.lb.
