Technical Service Information

AISIN SEIKI 450-43LE

FLYWHEEL/FLEXPLATE ALIGNMENT

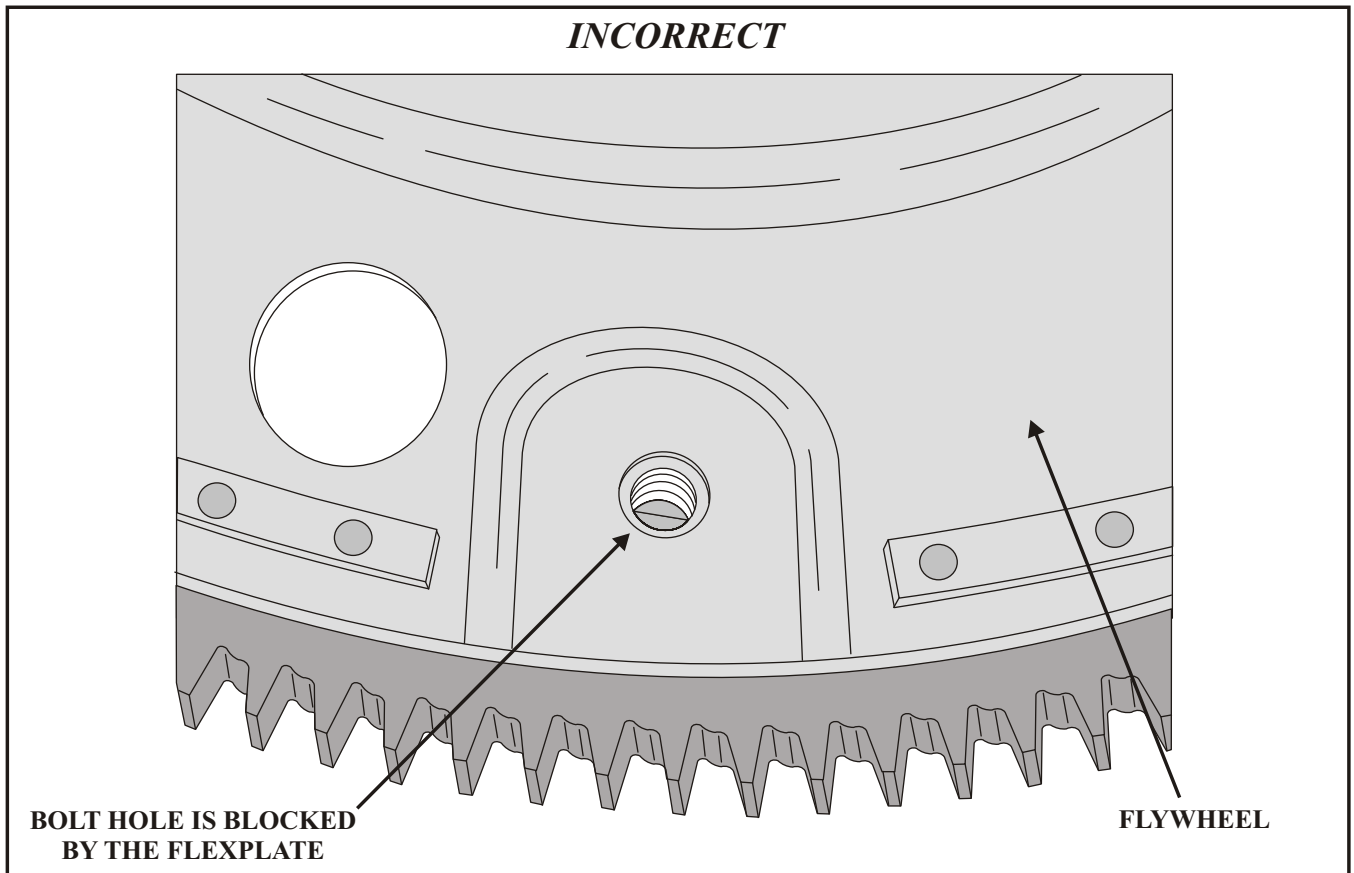
Figure 1

COMPLAINT: After flywheel and or flexplate replacement, the returns is a short period of time with the transmission leaking out the front and a vibration complaint.
Upon removal of the converter, a check of the front seal area reveals that the pump bushing is severely worn.

CAUSE: One or more of the flywheel bolts have bottomed out against the flexplate causing the flywheel, flexplate and converter assembly to have excessive run out resulting in the above complaints as seen in Figure 1.
