Technical Service Information

SATURN TAAT FALLS OUT OF DRIVE AT A STOP

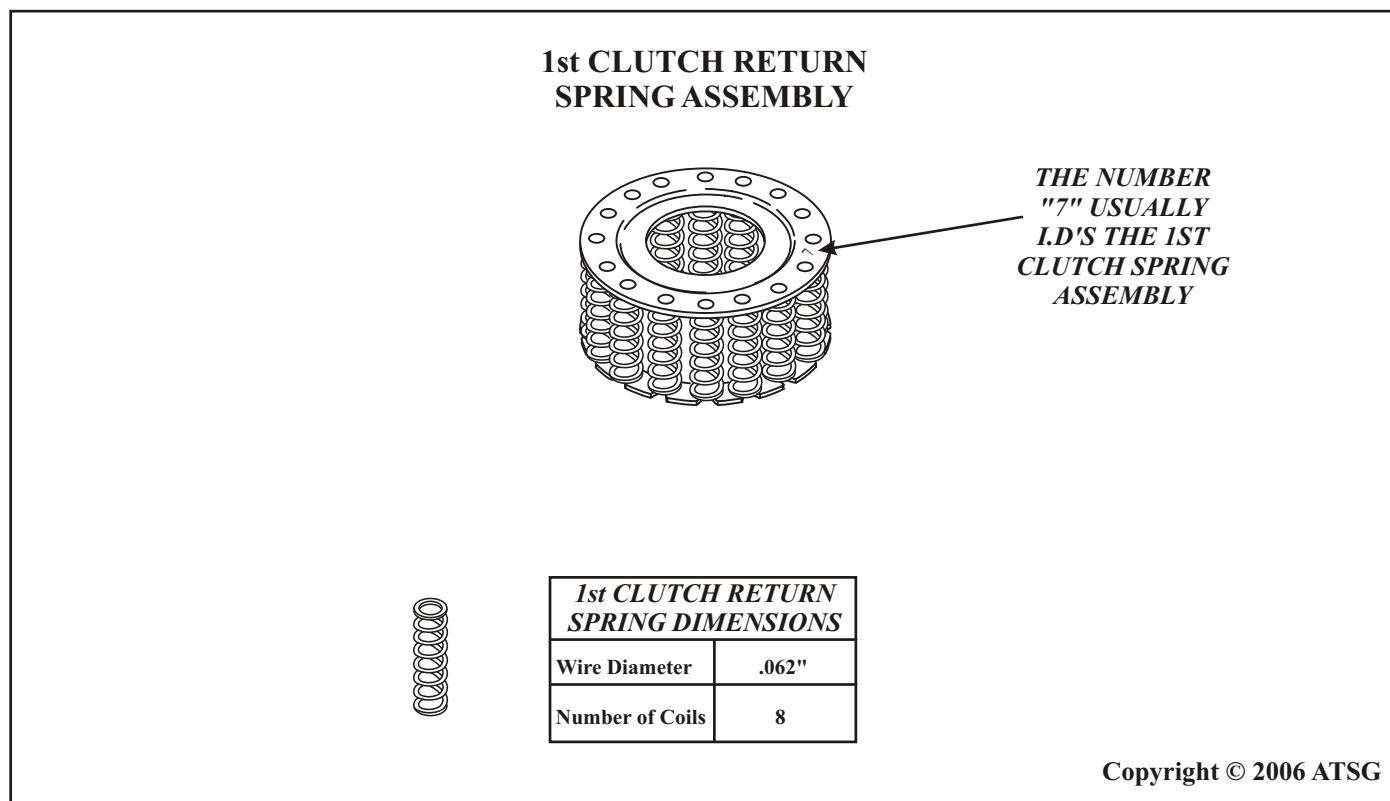
CAUSE: The cause may be, that during overhaul, the 2nd, 3rd or 4th Clutch return spring assembly was mistakenly used in place of the 1st Clutch spring assembly. When this happens, the 1st Clutch can not fully engage until line pressure is increased. Refer to Figure 1 and 2 to compare the 1st Clutch return spring assembly to the 2nd, 3rd and 4th. Notice that the coil diameter of the springs, on 2nd, 3rd and 4th are approximately .010" larger and the number of coils are one more than the 1st which makes them stronger.

CORRECTION: Refer to Figure 1 to identify the 1st Clutch return spring assembly, and ensure it is in the correct location.

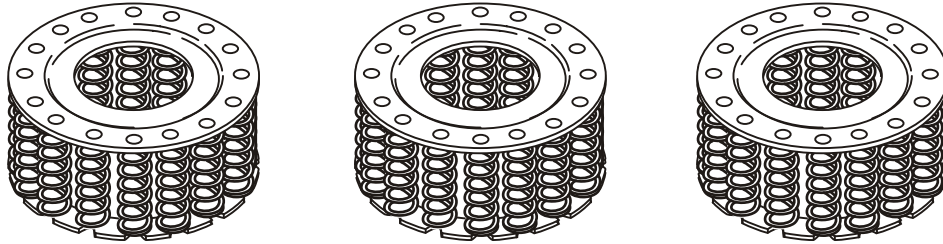
Figure 2

2nd, 3rd and 4th CLUTCH RETURN SPRING ASSEMBLIES

<i>2nd, 3rd and 4th CLUTCH RETURN SPRING DIMENSIONS</i>	
Wire Diameter	.072"
Number of Coils	9
