# Technical Service Information

## 4L80-E

### ENGINE STUMBLE/STALL ON ENGAGEMENT

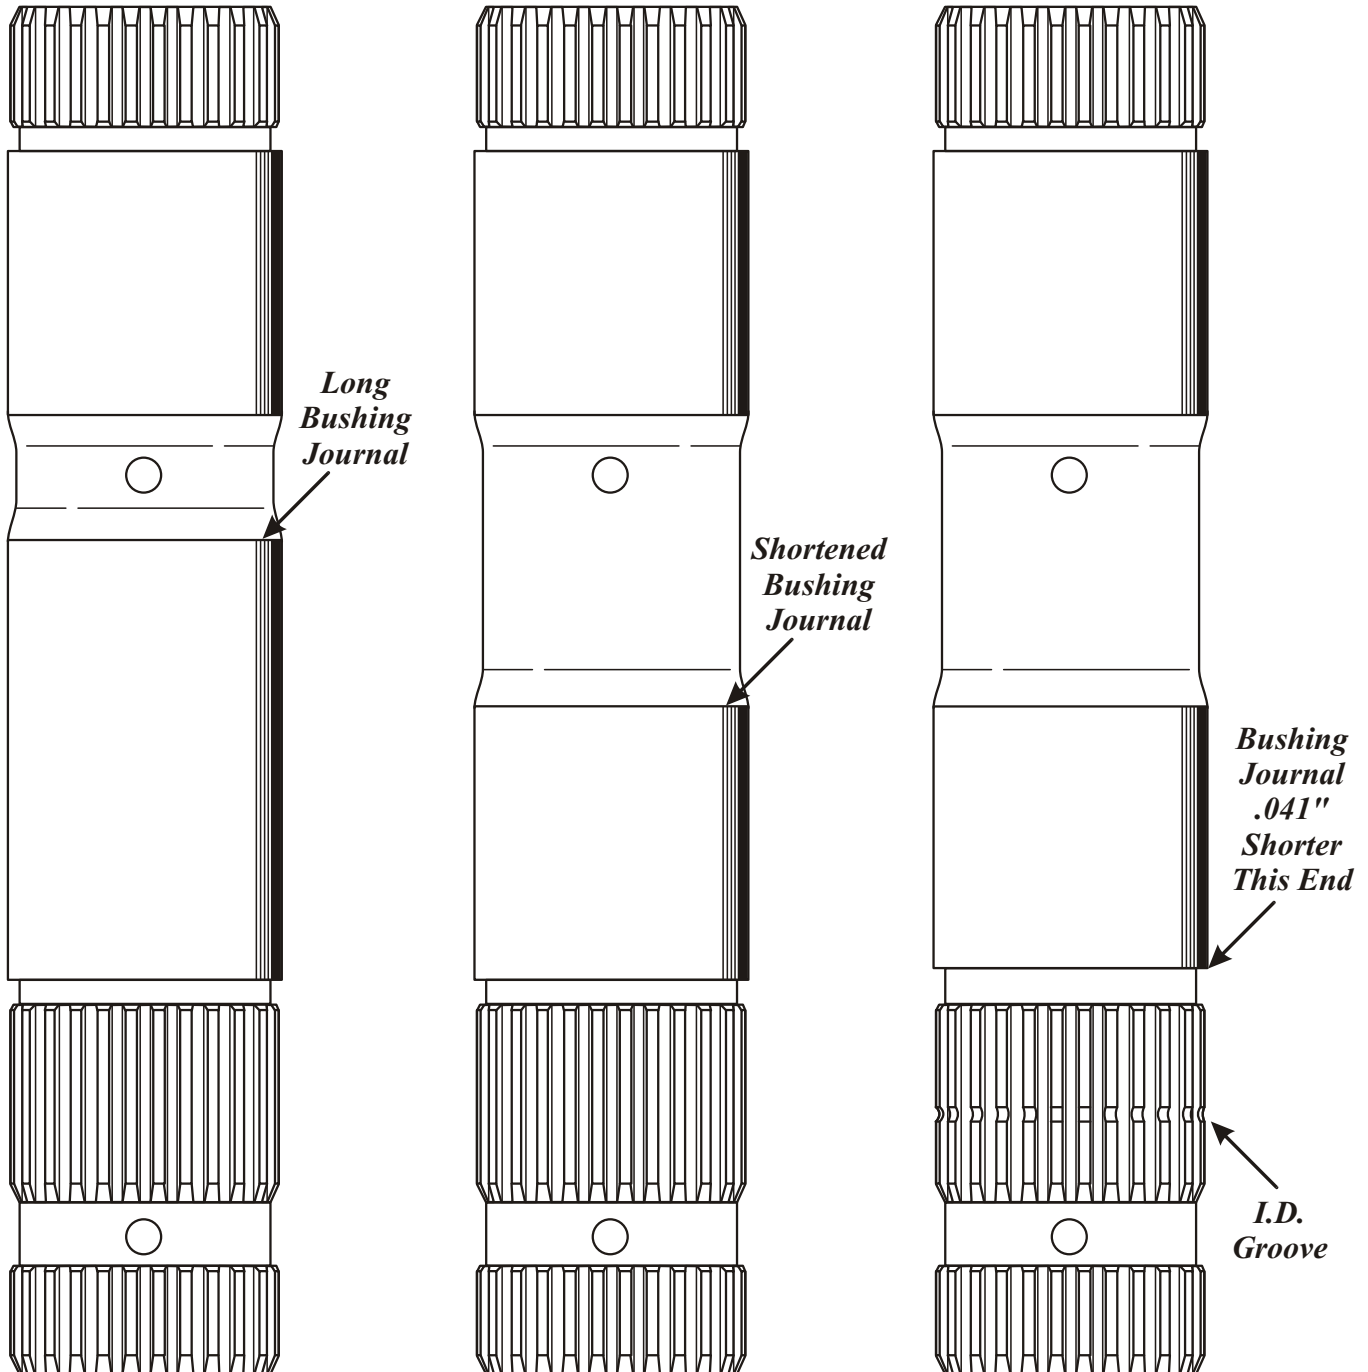
Figure 1

**CORRECTION:** The sun gear shafts used in 1997 and later center lube transmissions have a shortened bushing journal when compared to the earlier design. Using the earlier design shaft with the longer bushing journal will create a restriction in the oil cooler/lube circuit and cause the converter clutch to drag.

**1ST DESIGN LEVEL  
SUN GEAR SHAFT  
1991-96**

**2ND DESIGN LEVEL  
SUN GEAR SHAFT  
1997-98  
PART NO. 24207247**

**3RD DESIGN LEVEL  
SUN GEAR SHAFT  
1999- UP  
PART NO. 24207264**

Replace the sun gear shaft with the proper part for your application. (See figure 1)
