## FORD AX4N

### VEHICLE SPEED SENSOR ELIMINATED

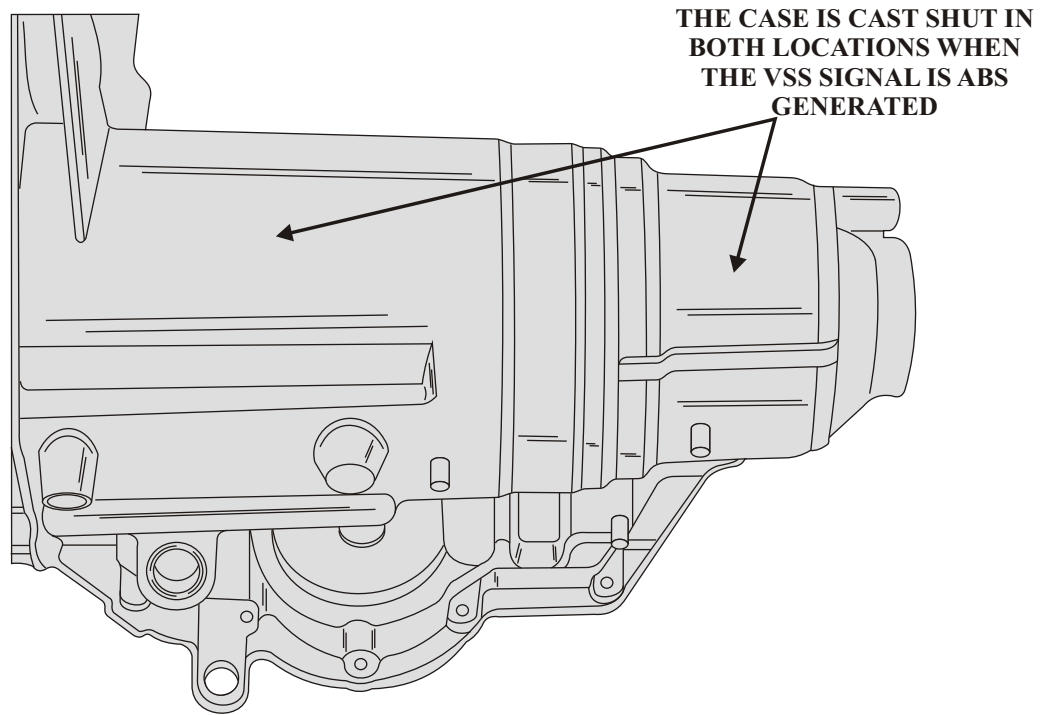
Figure 1

A visual check of the VSS reveals that no VSS is located in either of the two locations it would normally be found! (Refer to Figure 1)

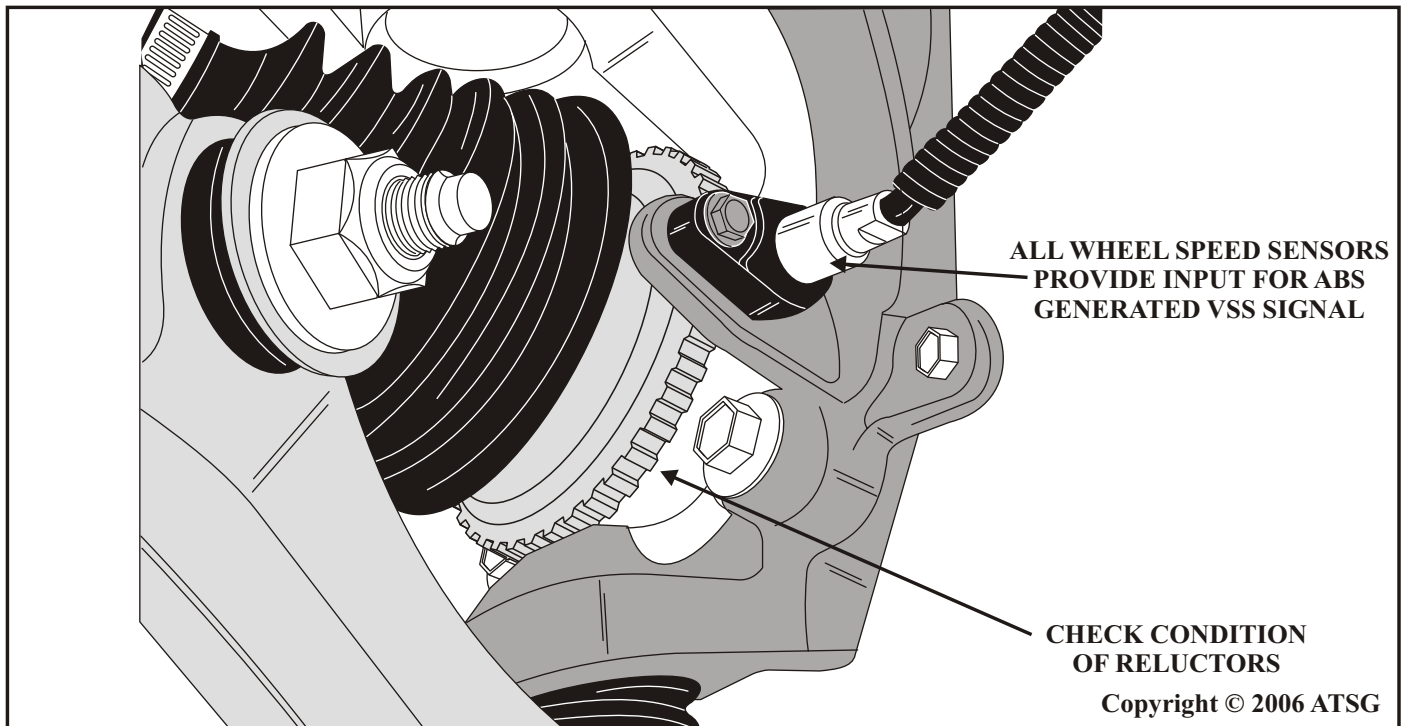
Figure 2

**CAUSE:** These vehicles obtain the VSS signal from the Antilock Brake Control Module. This means that the raw signal the ABS Module is receiving comes from all four (4) Wheel Speed Sensors (WSS), Refer to Figure 2.

**CORRECTION:** The ABS Module will have to be scanned for wheel speed sensor codes in order to find the one, or more, wheel speed sensor(s) that are faulty. It would also help to view the ABS data to see if all four (4) wheel speeds are the same when driving in a straight line, (no turns).

**Note:** The reluctors at each wheel can become caked with mud or rust resulting in an erratic or no signal condition, be sure to check for this or any other condition that might cause a problem with the wheel speed sensor to reluctor relationship.

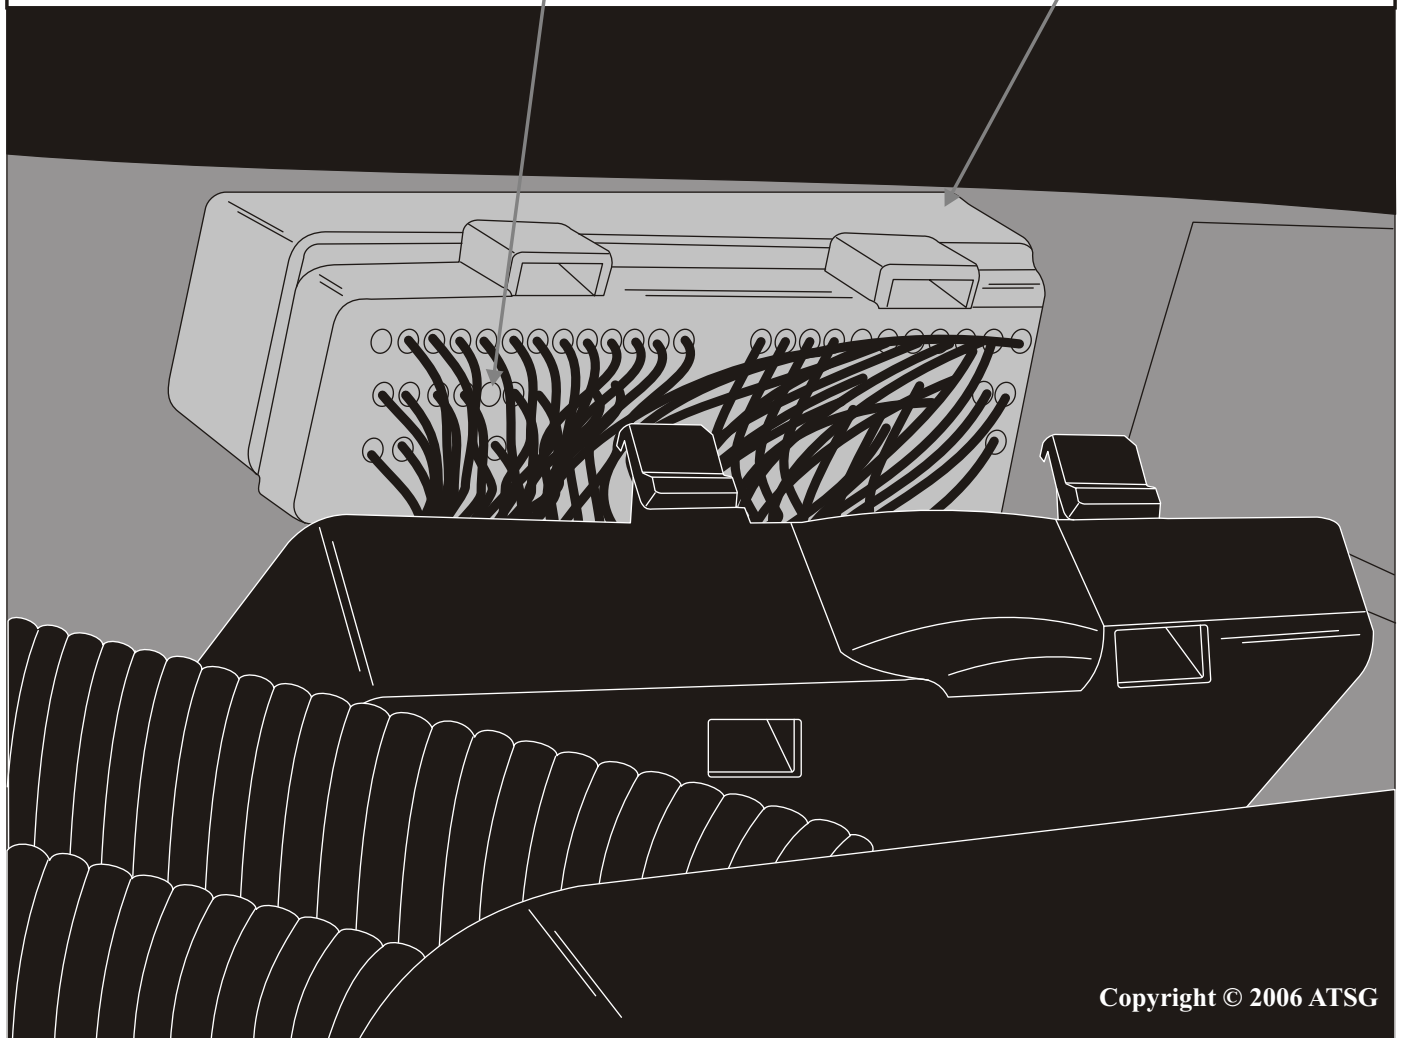
Figure 3

Systems using the gear driven or permanent magnet type of VSS, will have a wire at PCM terminal 58, with the ground circuit found at PCM terminal 33. Systems using the ABS Module to generate the VSS signal will not have a wire at PCM terminal 58 as shown in Figure 3. The VSS signal is sent from the ABS Module over the vehicles Multiplex Communication Network to the Speed Control Module (cruise control) and then to other modules that require a VSS signal as illustrated in the electrical schematic shown in Figure 4.

PCM TERMINAL 58 WILL BE EMPTY WHEN  
THE VSS SIGNAL IS ABS GENERATED
