Technical Service Information

4T80E

SLIPS IN FOURTH OR NO FOURTH

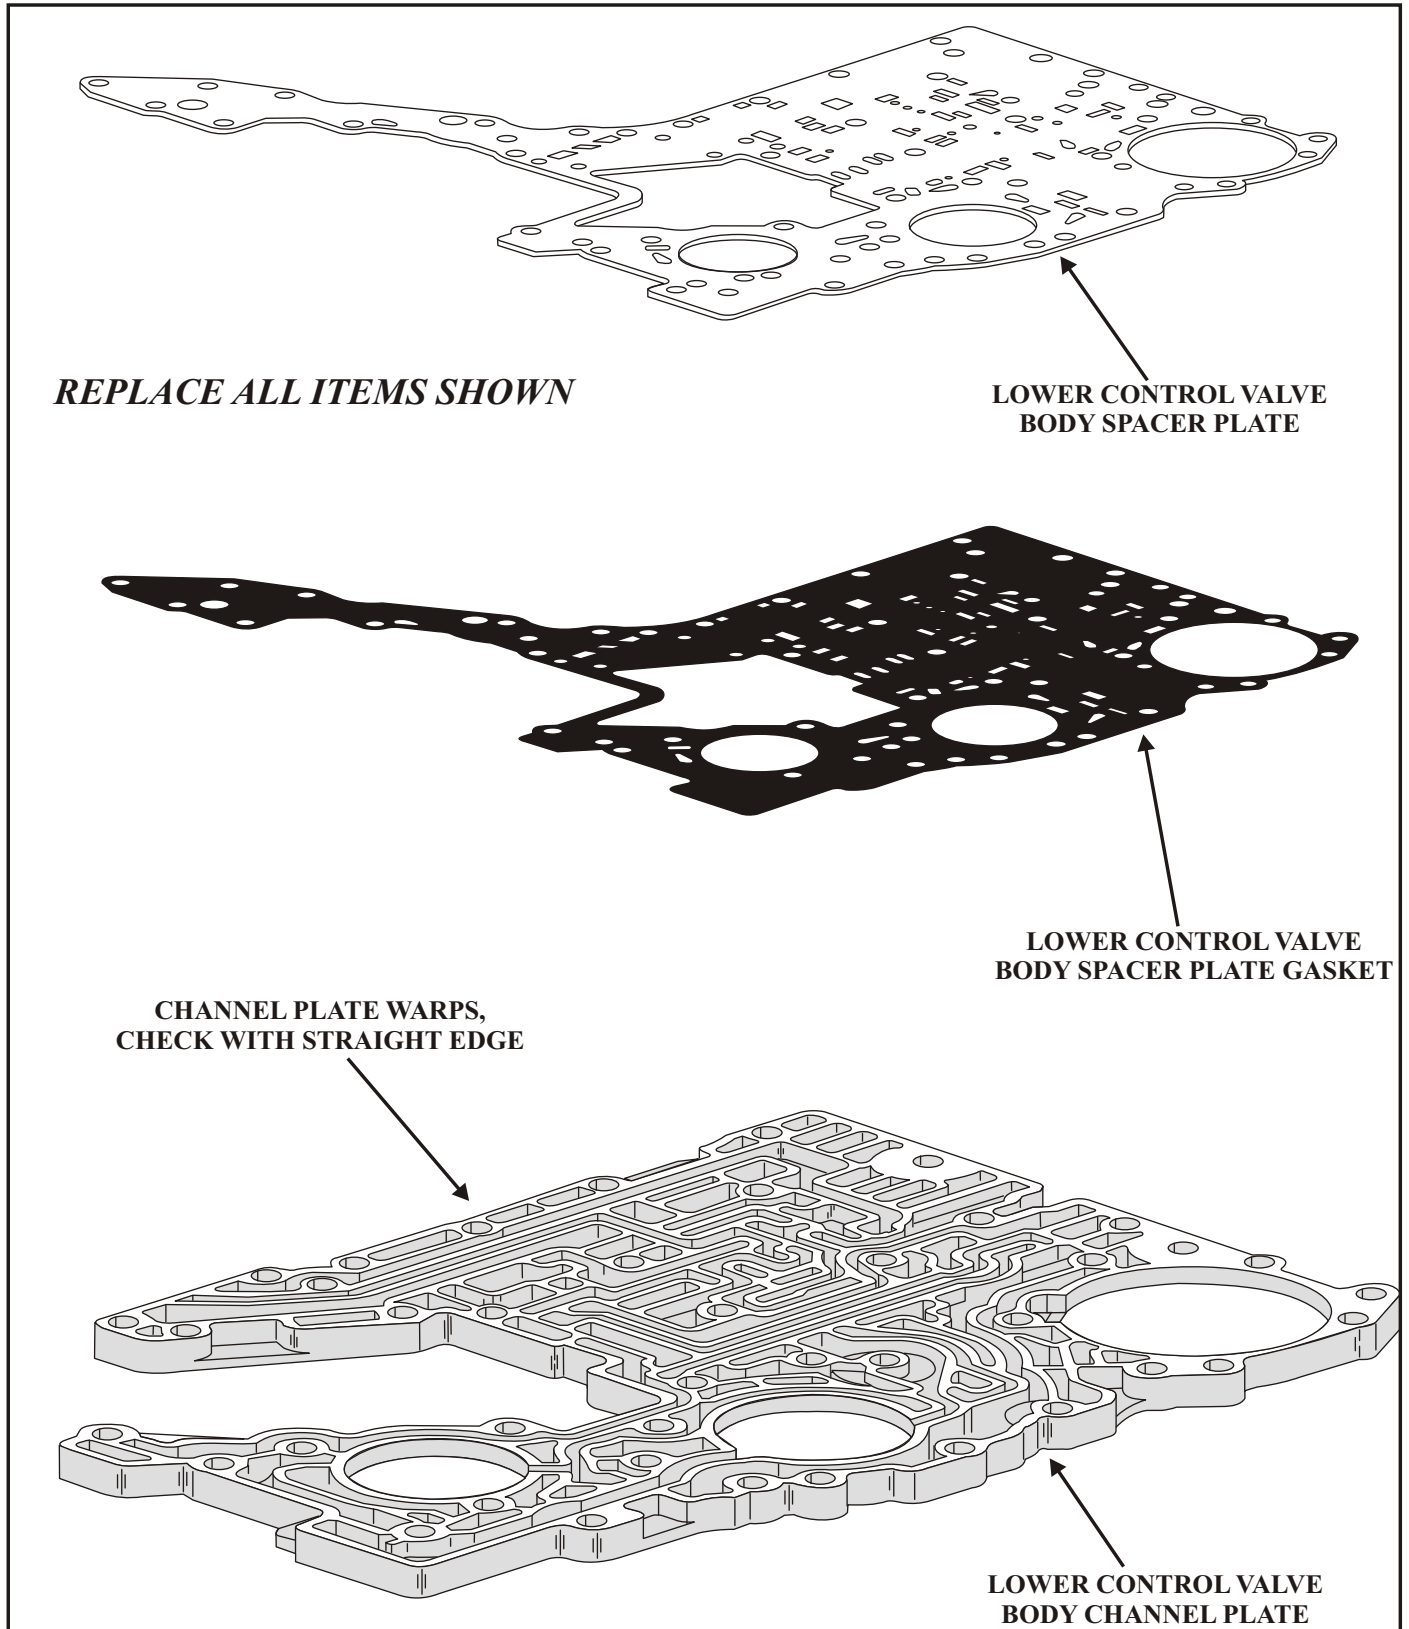
Figure 1

CAUSE: This complaint may be caused by a warped lower control valve body channel plate, shown in Figure 1.
The warped channel plate causes a loss of fourth band apply pressure resulting in damage to the fourth band and the reverse clutch housing.

CORRECTION: Inspect the fourth band and the reverse clutch housing and replace them if necessary. Replace the lower control valve body channel plate, spacer plate and gasket.
