2000 & LATER DODGE TRUCKS & VANS

46RE INTERNAL LINKAGE AND SAFETY NEUTRAL SWITCH CHANGES

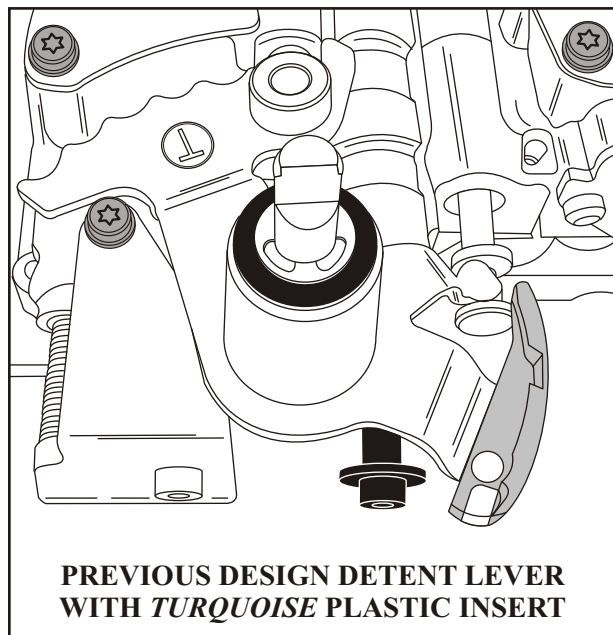
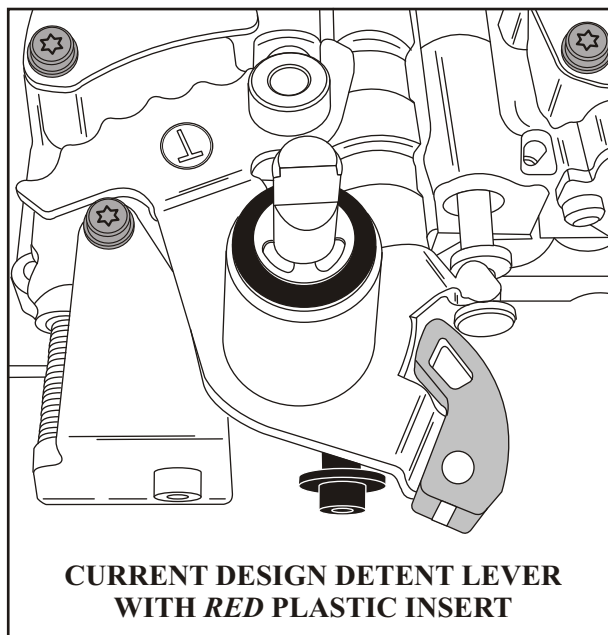
CAUSE: The safety neutral switch and the valve body detent lever changed for the 2000 model year. The switch is longer and the detent lever dimensionally changed to accommodate the new switch. Figures 1 and 2 show the dimensional differences between the previous and current design detent levers. Figures 3 and 4 illustrate the correct and incorrect assembly using the short switch. Figure 5 shows the correct assembly using the long switch.

CORRECTION: The detent lever with the *turquoise* plastic insert goes with the *short* safety neutral switch. The detent lever with the *red* plastic insert goes with the *long* safety neutral switch.
