## VOLKSWAGEN/AUDI ZF5HP19FL/FLA NEUTRALS ON TAKEOFF

## Technical Service Information

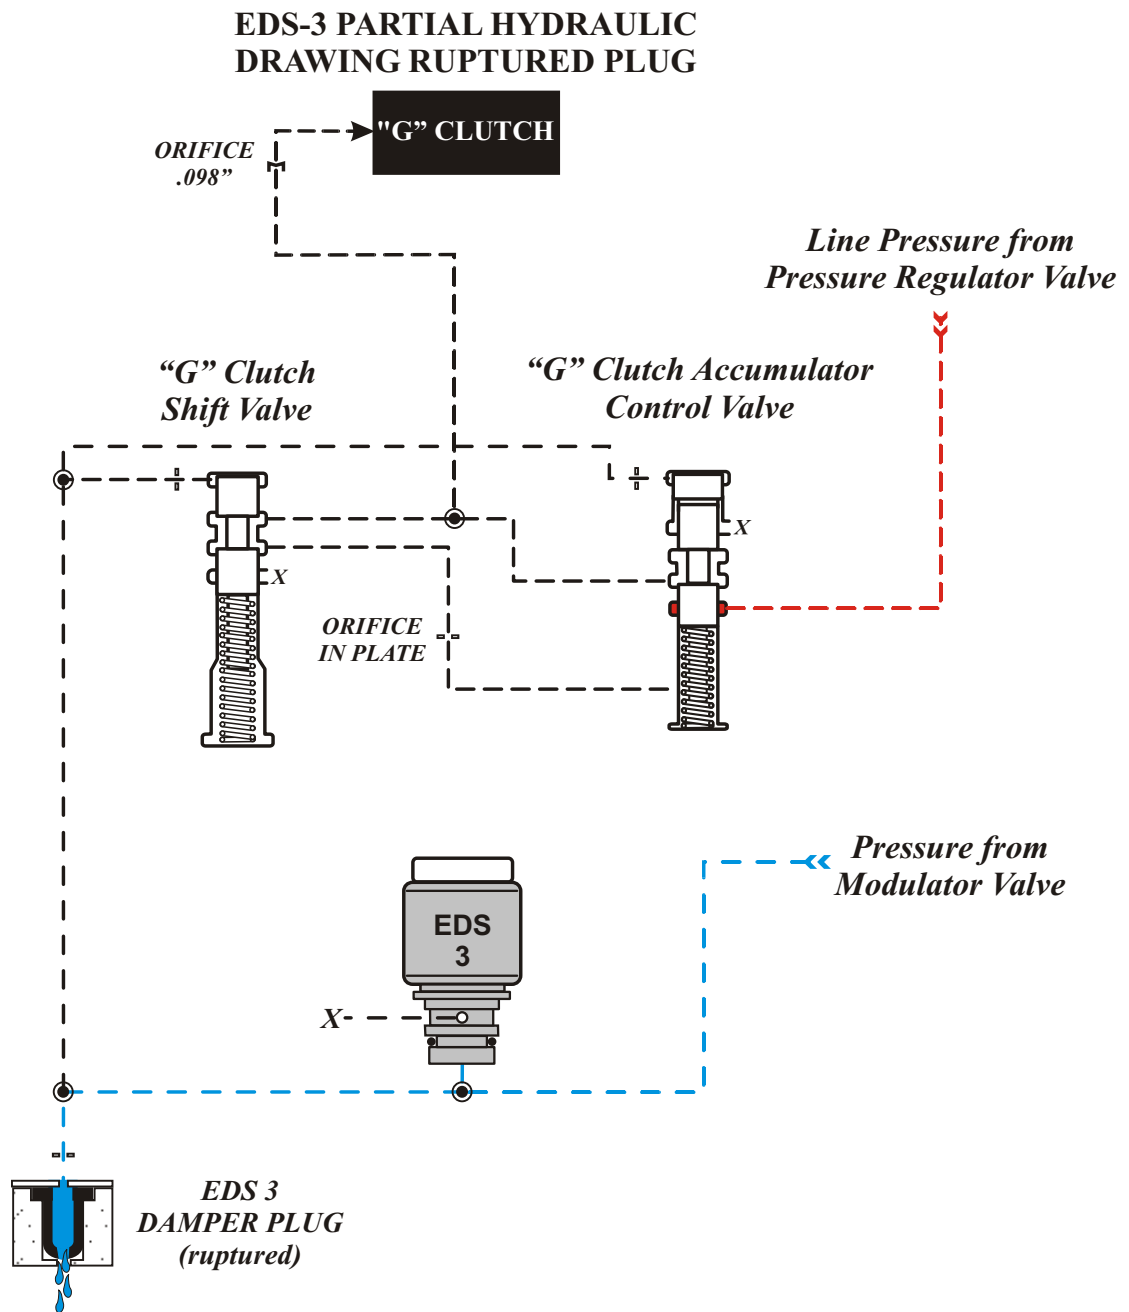
**CAUSE:** One cause may be a ruptured rubber damper plug in the channel plate section of the valve body. The root cause of the burned clutch may not be apparent during initial inspection, especially if the time is not taken to disassemble the valve body. In the channel plate section of the valve body are located three rubber damper plugs. These damper plugs act as accumulators for the pulse-width-modulated solenoids EDS 2, EDS 3, and EDS 4. The damper plugs must be removed from the valve body and carefully inspected. The reason they must be looked at carefully is because of their tendency to “rupture” or “burst”. If you experience a similar neutralizing effect during heavy acceleration, EDS 3 damper assembly will be the accumulator plug you want to look at closely. EDS 3 solenoid is pulsed “ON” in reverse, neutral, 1<sup>st</sup>, and 2<sup>nd</sup> gear. Refer to Figure 1. This drawing illustrates that modulator pressure is fed to solenoid EDS 3. With the solenoid “ON”, modulator pressure flows to the EDS 3 damper plug and then strokes the “G” clutch shift valve and “G” clutch accumulator control valve allowing line pressure to apply the “G” clutch. During heavy acceleration conditions, increased modulator pressure can cause a “rupture” or “burst” hole to occur in the plug and exhaust through the channel plate. When this occurs there will not be sufficient pressure to stroke the “G” clutch shift valve or accumulator control valve which will lead to a partial apply of the “G” clutch and the neutralizing condition.

*EDS 3 is used to control the engagement of the "G" clutch. This hydraulic circuit drawing shows oil flow with a ruptured EDS 3 Damper.*

**NOTE:** *With a ruptured EDS 3 Damper Plug, EDS 3 oil pressure exhausts through the hole in the bottom of the damper plug thereby not accumulating and passing to both Shift Valve "G" and Accumulator Control Valve "G".*

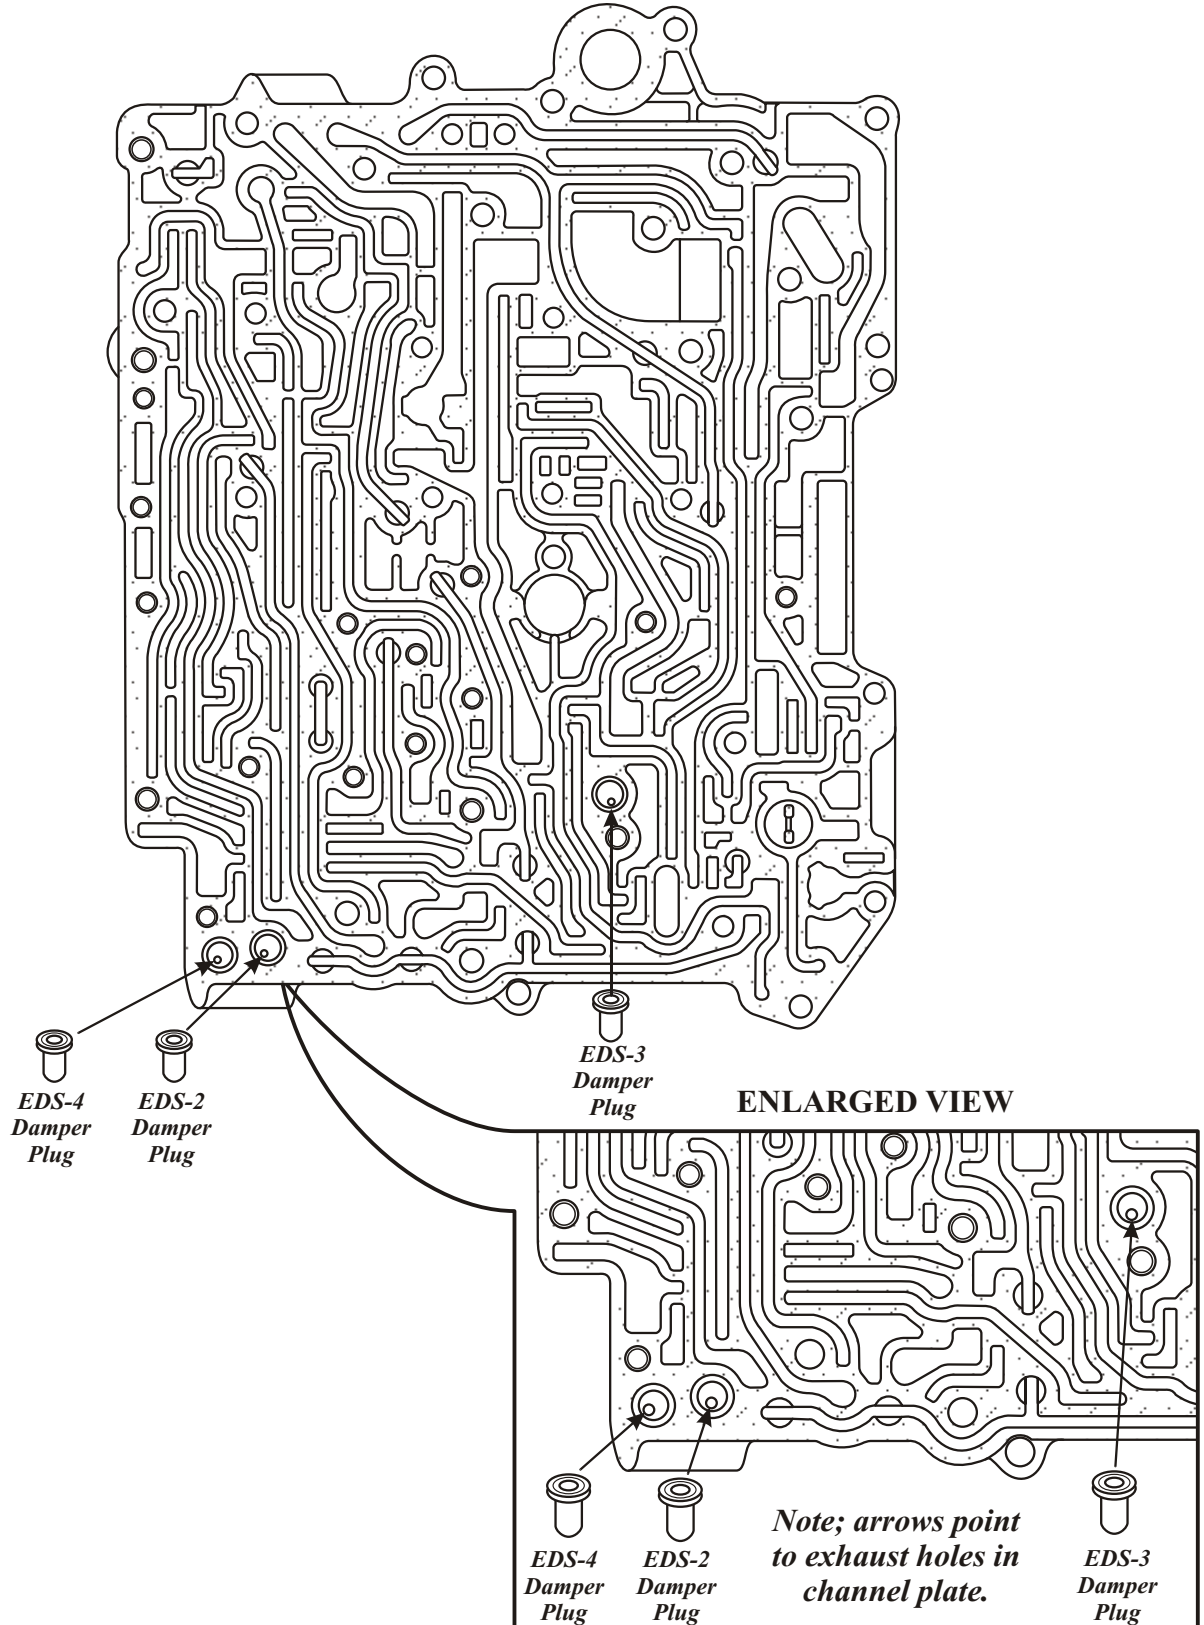
## EARLY CHANNEL PLATE WITH RUBBER PLUGS

**CORRECTION:** Replace the rubber damper assembly, or use the updated aluminum plugs which requires the updated channel plate and spacer plate. Refer to Figure 2 this picture shows the channel plate with the EDS damper plug locations, and also an enlarged view which shows the early style rubber plugs and focuses on the exhaust holes in the channel plate. These rubber damper plugs were used in ZF5HP19 models through 1999. During model year 2000, ZF introduced an updated damper assembly. Figure 4 shows worm track differences in the later channel plate and also an enlarged view which depicts the later style damper pistons and illustrates the bore size difference in the channel plate for the later damper pistons. Refer to Figure 3. This drawing illustrates the same partial hydraulic circuit in Figure 1, *except*, it shows the new design EDS 3 accumulator piston. Notice the top of the accumulator piston, there is no orifice like in the previous plug, instead the surface is solid and in the bottom of the plug is a rubber insert that provides the cushion, or accumulation. The solid top obviously prevents rupturing and these new pistons eliminate the problem.

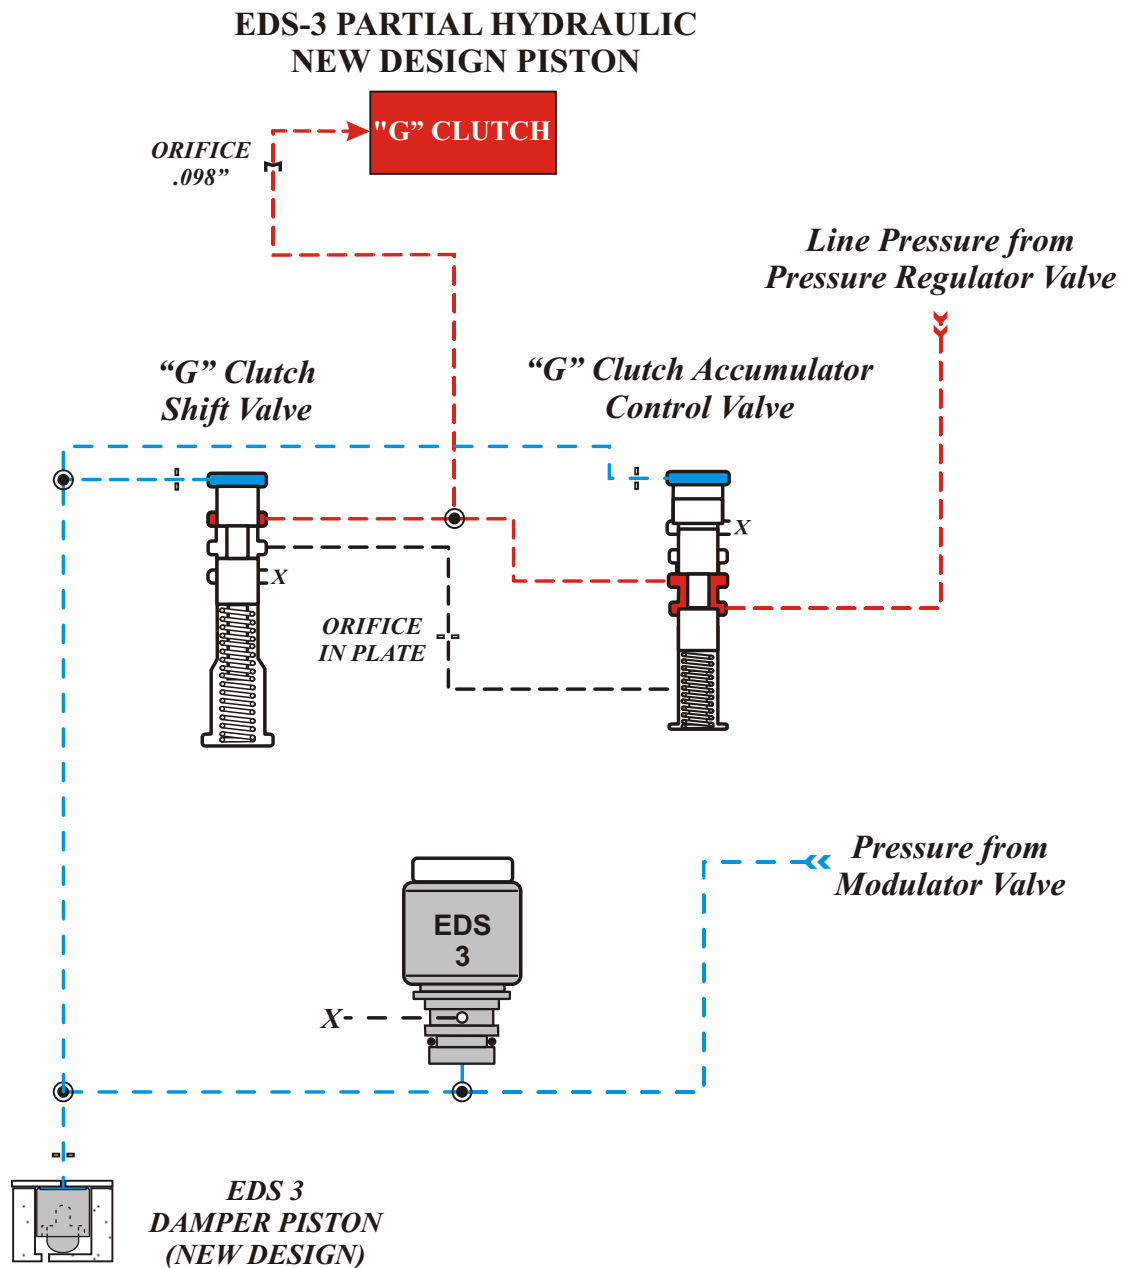
Figure 3

*This hydraulic circuit drawing shows oil flow with New Design EDS 3 Damper Piston.*

**NOTE:** *With a new design damper piston installed in the valve body, oil pressure only contacts the face of the plug. Since the hole is eliminated in the new plug, it reduces the possibility of the plug rupturing, and normal oil accumulation is achieved.*

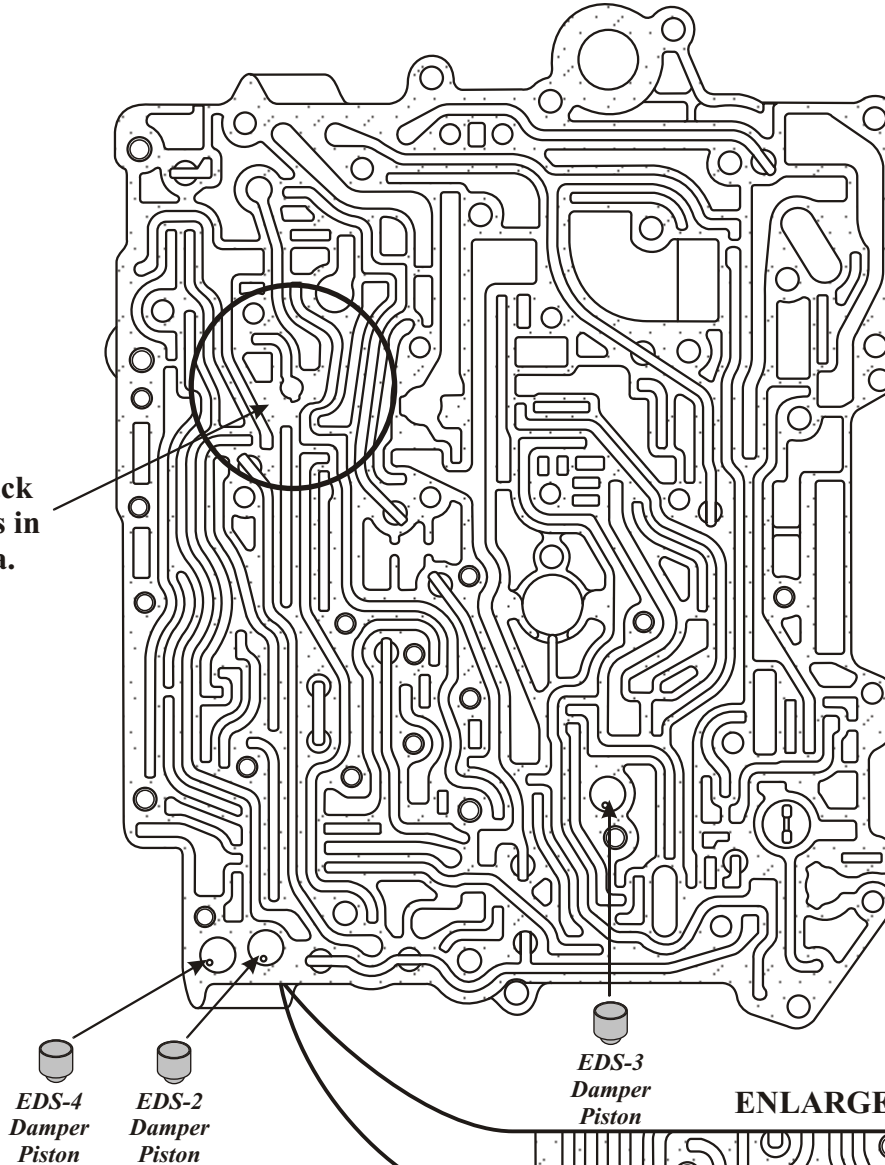
Figure 4

## LATER CHANNEL PLATE WITH ACCUMULATOR PISTONS

**Note:**  
Worm track  
differences in  
this area.

*Note; accumulator bores  
for the pistons are  
larger in diameter  
than early plate*

Refer to Figure 4. The text in the enlarged view states the accumulator bores in the channel plate are larger in diameter than the early plate. The bores are larger in diameter to accommodate the updated pistons. The diameter of the accumulator plug bore in the early channel plate is approximately .315 inches and houses the rubber damper plug. The outside diameter of the accumulator piston bore in the later channel plate is approximately .471 inches in diameter for the updated piston. Figure 5 shows the early valve body separator plate, and Figure 6 shows the later separator plate. Note the differences in hole size and configuration between the two plates. ***They are not interchangeable.*** Therefore, if you have a rubber damper that is ruptured, you will have to use a new rubber damper. If you want to use the later style piston to prevent a future incident, you will need to purchase a new channel plate, separator plate and pistons from a ***ZF-AUTHORIZED*** distributor. Most overhaul kits will come with both the rubber plugs and the newer pistons so if you have an overhaul kit you will only need to purchase the new style separator and channel plate. ***Note:*** There are two different versions of the separator plate and channel plate combinations, the first version is the type that has a Pulse Generator, which supplies Turbine shaft speed to the TCM, and is bolted to the middle of the channel plate. The second version is the type that uses a Hall effect turbine speed sensor, which is bolted the case. These 2 different channel plates are not interchangeable. Refer to the chart below for the correct part numbers for the version needed.

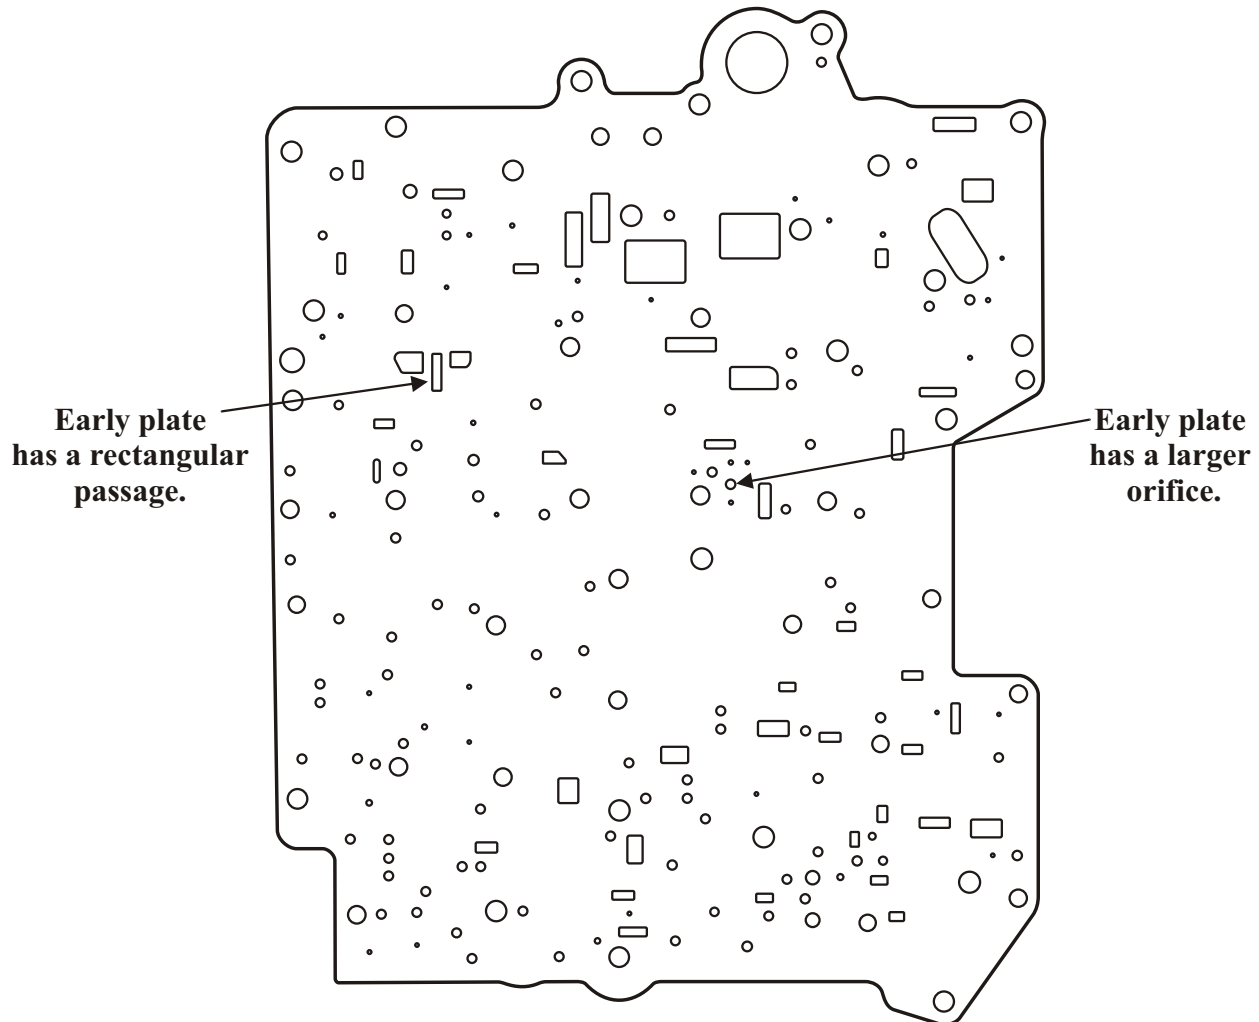
## EARLY STYLE SEPARATOR PLATE

**NOTE:  
SEPARATOR PLATE  
DIFFERENCES**

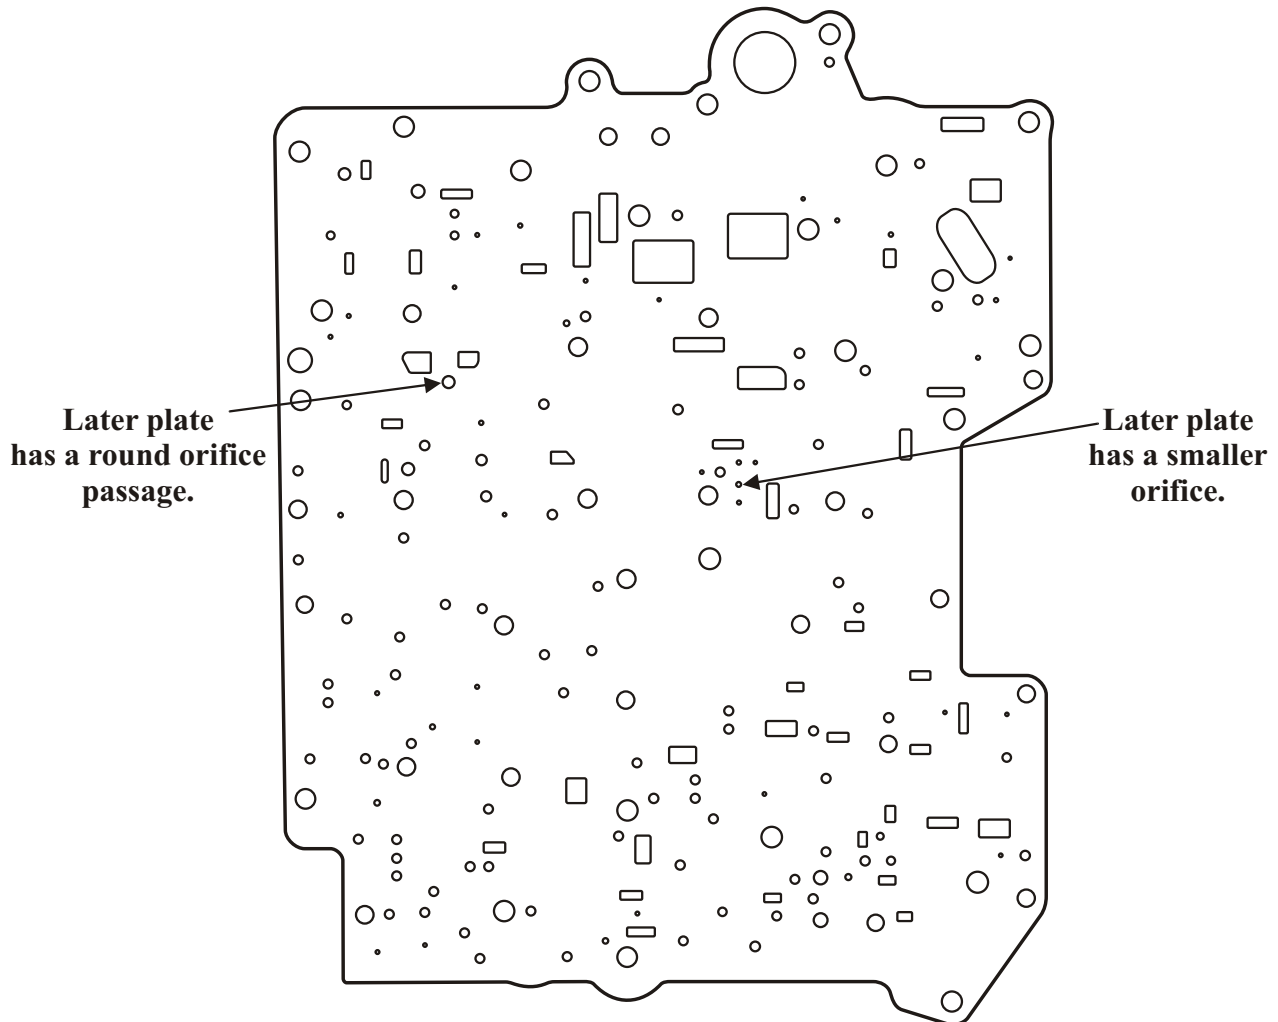
Figure 6

## LATER STYLE SEPARATOR PLATE

**NOTE:  
SEPARATOR PLATE  
DIFFERENCES**
