# Technical Service Information

## GM 4T40E

### SLIPPING FORWARD AND/OR REVERSE

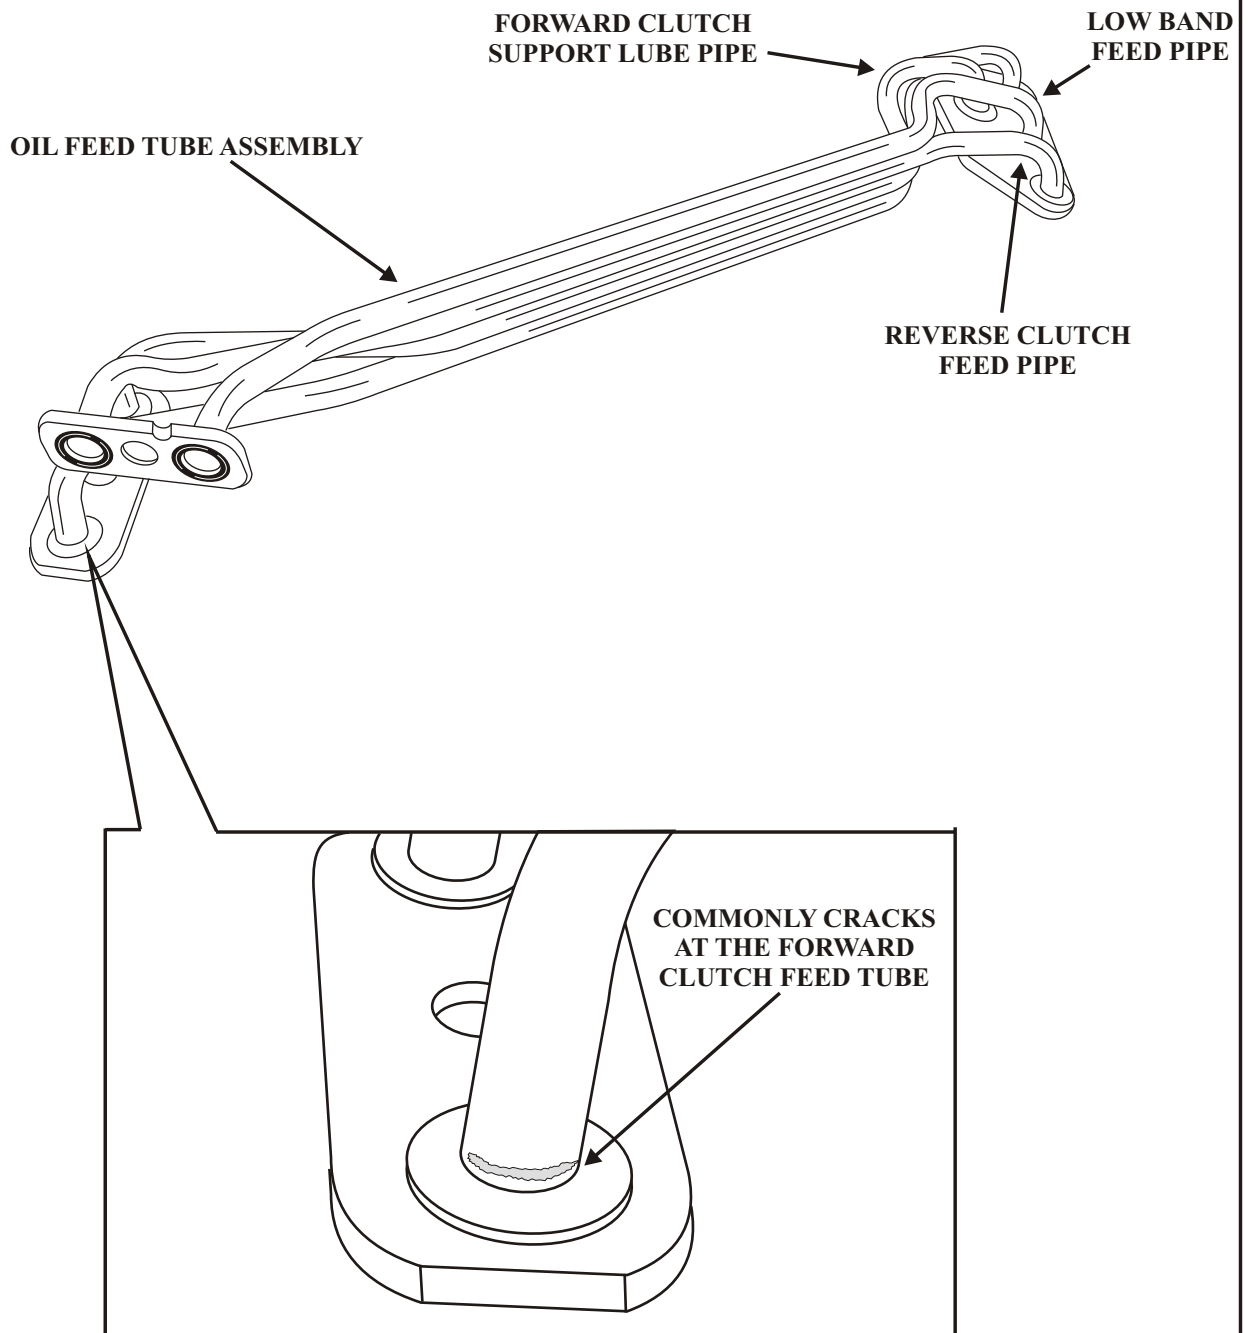
Figure 1

**CAUSE:** The oil feed tube assembly has developed cracks at the welds, located in the bottom pan area. Commonly, it is the forward clutch feed tube that cracks, (Refer to Figure 1).

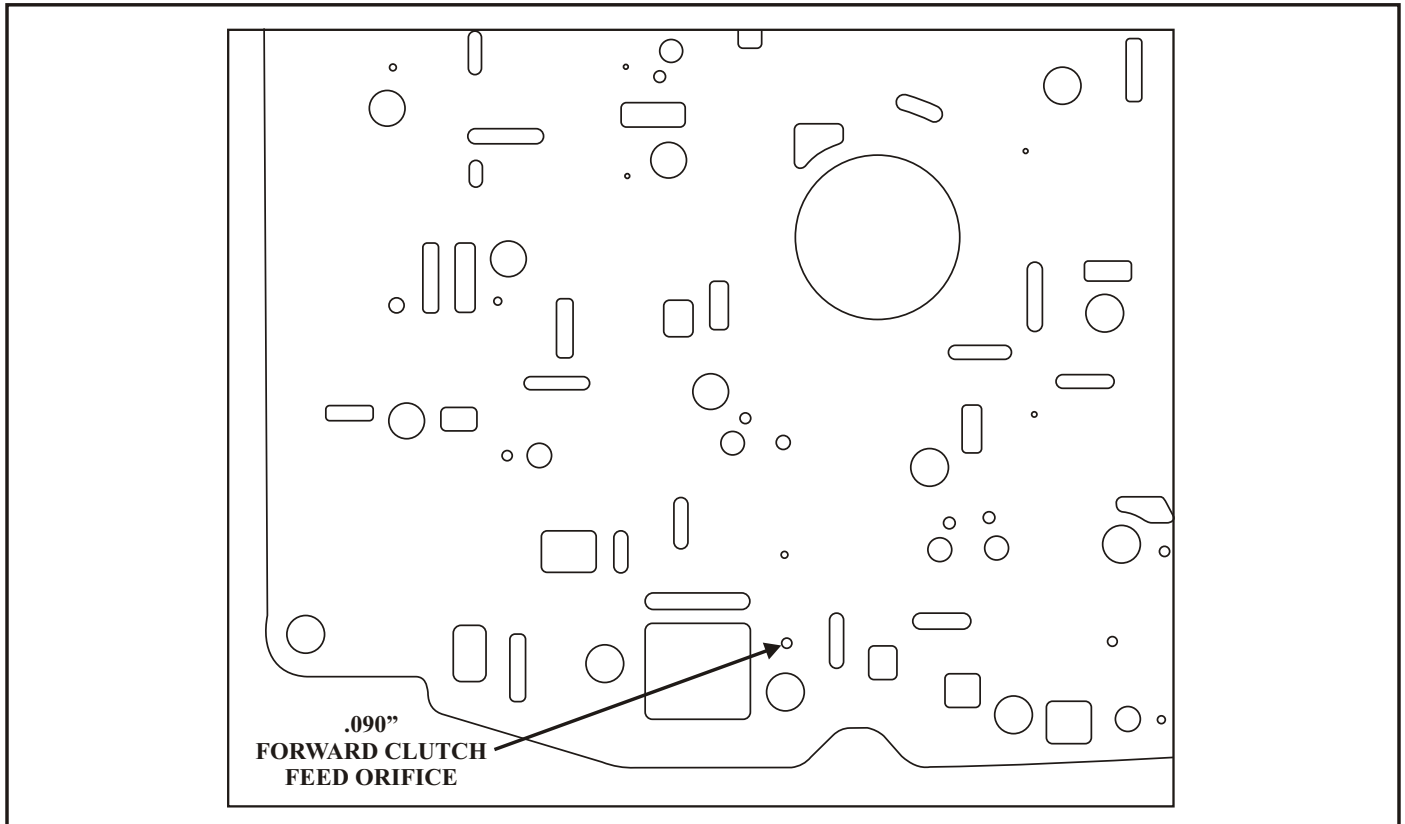
Figure 2

**NOTE #2:** The fluid going through the feed tube to the forward clutch must first pass through a .090” orifice in the spacer plate, (Refer to Figure 2). Line pressure feeding this orifice comes from the manual valve. The line pressure service port is located in the circuit before the manual valve. The feed pressure on the service port side of the orifice via the manual valve is not affected by the pressure drop on the feed tube side of the orifice. This is why a line pressure check does not reveal the loss of forward clutch pressure due to the cracked feed tube.
