4T65-E

P1887 TCC RELEASE SWITCH MALFUNCTION

Technical Service Information

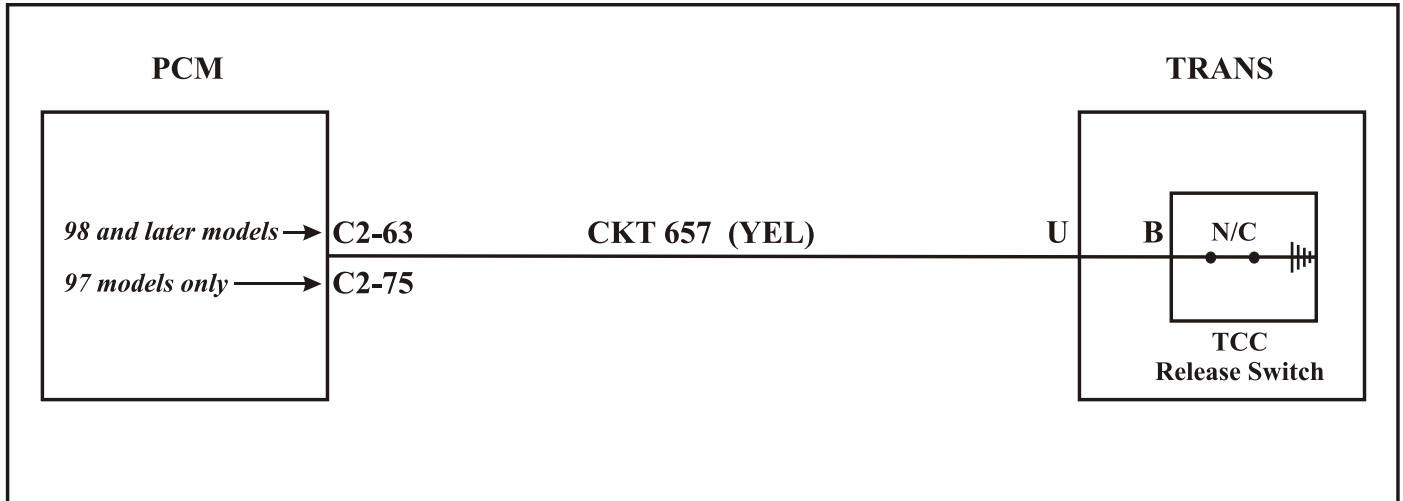
Figure 1

CAUSE: The PCM supplies 12 volts on CKT 657 to the TCC release switch with the ignition switch on or in the run position. (See figure 1) The TCC release switch is located inside the transaxle as part of the fluid pressure switch assembly. (See figure 2) This code is typically set when voltage on CKT 657 remains high for 6 seconds or longer when TCC is commanded on and TCC slip speed is -20 to +60 RPM.

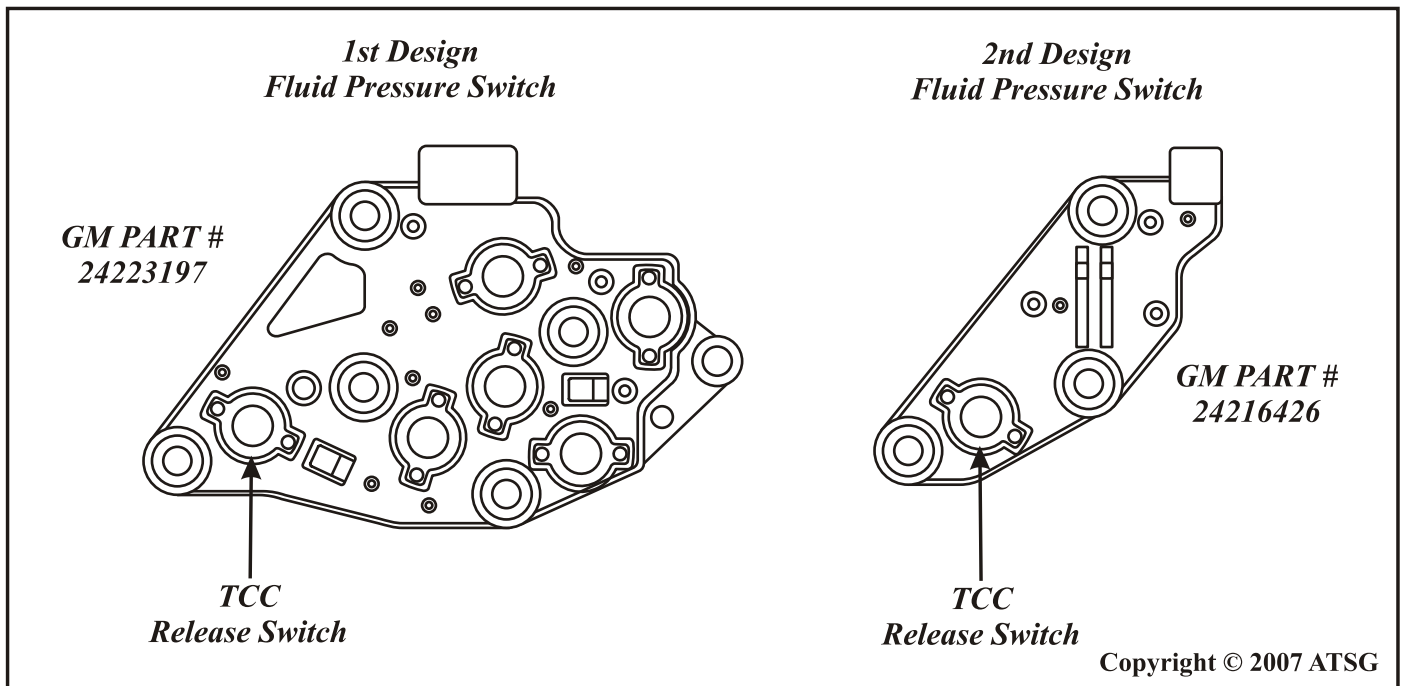
Figure 2

24223197 = 1st Design Fluid Pressure Switch Assembly

24216426 = 2nd Design Fluid Pressure Switch Assembly

Turn the key off. Plug in trans harness connector and then turn key on again. Recheck voltage on wire at terminal U from wire entry side of connector. No voltage should be seen. If battery voltage remains, then either the internal harness is open or the TCC release switch is defective as this switch is normally closed to ground without oil pressure present. Repair internal harness or replace fluid pressure switch assembly as necessary

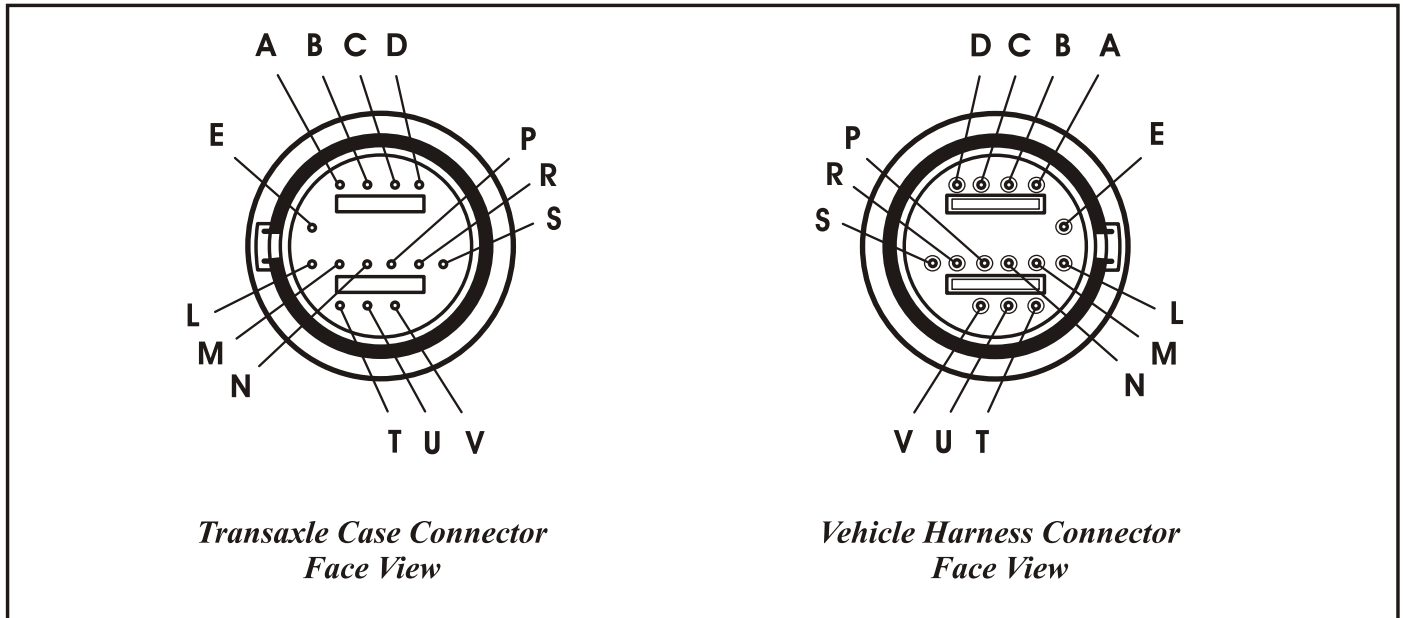
Figure 3

To test CKT 657, unplug the harness connector at the transmission and identify terminal U. (See figure 3) With a DVOM set to DC volts, place the negative lead to a known good ground and the positive meter lead to terminal U in the harness connector. Turn the **key on** with the **engine off**. Battery voltage should be seen.

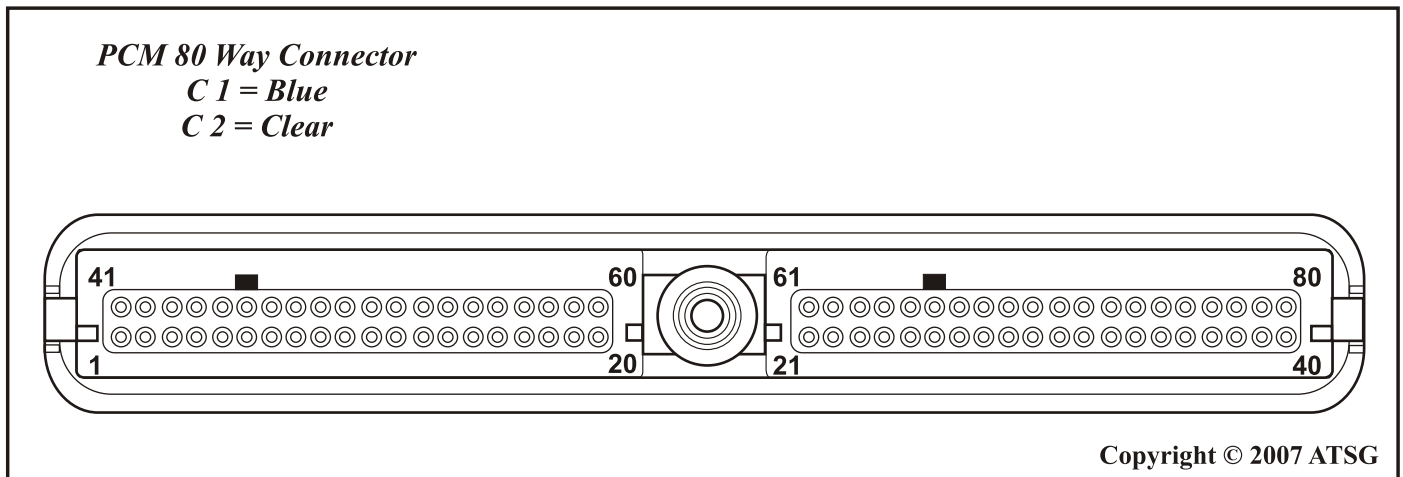
Figure 4

For 98 and newer models, check voltage on wire at terminal 63 in the PCM C2 connector. For 97 vehicles use terminal 75. (See figure 4) If battery voltage is present then repair break in wire or run a new wire to the trans harness connector terminal U. This is usually a yellow wire from the PCM to the trans harness connector. If no voltage is present on the wire at PCM connector then turn **key off**, disconnect battery and unplug PCM connector. Remove terminal end and wire from connector to inspect for damaged crimp or broken wire. Test terminal end for loose fit on PCM pin. Repair as necessary. Plug connector in to PCM. Reconnect battery. Turn key on and recheck voltage on wire at PCM connector. If battery voltage is now seen then verify voltage is present at unplugged trans connector terminal U and your repair is complete. If there is still no battery voltage with key on/engine off and the trans connector unplugged, then the PCM will require replacement.

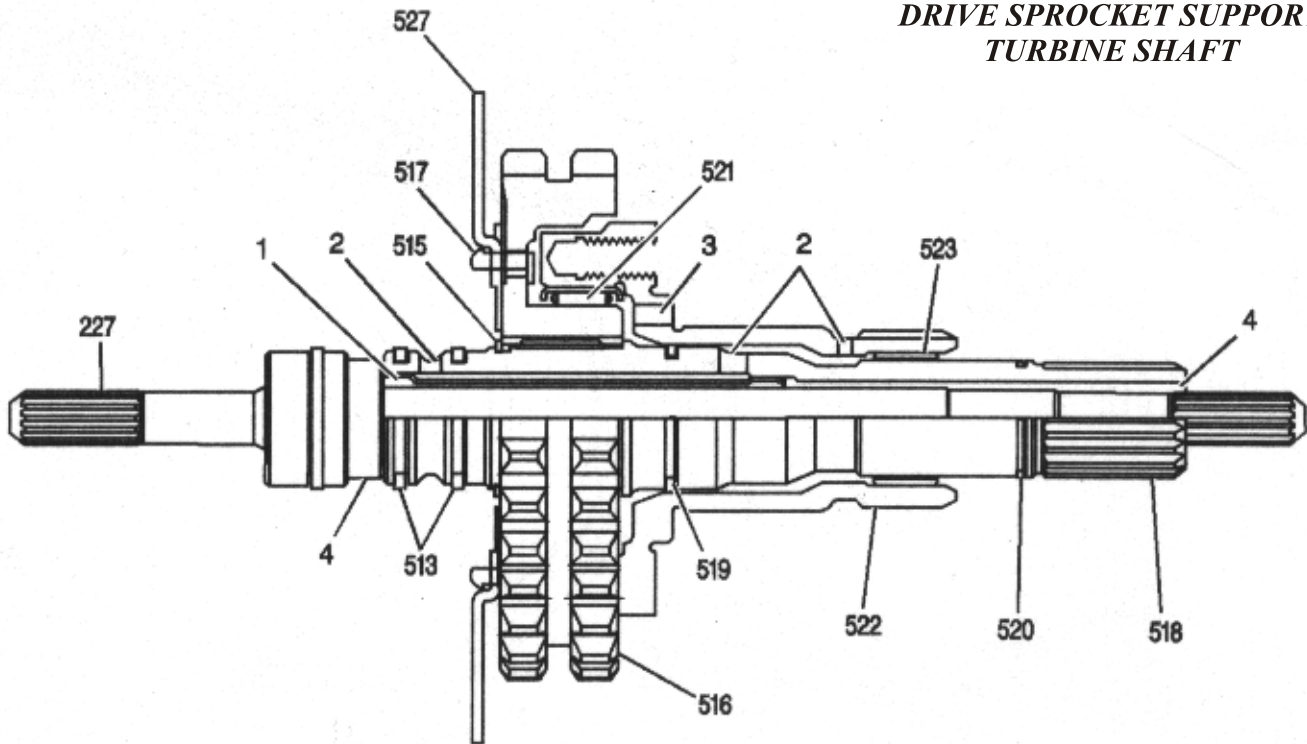
Figure 5

A damaged turbine shaft, teflon seal rings, O-ring or front stator support bushing.

A worn or damaged drive sprocket and/or bearing or channel plate sleeve.

Check for damaged turbine shaft or loose inner steel sleeve. Replace turbine shaft as necessary. Inspect for worn or damaged turbine shaft O-ring or seal rings and replace as necessary. Check for worn or loose drive sprocket support bushing and replace bushing or support as needed. (Stator Support) A worn or damaged drive sprocket where it rides the bearing or a damaged bearing will require replacement of both pieces. (See figure 5) If the channel plate sleeve has been damaged at the turbine shaft seal ring area from turbine shaft misalignment due to drive sprocket bushing or bearing failure, then replacement of the sleeve or entire channel plate assembly may be required. Valve body concerns such as a sticking or worn TCC control valve or bore will require repair or replacement of the control valve assembly. (See figure 6) Look for metal particles or debris that would not allow the # 1 checkball to seat properly. Clean or remove debris from the channel plate area as needed. (See figure 7)

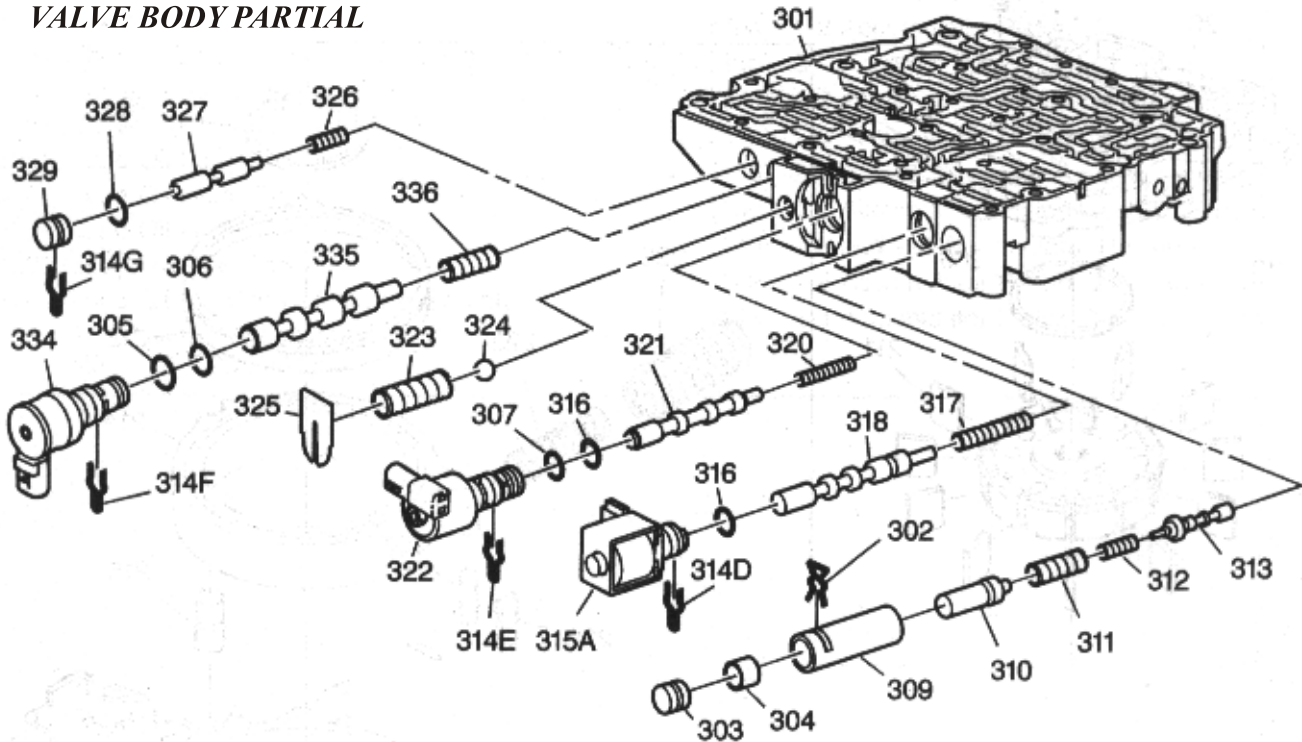
Figure 6

A sticking or worn TCC control valve or bore in the valve body.

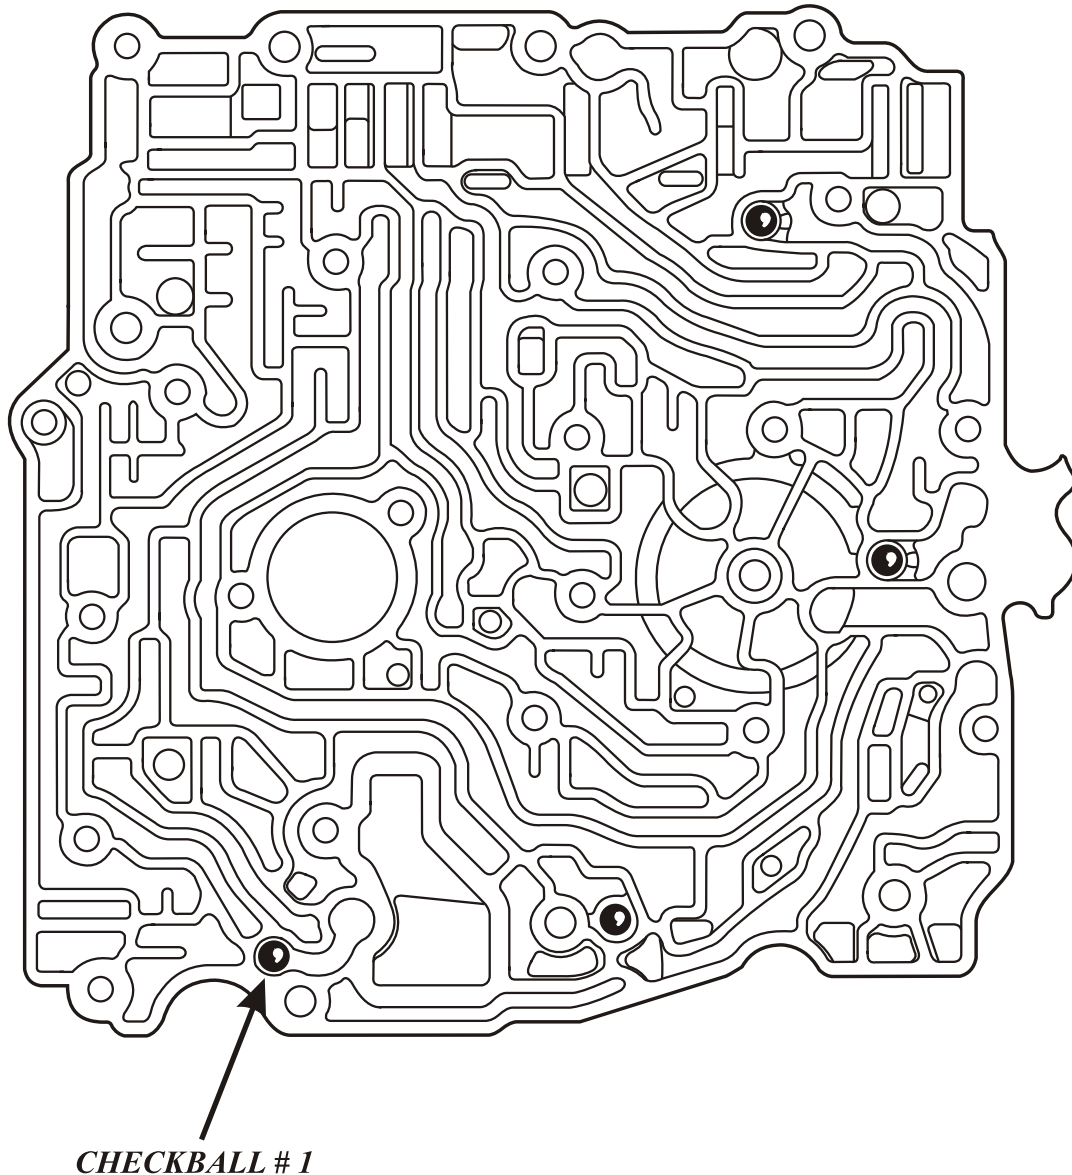
Figure 7

The #1 checkball in the channel plate is leaking or not seating properly.
