4T65-E

P0742 TCC SYSTEM STUCK ON (*In depth Diagnosis*)

Technical Service Information

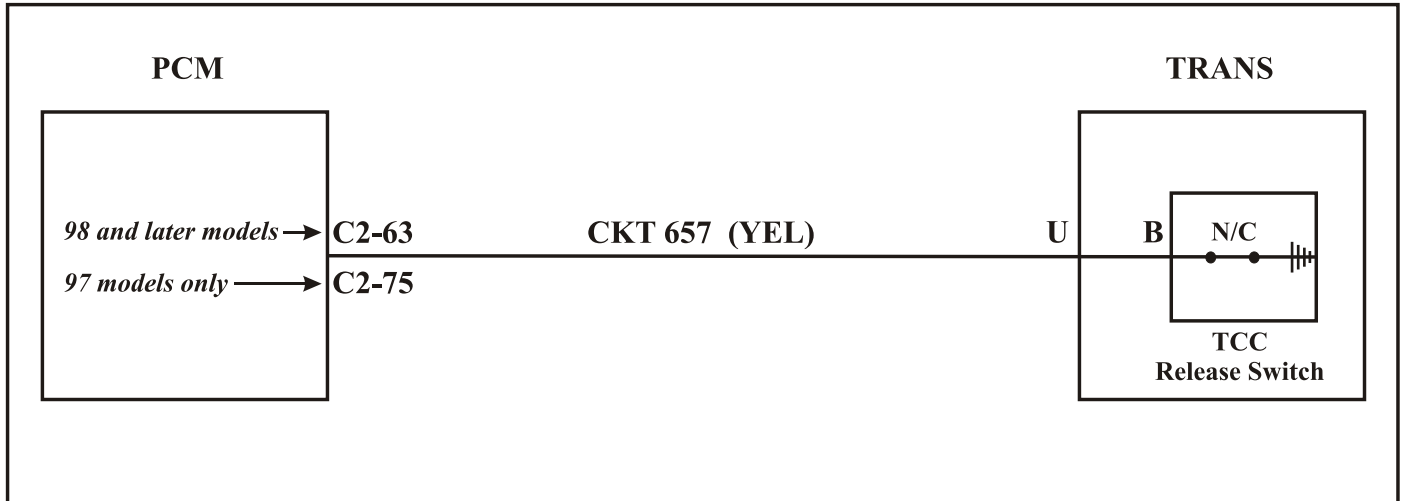
Figure 1

CAUSE: The PCM supplies 12 volts on CKT 657 to the TCC release switch with the ignition switch on or in the run position. (See figure 1) The TCC release switch is located inside the transaxle as part of the fluid pressure switch assembly. (See figure 2) This code is typically set when voltage on CKT 657 remains low, 6 times for 4 seconds, when TCC is commanded off during the current ignition cycle.

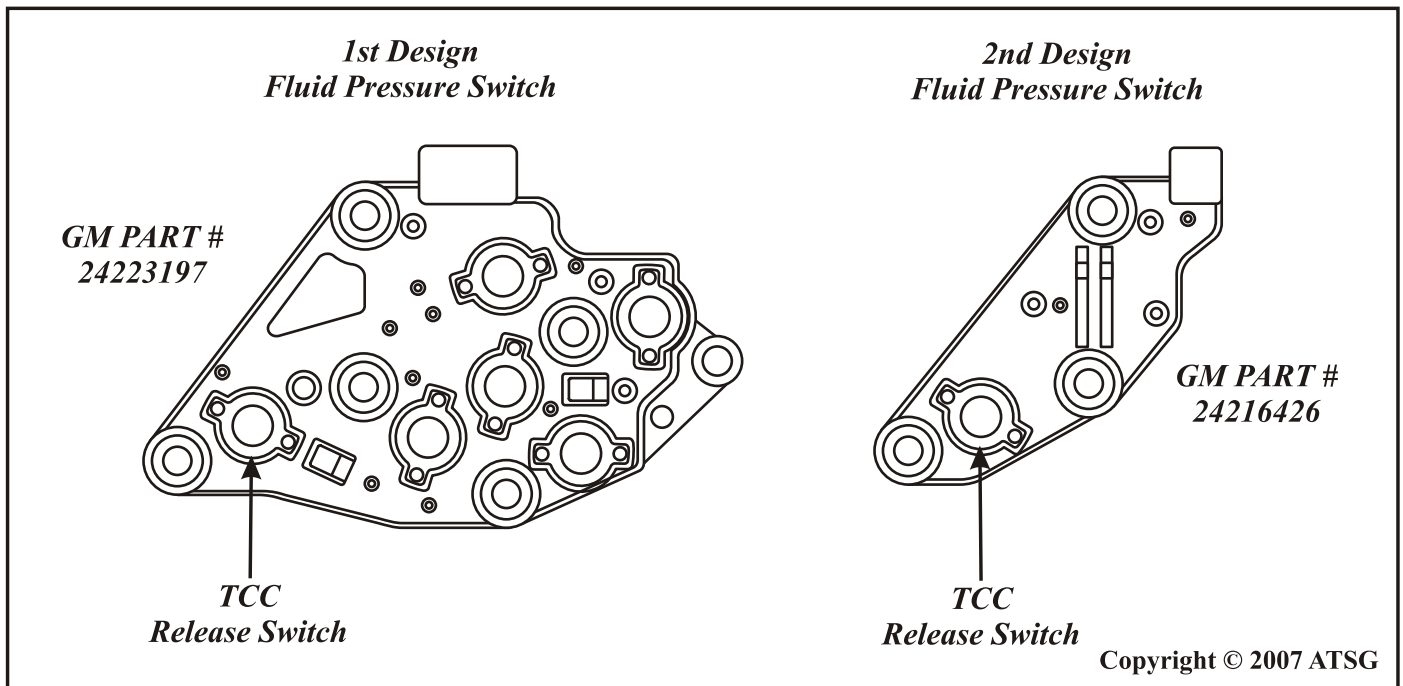
Figure 2

This switch is normally closed to ground without oil pressure present. With the engine running in Park or Neutral, TCC release oil acting on the switch should open the contact.

Repair internal harness or replace fluid pressure switch assembly as necessary.

SERVICE INFORMATION: (See Figure 2)

At the time of this printing, the current OEM part numbers are as follows:

24223197 = 1st Design Fluid Pressure Switch Assembly

24216426 = 2nd Design Fluid Pressure Switch Assembly

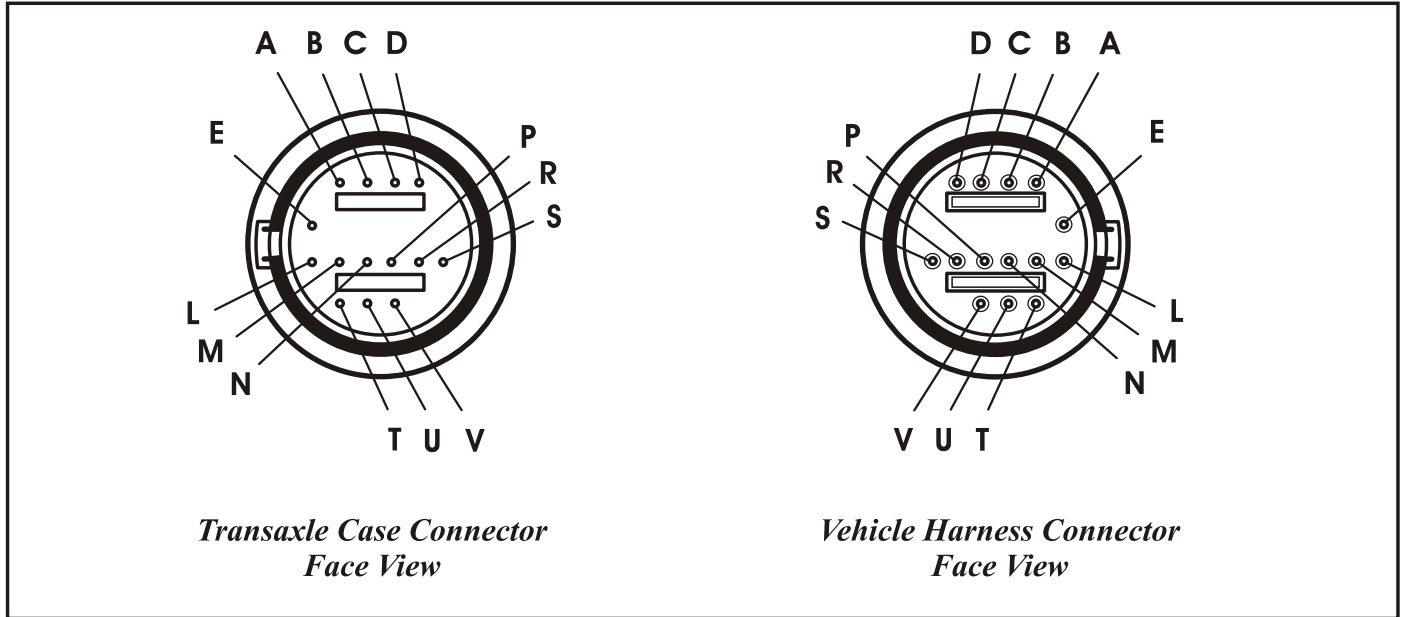
Figure 3

To test CKT 657, unplug the harness connector at the transmission and identify terminal U. (See figure 3) With a DVOM set to DC volts, place the negative lead to a known good ground and the positive meter lead to terminal U in the harness connector. Turn the **key on** with the **engine off**. Battery voltage should be seen.

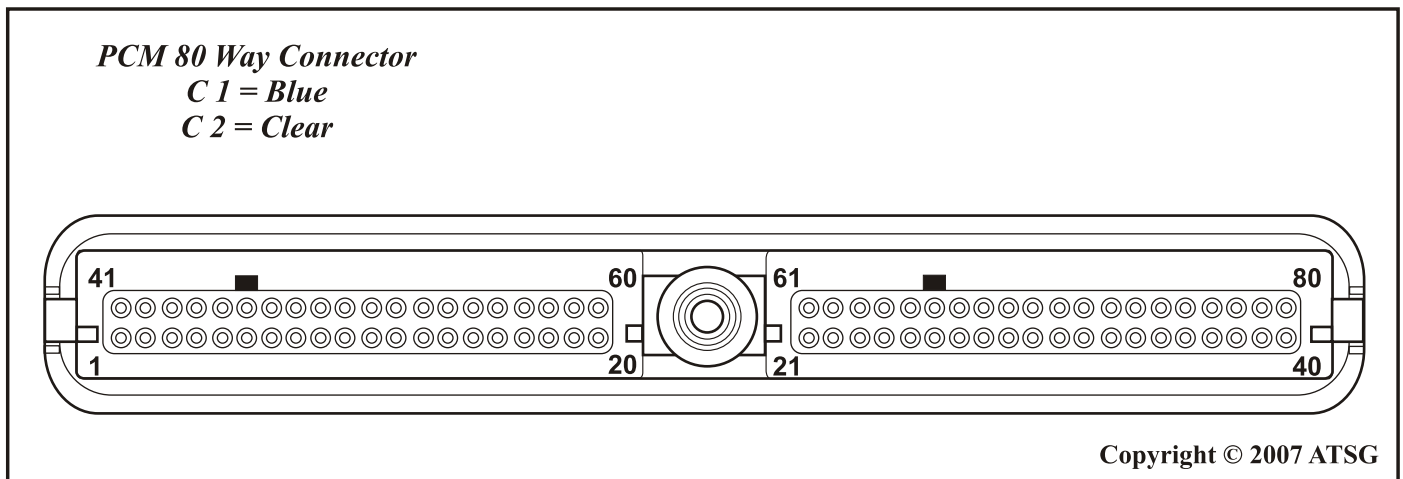
Figure 4

For 98 and newer models, cut the wire at terminal 63 in the PCM C2 connector, approximately 2 inches from the connector. For 97 vehicles use terminal 75. (See figure 4) Recheck voltage on the piece of cut wire that is protruding from the PCM connector. If battery voltage is now present, then trace and repair short to ground in wire between PCM connector and trans connector terminal U. Or, run a new wire to the trans harness connector in place of the existing wire. Cut the old wire out of the harness at both ends and tape it back. Be sure to solder and shrink wrap the new wire and tape it into the existing harness for neatness. This is usually a yellow wire from the PCM to the trans harness connector.

If no voltage is present on the cut wire at PCM connector, then the PCM will require replacement as the circuit would be shorted to ground inside the PCM.

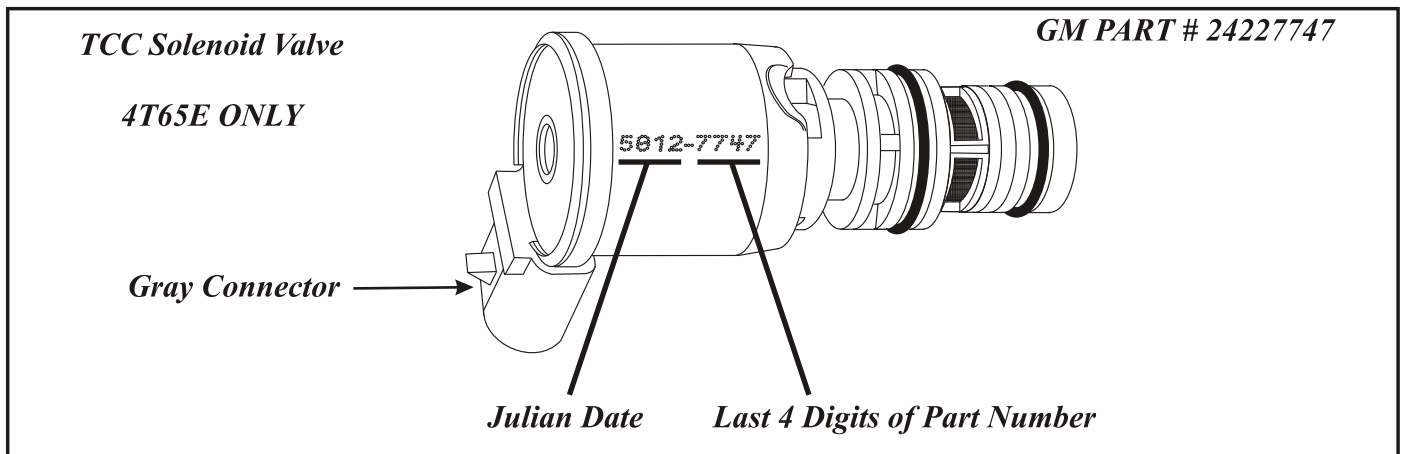
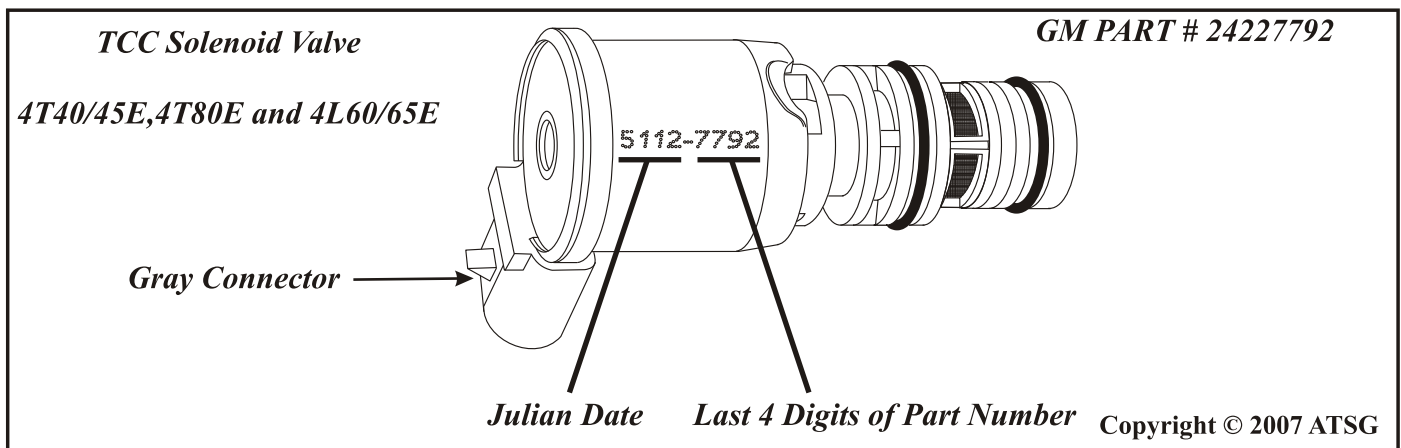
If all external electrical checks test good at this time, then unplug the harness connector at the transmission. Start the engine, step firmly on the brake pedal and place the shift lever in Overdrive. If the engine stalls out or if it feels like the converter clutch is dragging, then replace the TCC/PWM solenoid. It is stuck right now.

SERVICE INFORMATION: (See Figures 5 and 6) Identify the correct TCC/PWM solenoid for your application. It is very easy to use the wrong solenoid as both solenoids have a gray plastic connector with the same configuration and appear to be identical. They are not. Both solenoids will have 2 groups of 4 numbers etched on the can surrounding the solenoid winding. The first group indicates the Julian Build Date and the second group are the last 4 digits of the part number. Refer to GM TSB 02-07-30-039A dated Dec/2002. At the time of this printing, the correct OEM part numbers are as follows:
 24227747 = TCC Solenoid Valve for 4T65-E ONLY. This number supercedes previous part number 24214974.
 24227792 = TCC Solenoid Valve for 4T40/45-E and 4T80-E. This number supercedes previous part number 24212690. Refer to GM TSB 02-07-30-039F dated Aug/2005.
 Part number 24227792 is currently listed for use in 4L60/65-E units as well.

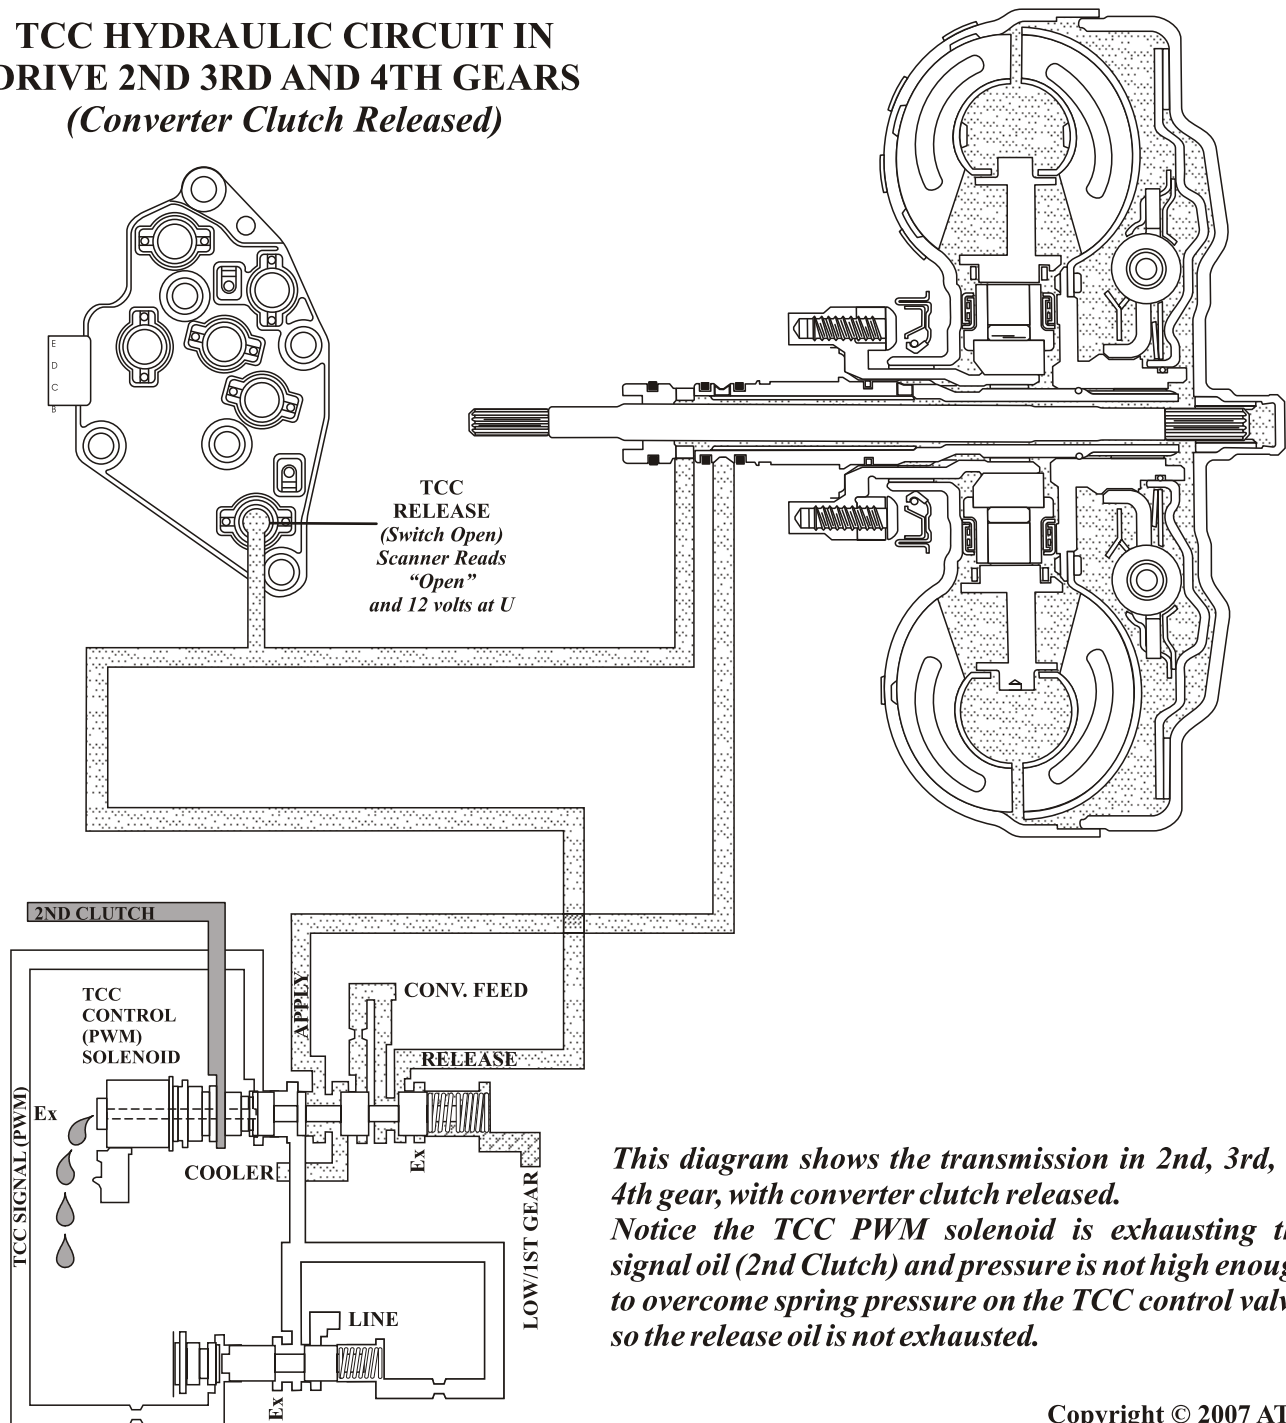
Figure 7

With the trans connector unplugged and both shift solenoids off, the transmission will be forced to 3rd gear allowing 2nd clutch oil to feed the TCC/PWM solenoid. (See figure 7)

This does not necessarily mean that the solenoid is good if the engine does not stall out or drag at this time.

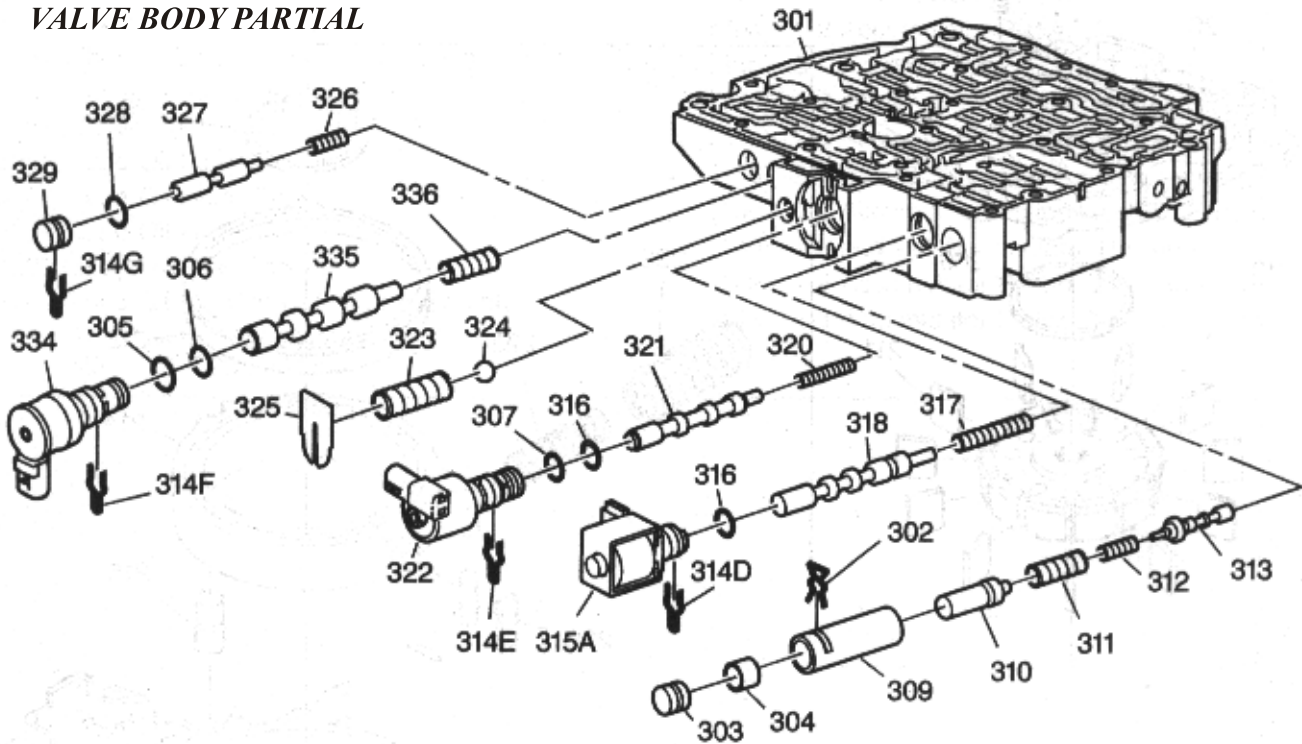
Figure 8

Valve body concerns such as a sticking TCC control valve may cause the vehicle to stall in a Drive range 1st gear or Reverse. The TCC regulator apply valve can cause a surge or harsh TCC engagement. Problems with the torque signal regulator or pressure regulator valve can result in harsh engagements and shifting. (See figure 8)

Disassemble and clean valve body. Free up sticking valves or replace control valve assembly as necessary if valves or bores are badly scored or damaged beyond repair.

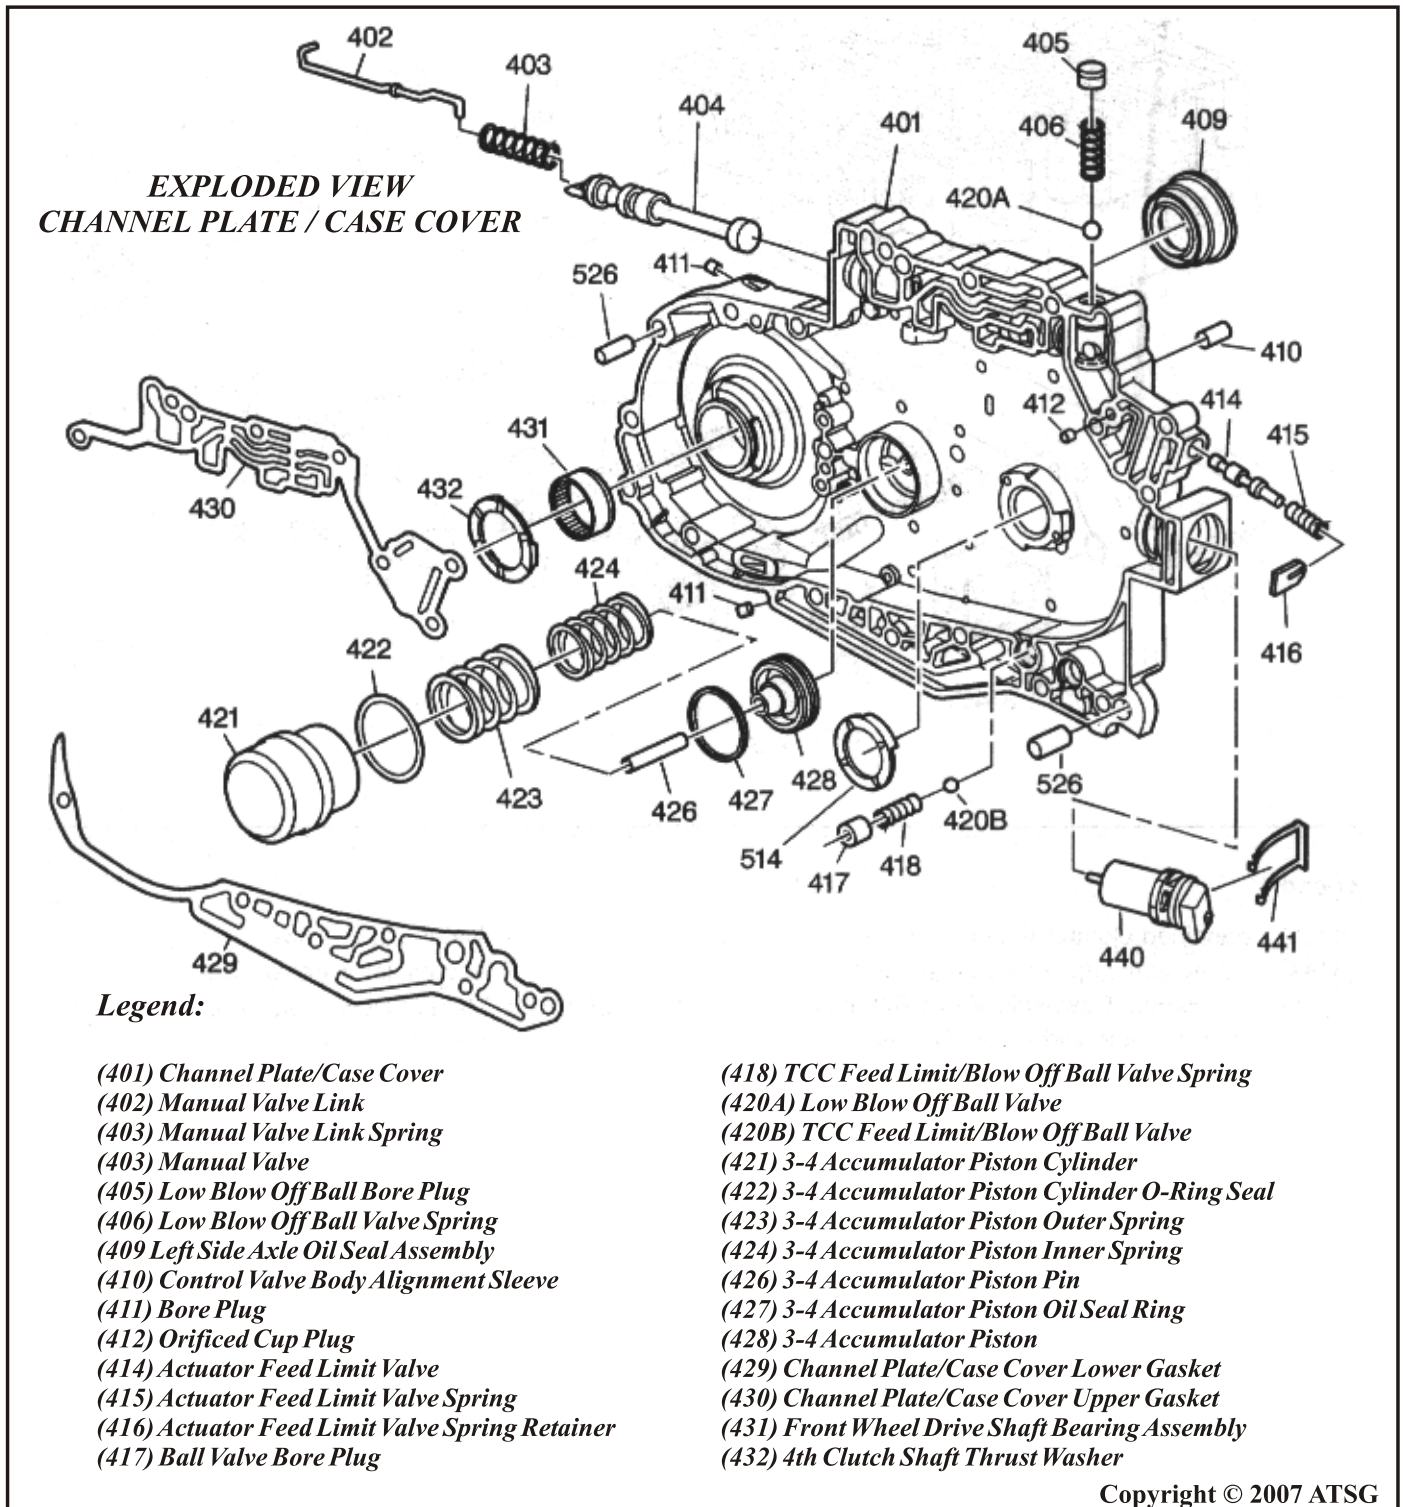
Figure 9

The TCC feed limit/blow off ball valve in the case cover/channel plate is stuck closed.

Check to see if the TCC feed limit/blow off ball valve in the case cover/channel plate is stuck and repair as necessary. (See figure 9)
