## MERCEDES 722.6 VARIETY OF SHIFT AND/OR TCC COMPLAINTS

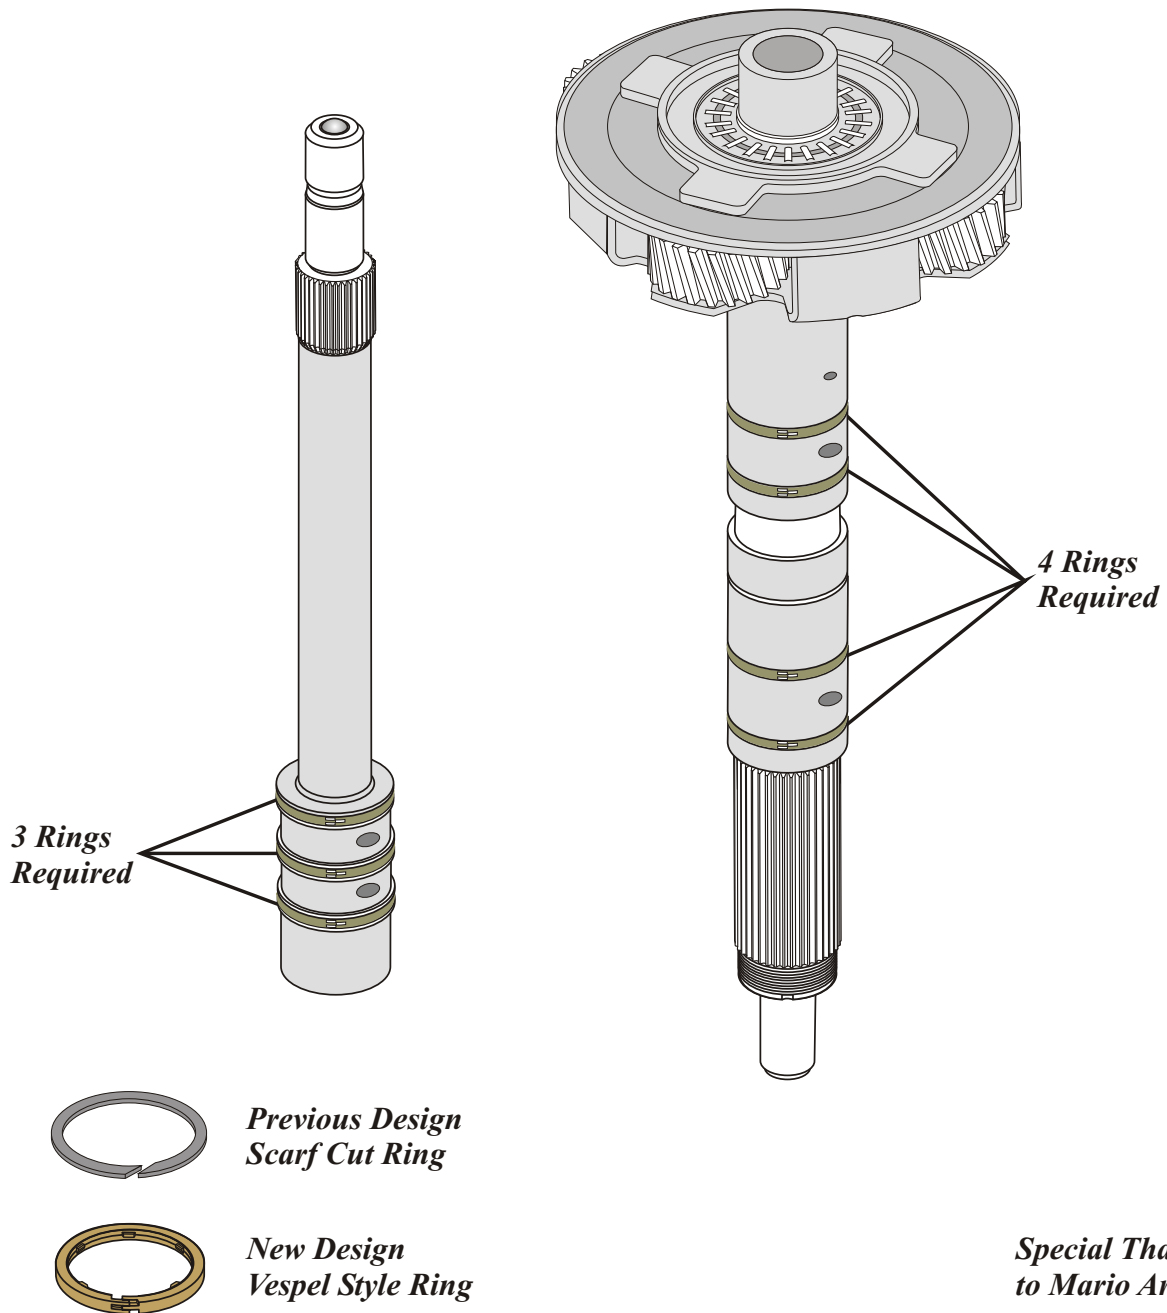
Figure 1

**CAUSE:** Low retention of OEM scarf cut sealing rings for the K2 clutch drum on the input shaft as well as the output shaft rings for the K3 clutch drum (See Figure 1). The rings on the input shaft could cause a loss of pressure for the K2 clutch and/or the converter clutch while the rings on the output shaft could lose K3 clutch pressure. The severity of the leak would determine the degree of shift complaints.

**CORRECTION:** Since pressure testing with a gauge is not available, it is highly recommended to update the rings to the newer style as seen in figure 1 and replace the sprags, especially if the F1 sprag has 16 elements and the F2 has 14. These are early sprags and are prone to slipping. Both sprags have been updated to 20 elements each (See Figure 2 and 3).

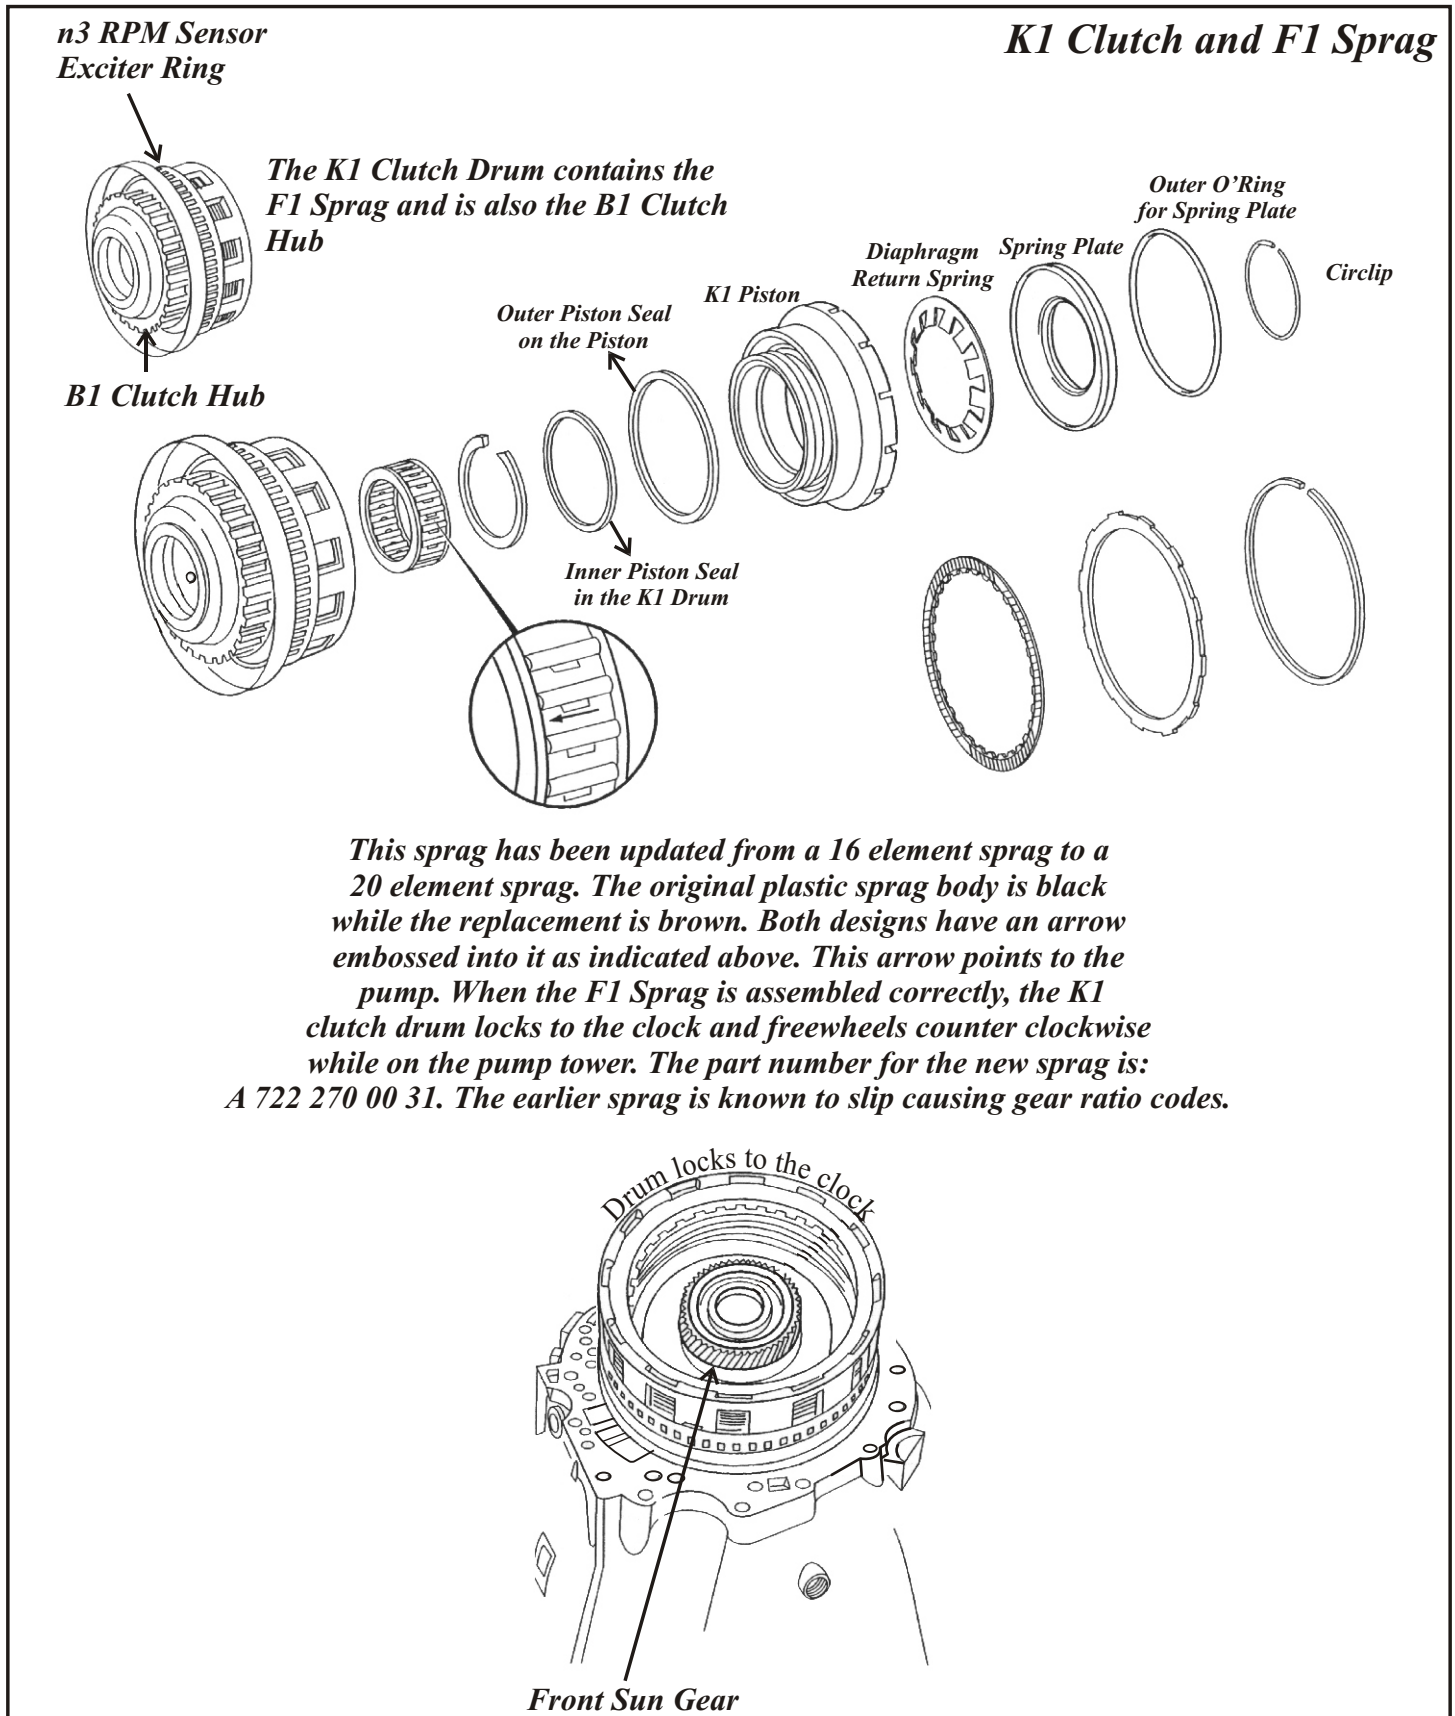
Figure 2

It should be noted that the F1 and F2 sprags are also known to slip causing shift complaints and implausible shift errors (gear ratio errors) especially if they are not the later 20 element design.

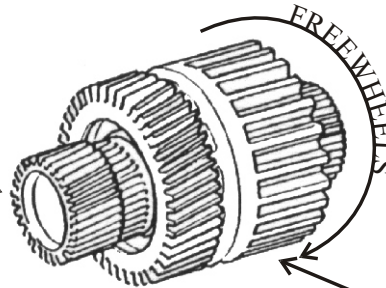
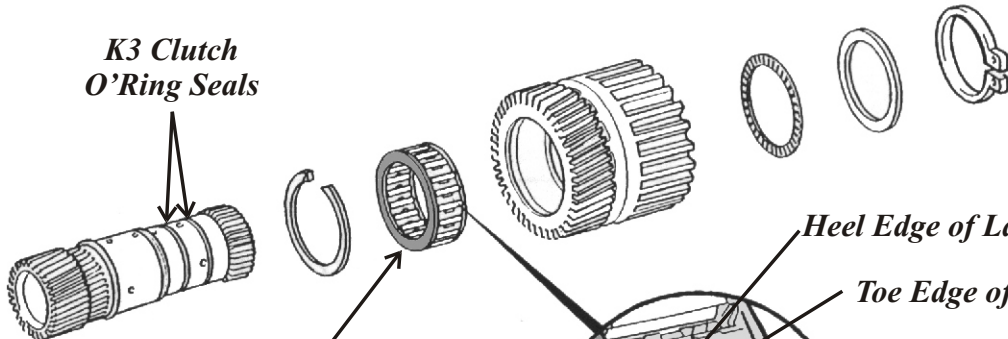
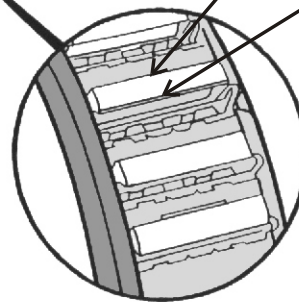
Figure 3

The F2 Sprag has one brass  
end cap integral to the cage. This  
end cap faces the center sun gear.  
\*Be careful, the elements fall out  
of the cage easily.

This sprag has been updated from 14 elements to 20. The new 20 element sprag part number is A 220 270 01 31. It is very common to find that some of the elements have fallen out from the retaining cage and laying loose in the package. This does not mean the sprag is defective. It is imperative that you insert the element back into the cage slot correctly. The shorter foot of the element faces the inner race as seen to the right. With the brass cap to the left as seen in the enlarged circled view, the toes face down. The early design sprag is known to slip causing gear ratio codes.
