Technical Service Information

MERCEDES 722.6 **K3 HUB AND REAR SUN GEAR ASSEMBLY DIFFICULTIES**

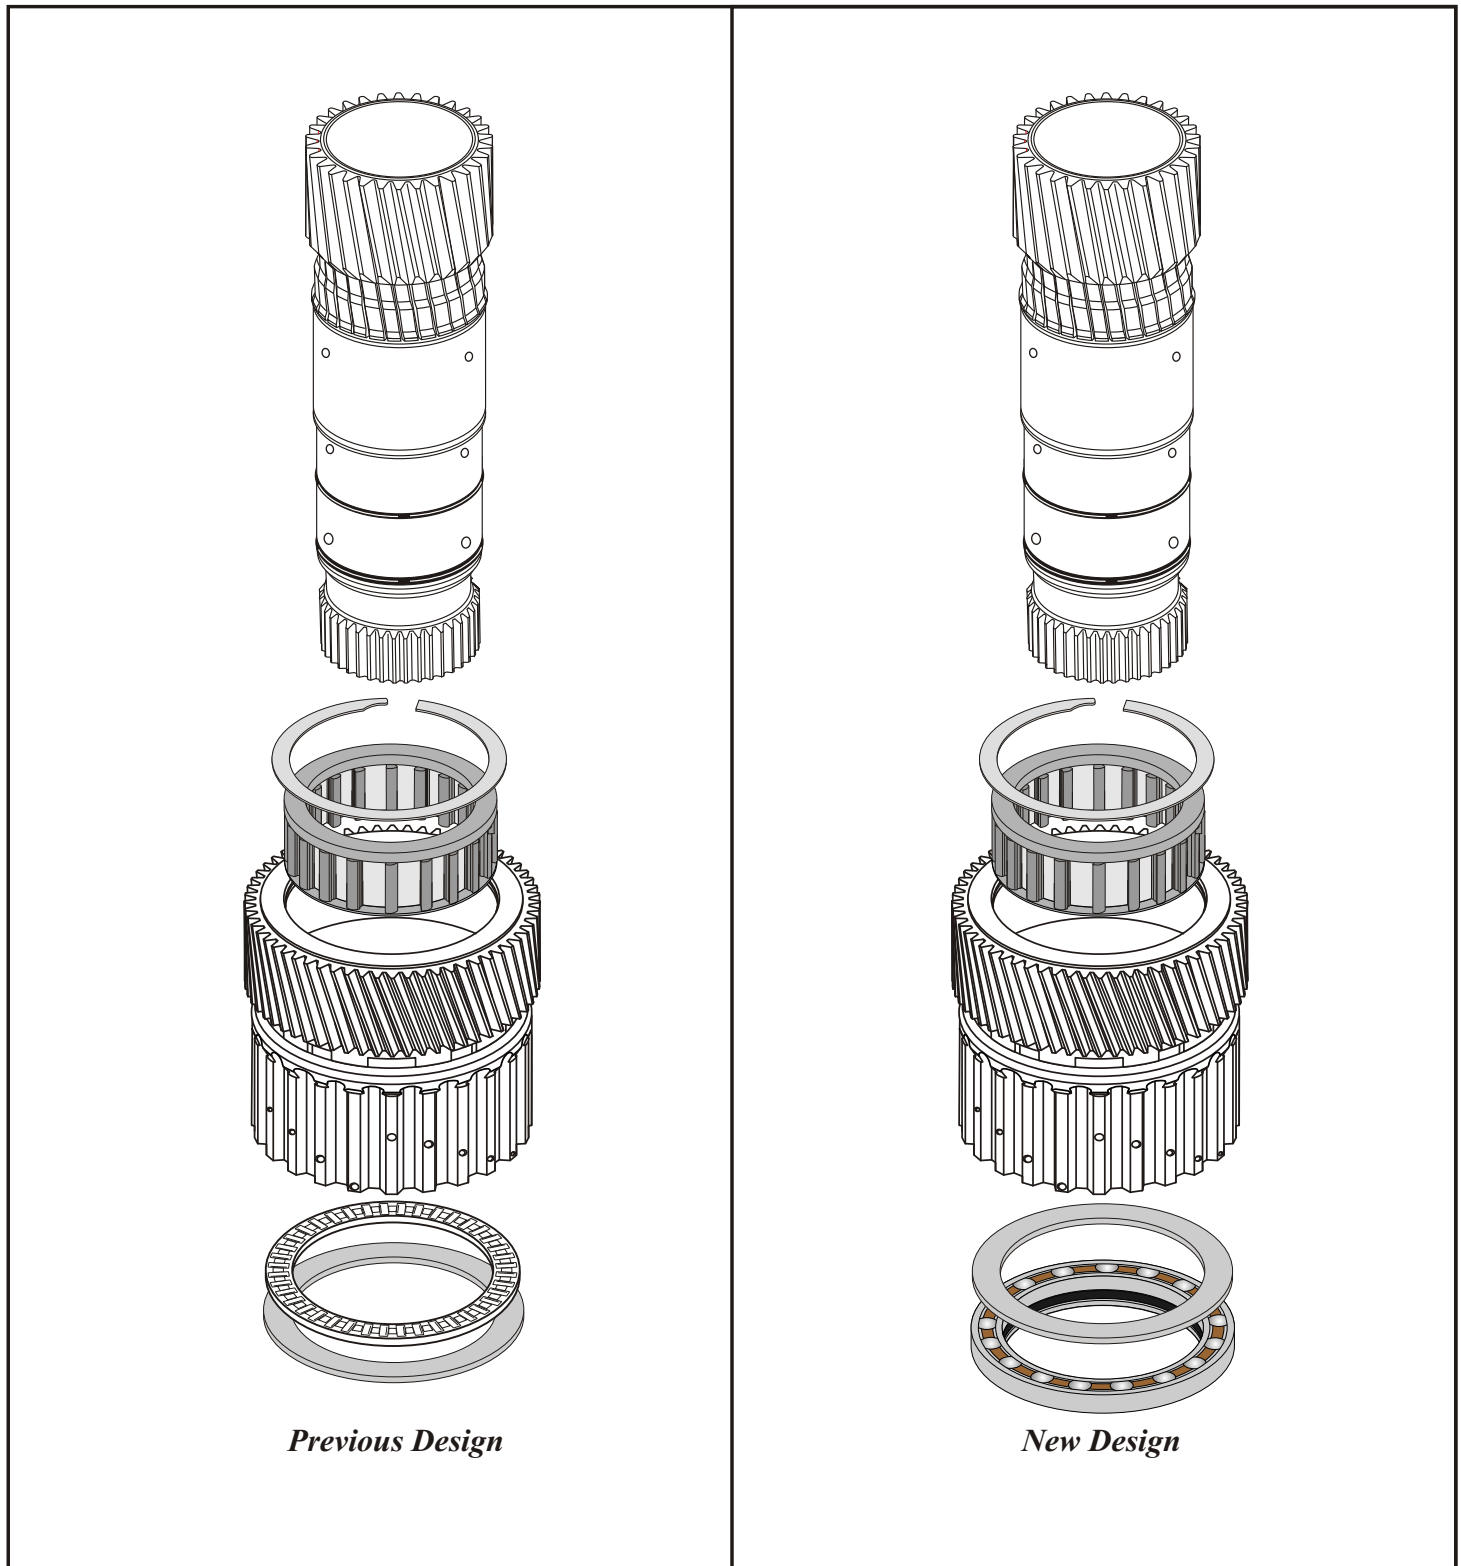
Figure 1

CAUSE: The new design K3 Clutch Hub and Rear Sun Gear have a flat spacer and ball bearing pressed into the hub assembly which replaces the previous design open face needle bearing and washer design (See Figure 1). In many cases, a brand new K3 clutch hub did not have the bearing fully pressed into the hub up against that flat spacer. This prevents the hub from being positioned correctly causing the insufficient clearance for the final retaining snap ring (Figure 2).

CORRECTION: Fully seat the bearing into the K3 Hub Assembly.

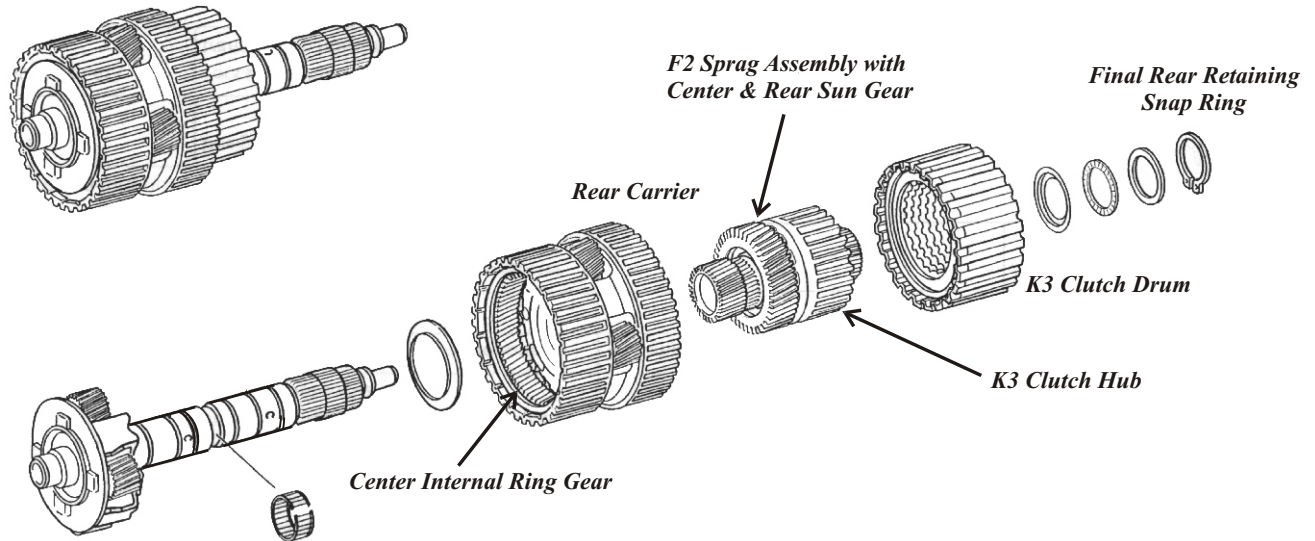
Figure 2

COMPLAINT: After a rebuild using a new K3 Clutch Hub, insufficient clearance occurs preventing the installation of the rear snap ring which holds the entire clutch assembly in place on the output shaft.
