# Technical Service Information

## GENERAL MOTORS SHIFT ADAPTS

**COMPLAINT:** A 1998 Buick Lesabre comes into the shop with a complaint of an intermittent harsh 1-2 shift. A code P1811 is stored indicating "Maximum Shift Adapt" has been reached.

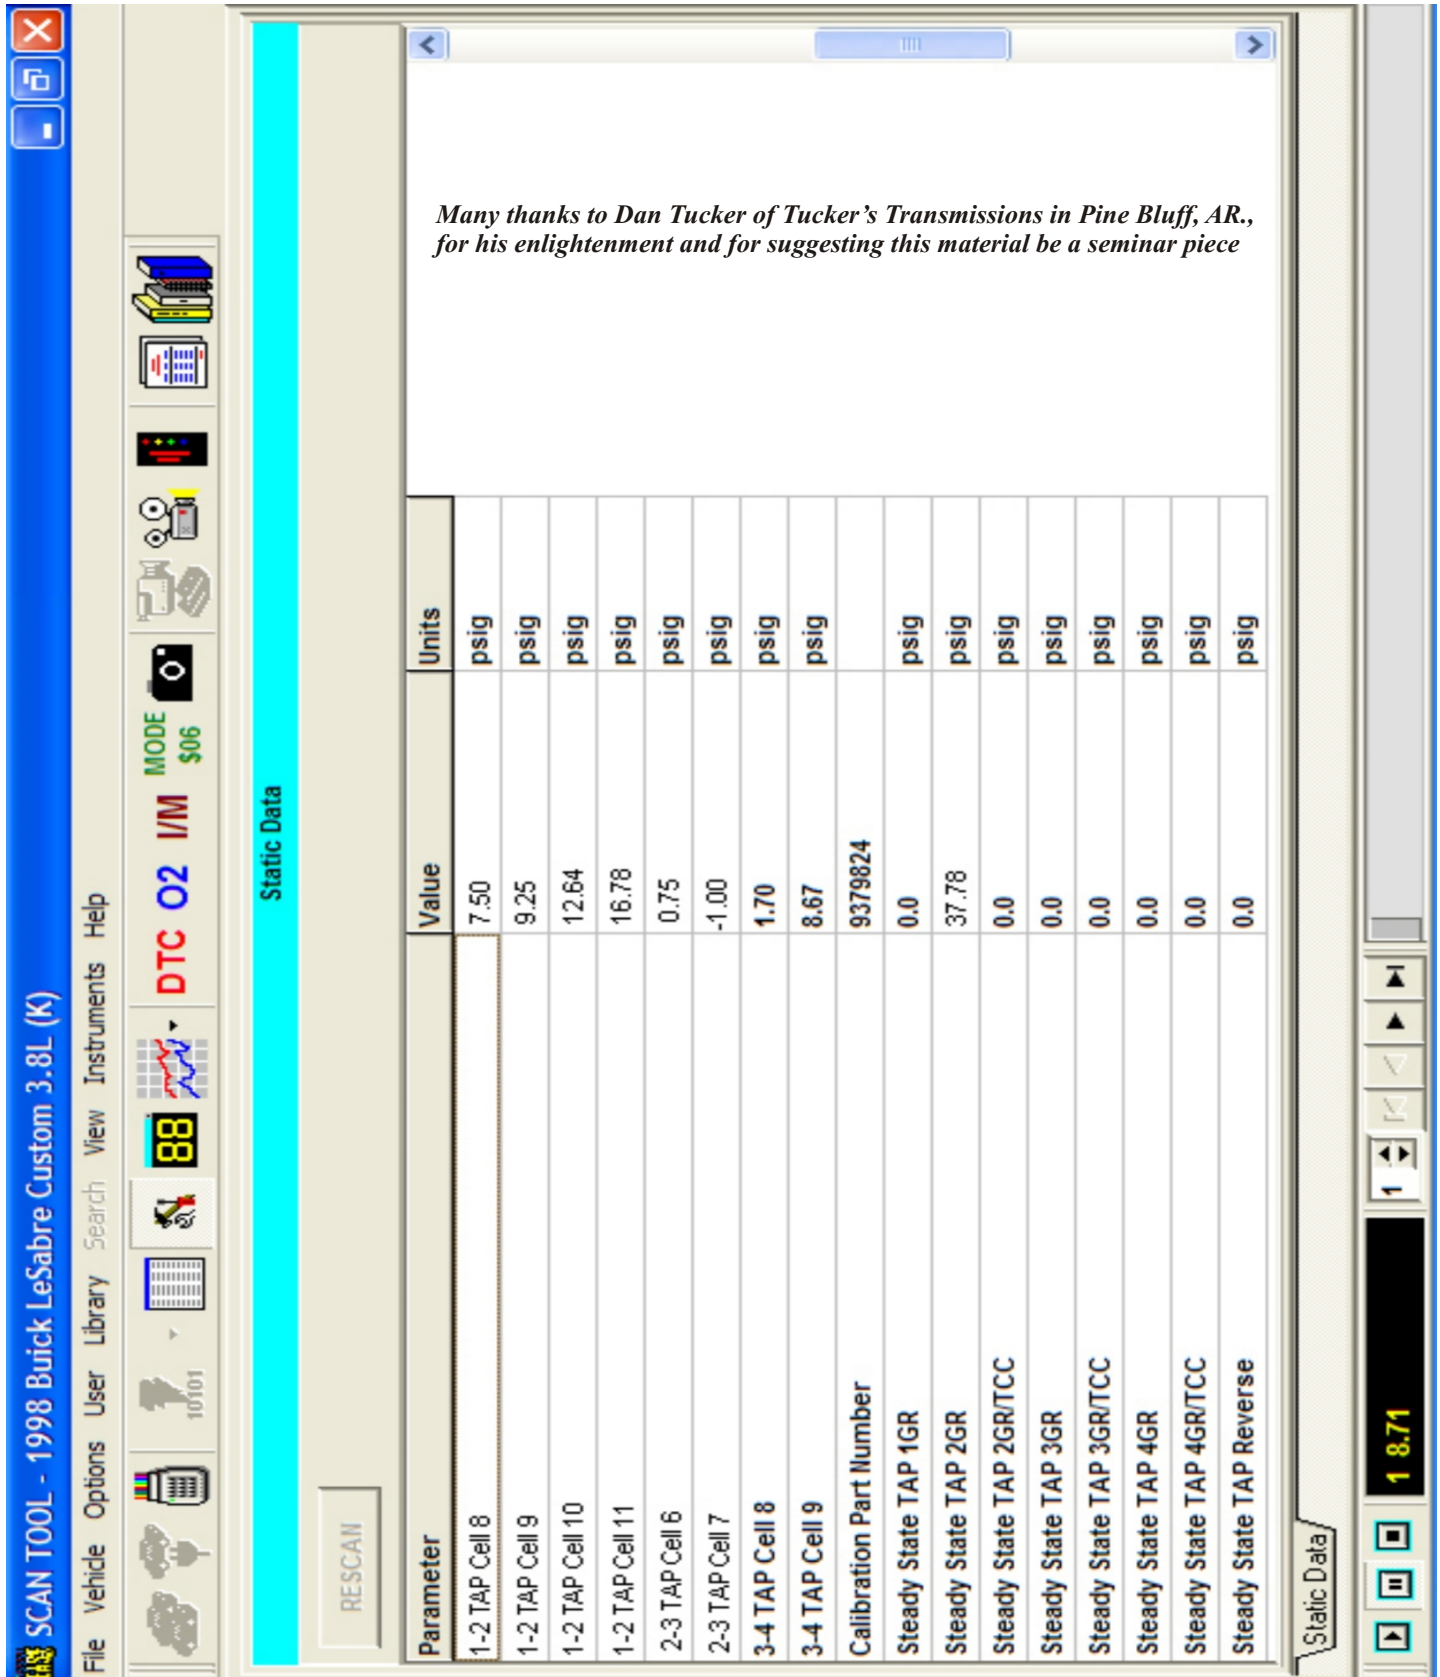
Figure 2

The P1811 indicates that the PCM has attempted to compensate for the intermittent shift timing error by raising line pressure during the 1-2 shift as seen in the shift adapt report in Figure 2. The numbers without minus signs indicate how much line rise will be added to the next 1-2 shift for that particular Tap Cell.

Should a component slip, this would be seen on the scan tools adaptive data list, (Refer to Figure 2), and would indicate a number which shows how much line pressure is going to be increased to keep that component from slipping. The worse it's slipping the higher that number will be, when there is no problem the steady state will be zero.

As can be seen in Figure 2, there is a problem with second gear, that steady state is elevated while the rest are zero. This would explain the above complaint.

**CORRECTION:** Using a 4T65E as an example, to correct slightly elevated Tap Cells usually requires replacement of the pressure control solenoid.

Another reason is, after repairs are completed, the PCM still believes it must slam that component on, in other words, it does not know the problem has been fixed. You must reset the shift adapts for the transmission to return to normal operating conditions.
