## 4L60/65/70-E

### PRODUCTION CHANGES / INPUT SPEED SENSOR ADDED

## Technical Service Information

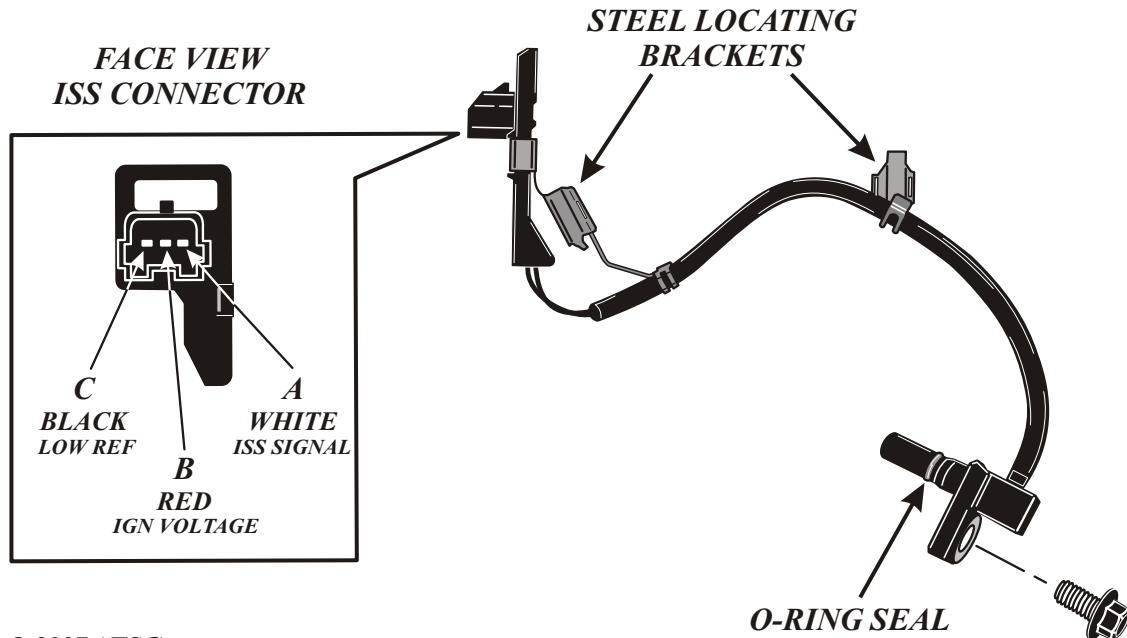
Figure 2

**Input Speed Sensor** - The ISS assembly as shown in figure 2, is internal to the transmission. Operation of the ISS should be thoroughly evaluated with a scan tool to monitor RPM prior to transmission removal for any repairs. Due to the ISS circuitry design with its internal integrated circuit (IC) chip, it is not beneficial to measure the internal resistance and therefore no internal resistance values have been made available. Improper converter clutch operation or possible converter drain back concerns may be caused if the o-ring seal is damaged or omitted when servicing the ISS. The steel locating brackets are necessary to keep the ISS wiring from coming in contact with the rotating reverse input clutch housing. These brackets push fit on to aluminum bosses that are cast into the oil pump cover.  
At the time of this printing, the OEM part number for the ISS assembly is **24237866**.

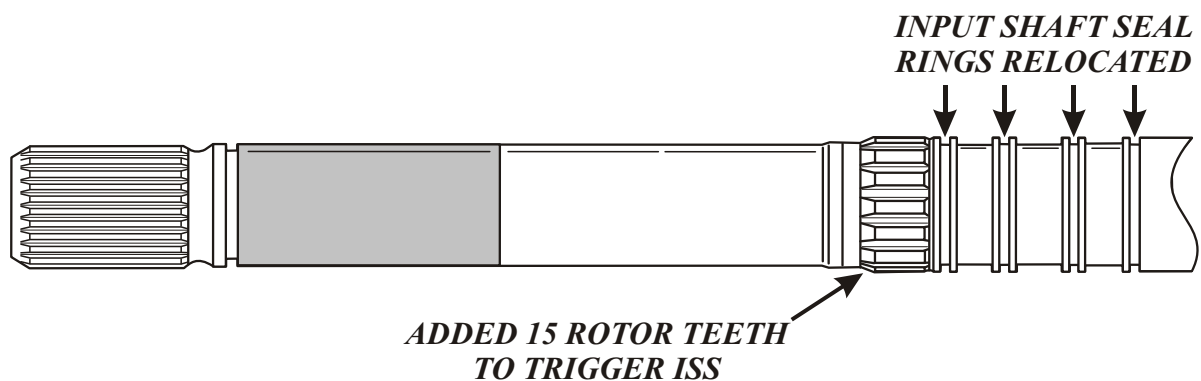
Figure 3

**Turbine Input Shaft** - The turbine input shaft as shown in figure 3 now has 15 rotor teeth added to trigger the ISS. The oil seal ring grooves have been relocated inboard towards the rear of the unit approximately 0.190”(in.) when compared to the previous design. Some pre ISS model turbine input shafts may have the rotor teeth machined in place and some may not. This was a manufacturing option. For this reason, great care must be taken when replacing the input clutch housing and turbine shaft assembly. A measurement from the front most oil seal ring groove to the base of the input shaft where it is pressed into the clutch housing must be taken and compared to the replacement component to ensure compatibility or transmission failure will be the result.

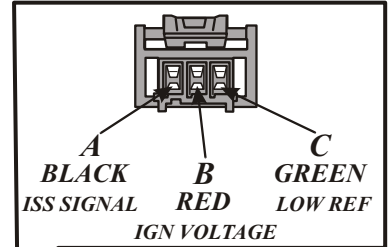
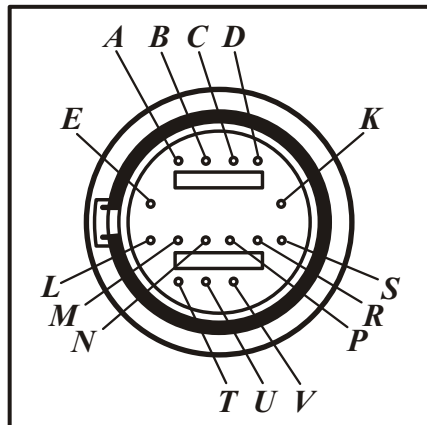
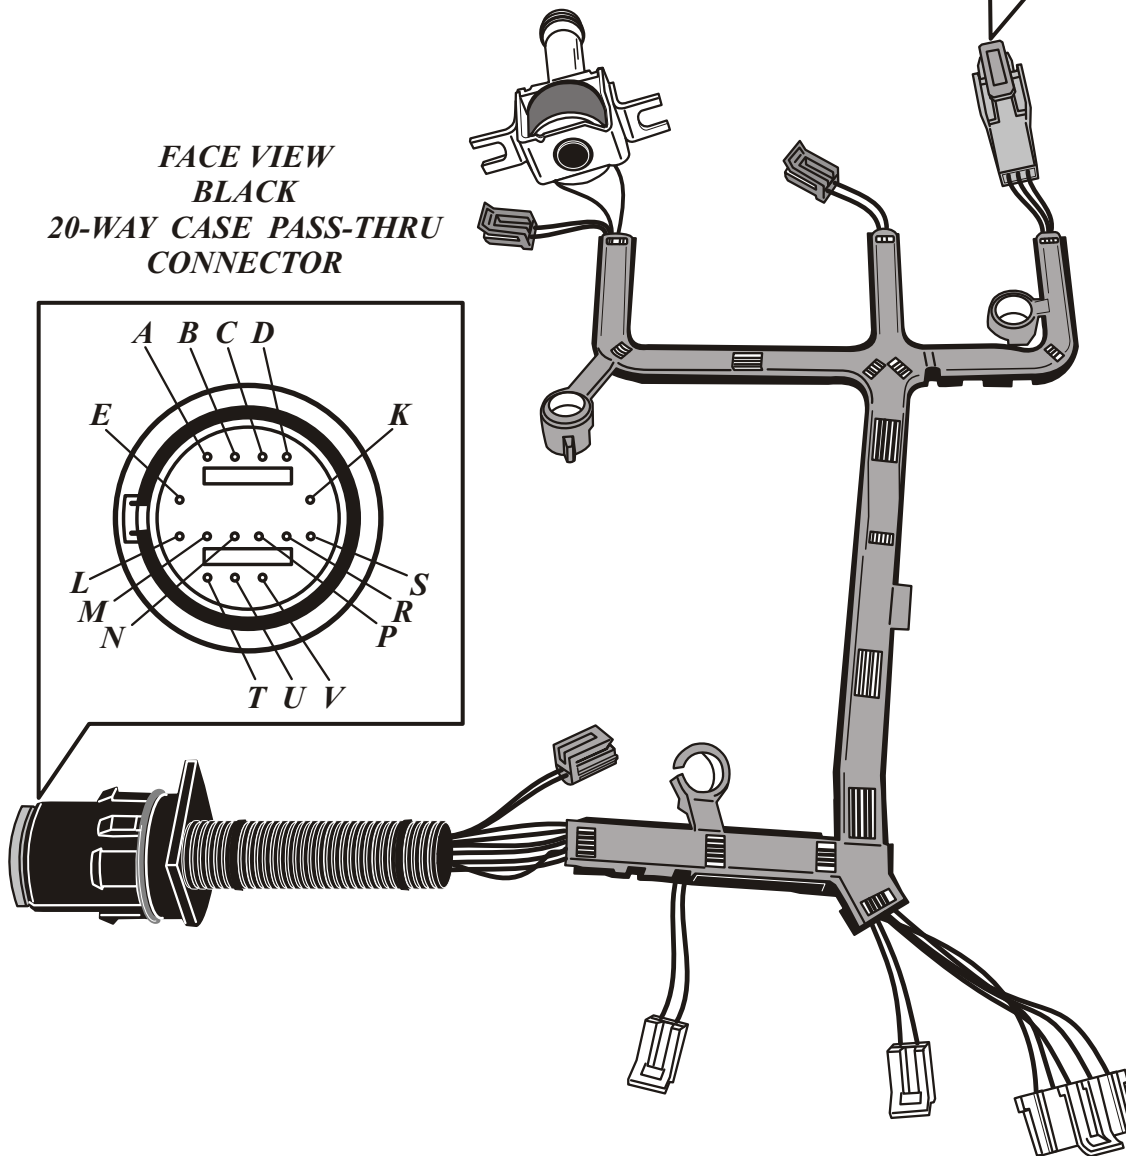
Figure 4

**Internal Wire Harness** - The internal wiring harness as shown in figure 4 contains additional circuits for ISS equipped transmissions and can be easily identified by the black 20-way pass-thru connector. Non ISS transmissions use the previous design harness which has a light grey connector. The ISS circuit shares pin position E (Ckt 839) for ignition feed voltage. This is a pre existing circuit and is spliced internally to supply power to the ISS. The additional pin terminals are K (Ckt 1230) for ISS signal and also V (Ckt 1231) for low reference.

At the time of this printing, the OEM part number for the new internal wire harness for ISS equipped transmissions is **24234121**.

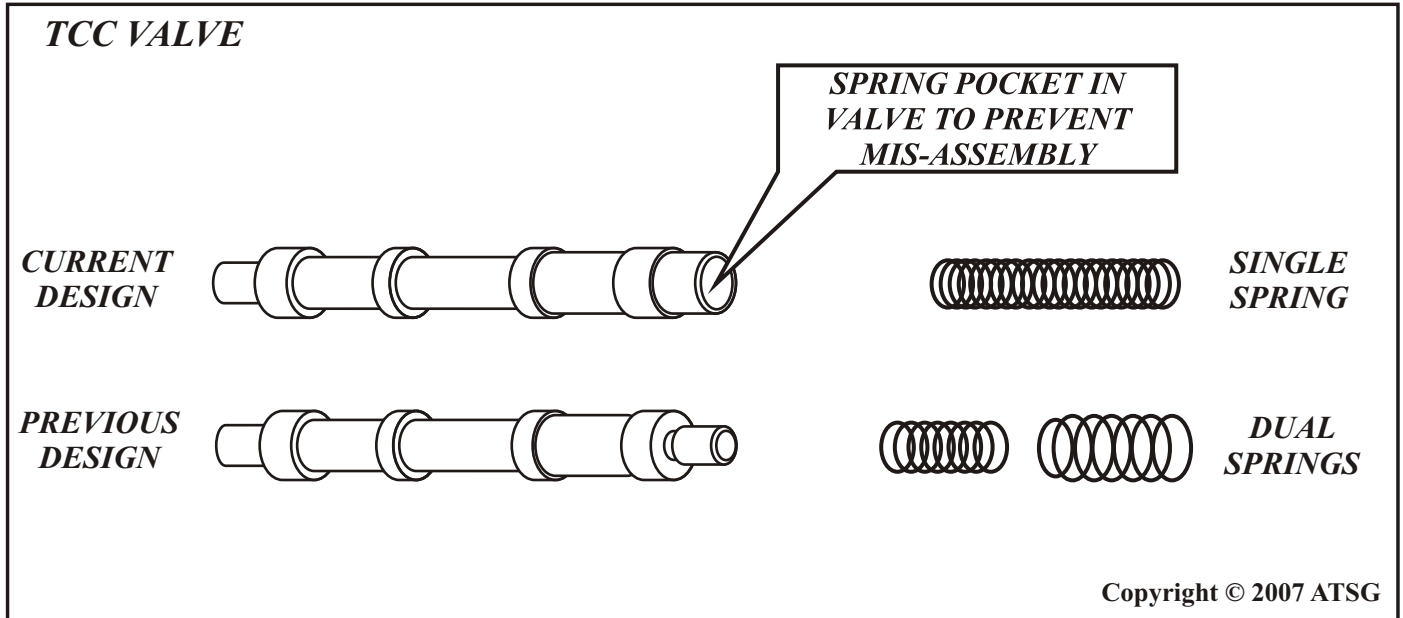
Figure 5

- CHANGE:** (1) Effective February 1st, 2005, the oil pump cover now uses a new design TCC valve with a single spring. (See figure 5)
- REASON:** Simplifies the assembly process, eliminates the possibility of springs becoming bound or bent and reduces material cost.

**TCC Valve** - The new design TCC valve uses a single spring and is shown along with the previous design level valve with dual springs in figure 5. The new valve incorporates a spring pocket to prevent incorrect installation by only allowing the spring to be assembled into the pocket end of the valve. Components of the previous and current designs may not be intermixed. However, the current design TCC valve and spring can be used to back service the previous design level.

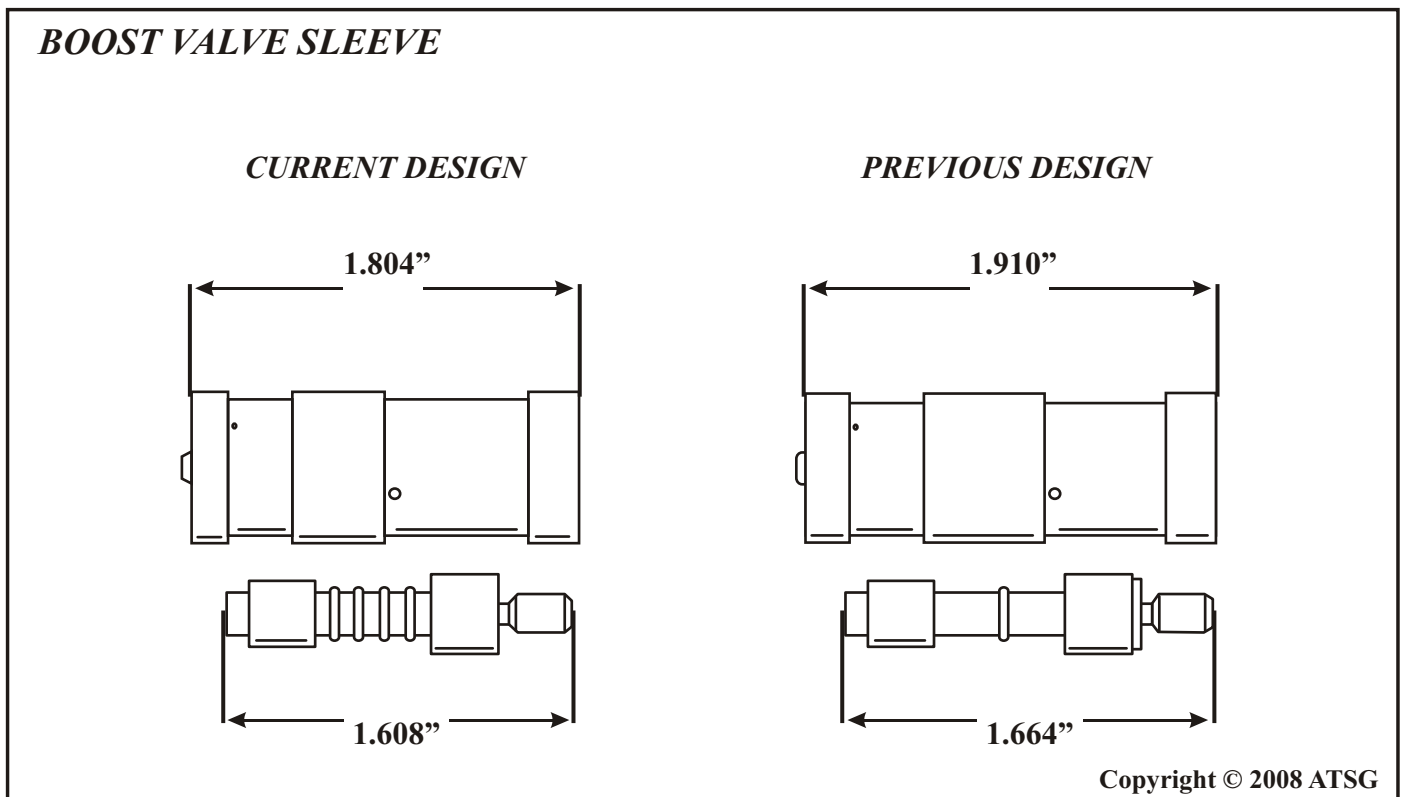
Figure 6

- CHANGE:** (2) Effective March 7th, 2005, the oil pump cover now uses a more compact boost valve and sleeve. (See figure 6) The snap ring groove location for the boost sleeve is now situated 2.57"(in.) from the bottom of the bore compared to 2.68"(in.) for the previous design. (Refer to figure 7) The bore length for the boost sleeve and snap ring has been reduced by 0.106"( in.).

**Boost Valve and Sleeve** - The boost sleeve as shown in figure 6 and its corresponding valve have been made shorter in overall length. No components of the current and previous designs may be intermixed, nor interchanged together as an assembly in place of the other. There are two versions of the current design boost valve and sleeve assembly with different valve land dimensions for standard and high performance use. The pressure regulator valve, pressure regulator valve spring and pressure regulator isolator spring remain the same as the previous design.

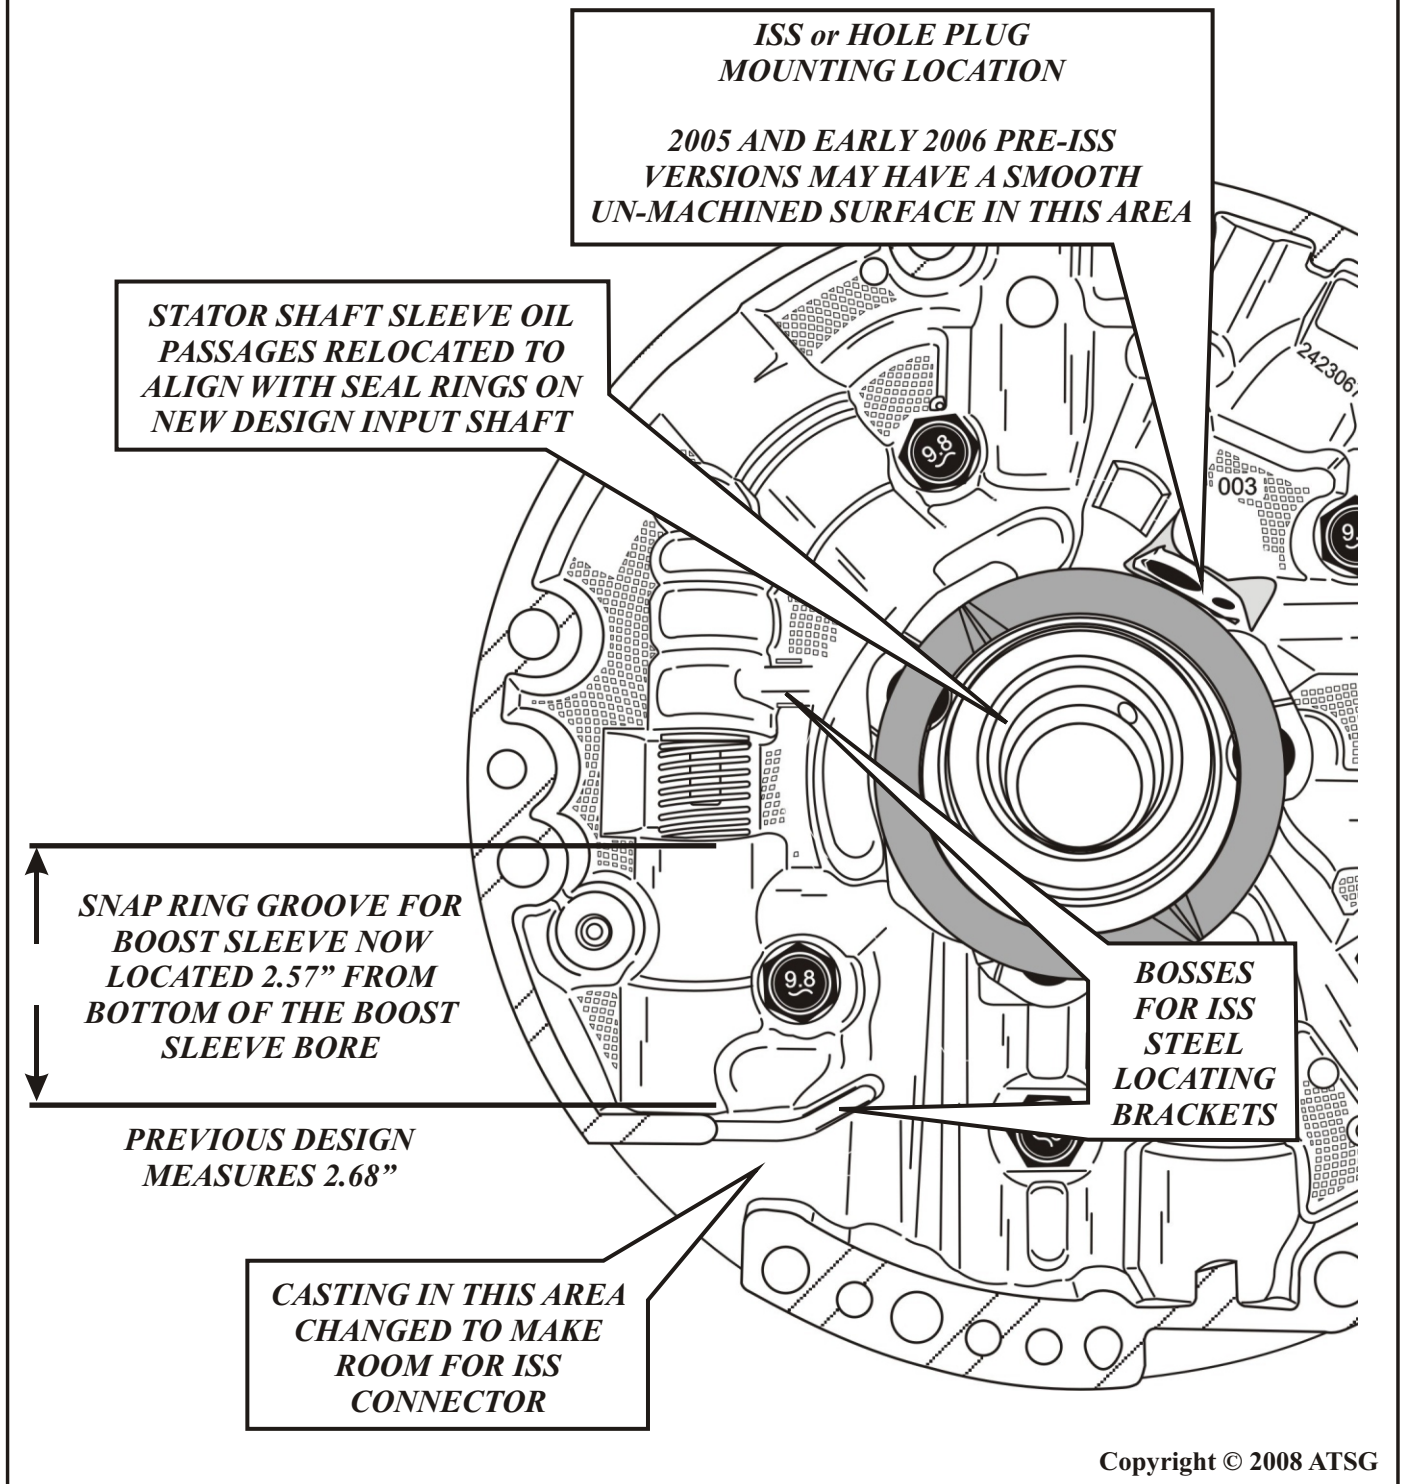
Figure 7

- REASON:** Necessary in order to prepare for the new input speed sensor (ISS) assembly that will be packaged into the pump cover.
- CHANGE:** (3) After July 16th, 2005, the pump cover casting was modified in order to situate the ISS connector. This modification removed metal directly below the PR valve and boost sleeve bore and extended a cast wall inward. The internal TCC release passage was also modified at this time. The ISS mounting holes are not yet machined into the oil pump cover. (This is shown in figure 7 also )

**Oil Pump Cover** - An outline of the oil pump cover and stator shaft changes can be seen in figure 7. Great care must be taken if the oil pump cover and/or stator shaft are to be replaced. This is due to the many changes in the oil pump cover casting and corresponding stator shaft sleeve oil passages. These pieces must be compatible with the turbine input shaft being used or transmission failure will be the result.

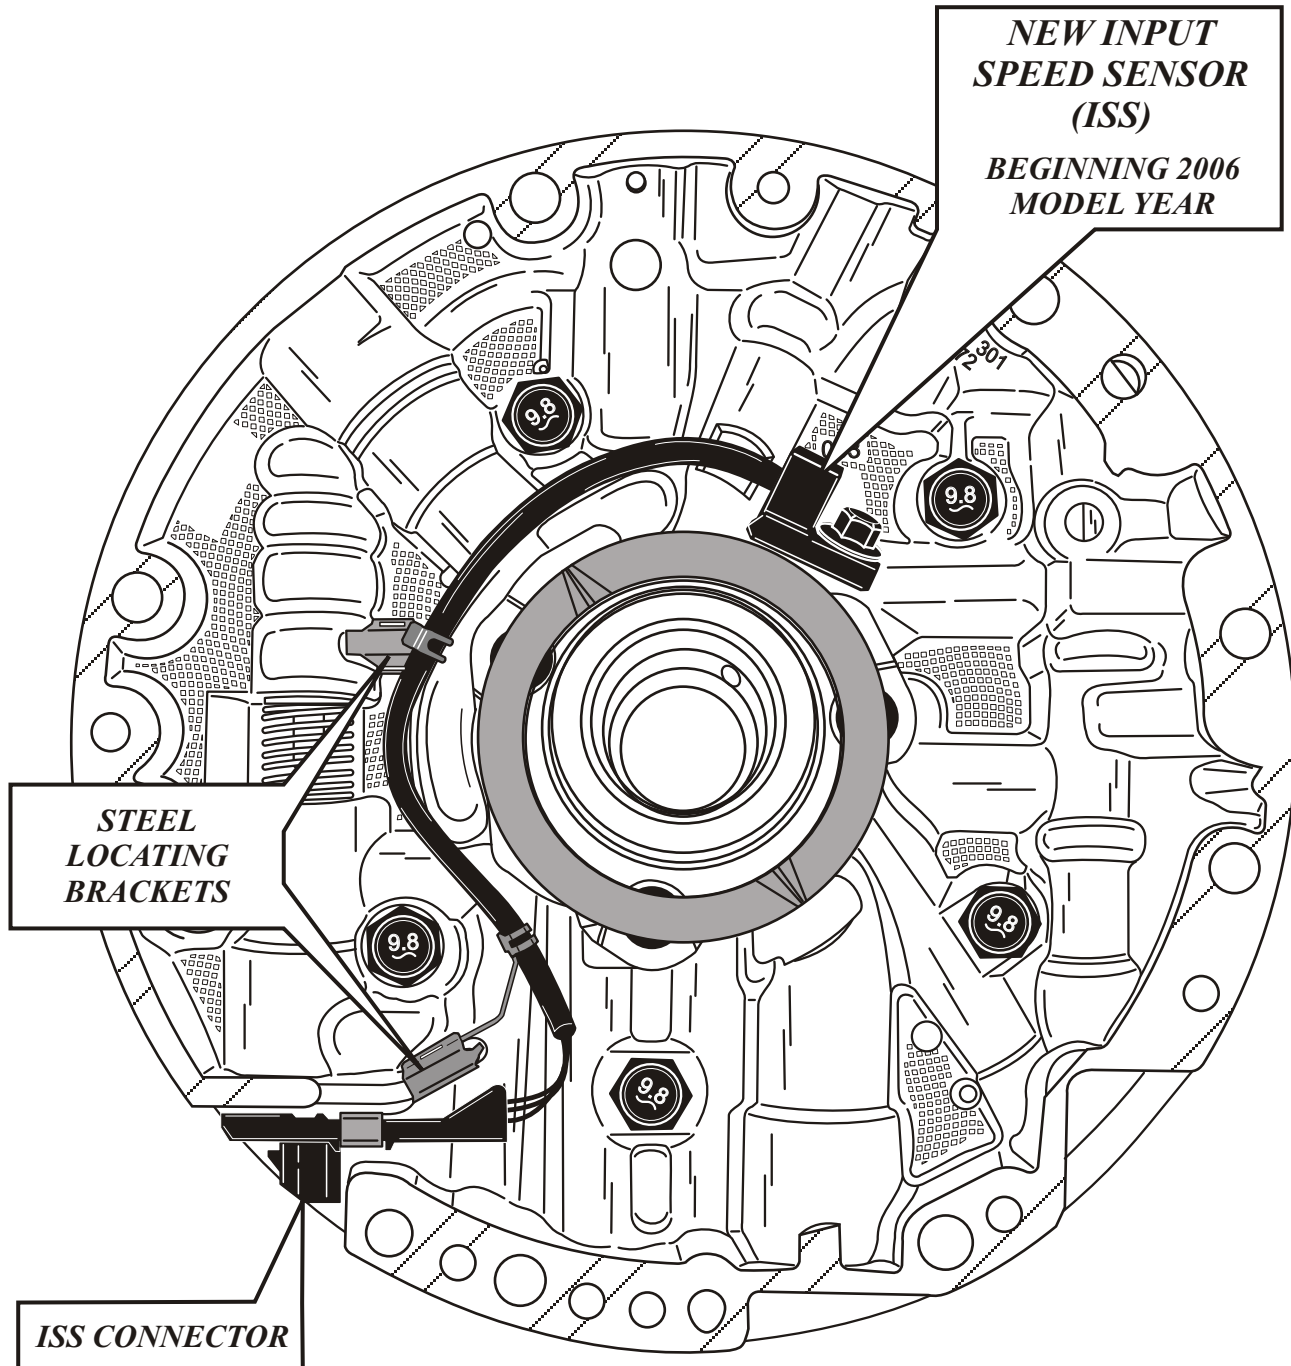
Figure 8

- CHANGE:** Oil pump cover changes also affected the stator shaft and stator shaft sleeve so as to relocate with oil passages within the oil pump cover.  
At the same time, the turbine shaft oil seal ring grooves were moved inboard towards the rear of the unit approximately 0.190”(in.) to create an area to manufacture 15 rotor teeth.
- REASON:** To correlate with changes in the stator shaft and sleeve assembly.
- CHANGE:** (4) Late in 2005 and early in the 2006 model year, some pre ISS models may still not have the ISS mounting holes machined into the cover. This will be evident as a smooth un-machined surface without the ISS mounting holes. As ISS models were introduced, the machining took place and the input speed sensor (ISS) was added. (See figure 8)  
For non ISS models, an ISS hole plug will be used in place of the ISS assembly.  
(See figure 9)

The boost sleeve and pressure regulator valve can not be serviced from the sump area on units equipped with an ISS because of the location of the ISS connector as shown in figure 8. This operation will require removal of the transmission and oil pump assembly. Pre ISS or non ISS models equipped with an ISS hole plug as seen in figure 9 will still allow access to the boost valve sleeve and pressure regulator valve from the sump. If the o-ring is damaged or omitted from the ISS hole plug then improper converter clutch operation or converter drain back concerns may be evident. Failure to install the ISS hole plug if required will result in low or no converter charge and no movement.
