# Technical Service Information

## FORD 4R44E 2-3 UPSHIFT FLARE

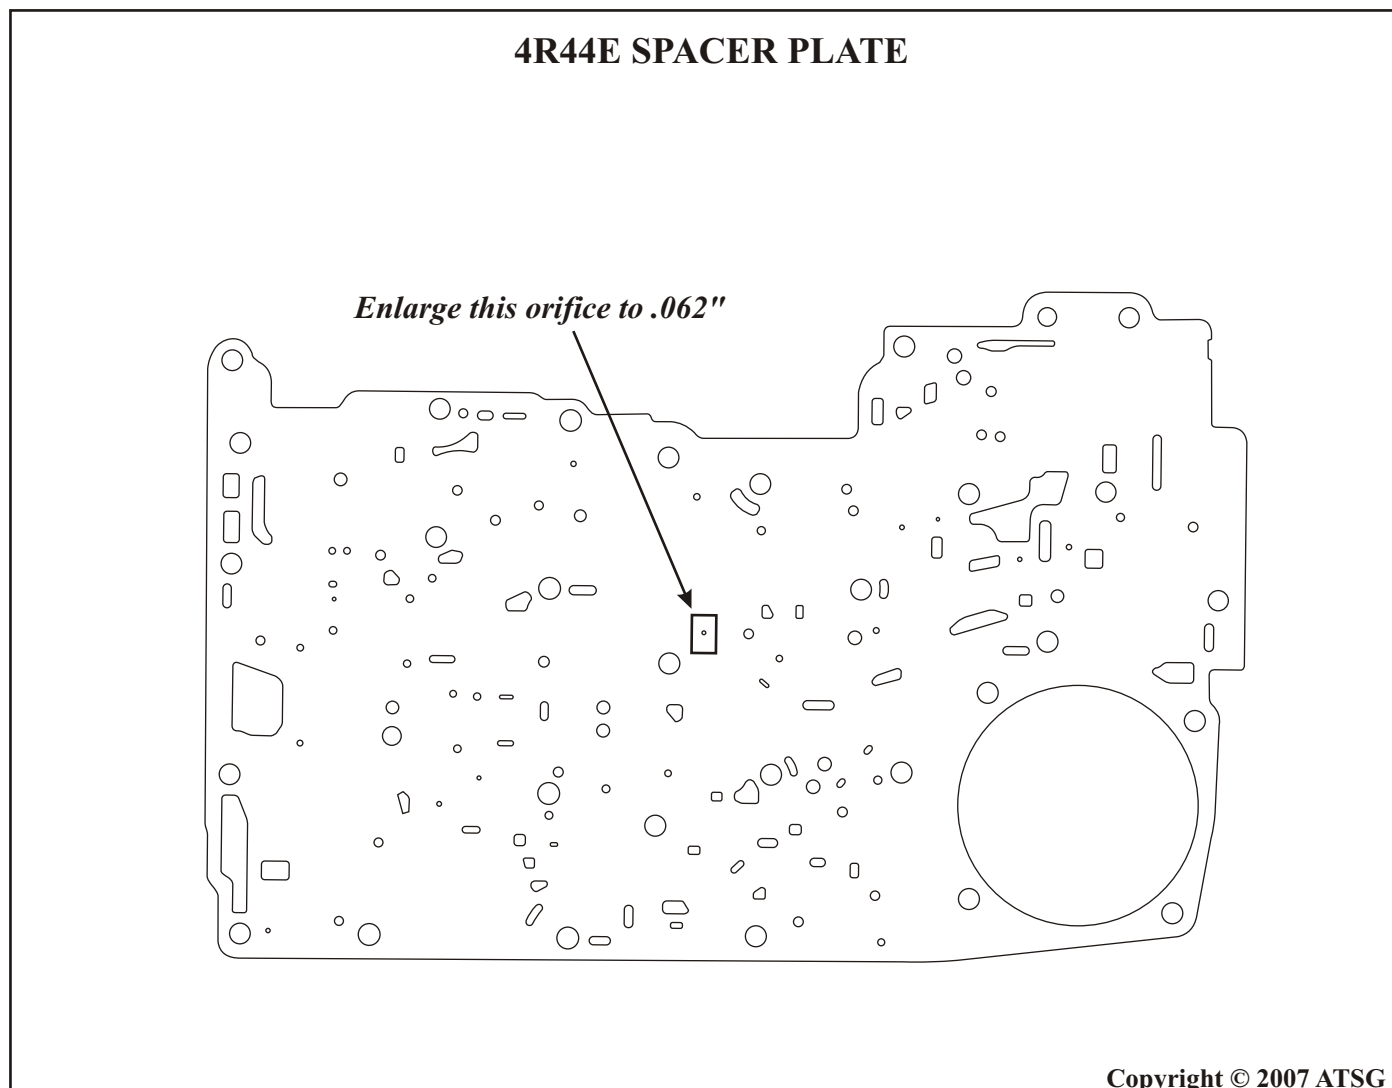
**COMPLAINT:** Vehicles equipped with the 4R44E transmission, may exhibit a 2-3 upshift flare before or after overhaul.

**CAUSE:** The cause may be, insufficient Direct Clutch pressure during the 2-3 upshift transition.

**CORRECTION:** Locate the orifice, as shown in Figure 1 and enlarge the hole to .062."
