# Technical Service Information

## FORD 5R55W/S

### TICKING OR RATTLING NOISE FROM BELLHOUSING

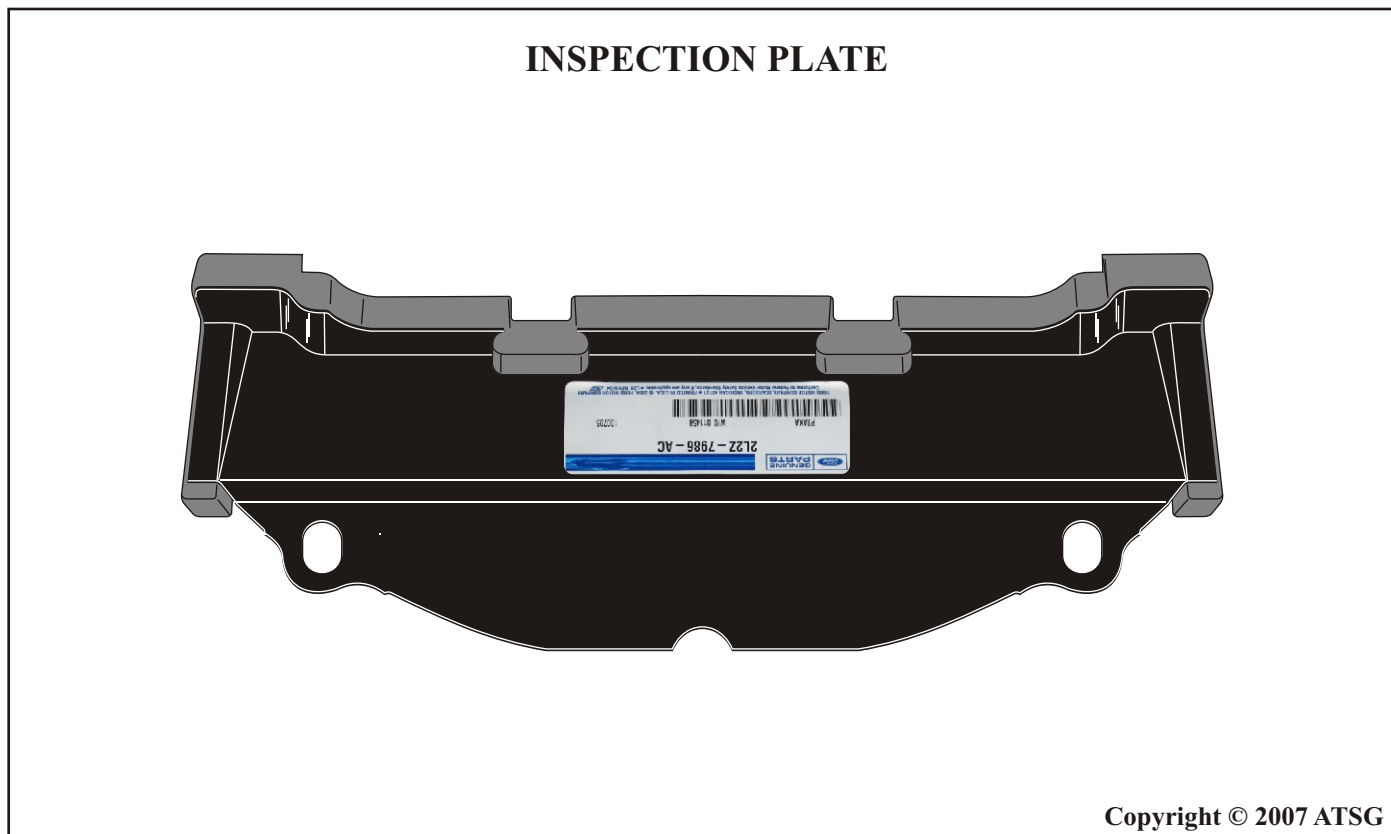
Figure 1

**COMPLAINT:** Explorer and Mountaineer models equipped with the 5R55W/S transmissions may exhibit a ticking or rattling noise coming from the bellhousing of the transmission. This noise can be commonly mistaken as a cracked flywheel or a mis-alignment of the flex-plate to the torque converter.

**CAUSE:** The cause may be, the plate between the engine block and the bellhousing is flexing, with increased engine rpm, causing the noise.

**CORRECTION:** Ford Motor Company has released a new style inspection plate, which is located at the bottom of the bellhousing, that has foam rubber to insulate the plate between the engine and transmission to keep it from flexing. Replace the inspection plate with new design as shown in Figure 1.

INSPECTION PLATE.....2L2Z-7986-AC
