Technical Service Information

2004 & LATER CADILLAC TPMS WARNING LAMP ILLUMINATED

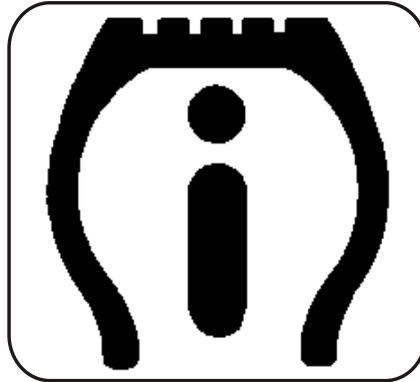
Figure 1

COMPLAINT: Transmission repairs have been completed on a 2004 Cadillac Deville, after delivery of the car to the customer, the car comes back to shop with a complaint of a warning lamp that is on which was not on prior to repairs. It is the Tire Pressure Monitoring System Warning Lamp, (Refer to Figure 1).

TIRE PRESSURE MONITORING SYSTEM WARNING LAMP

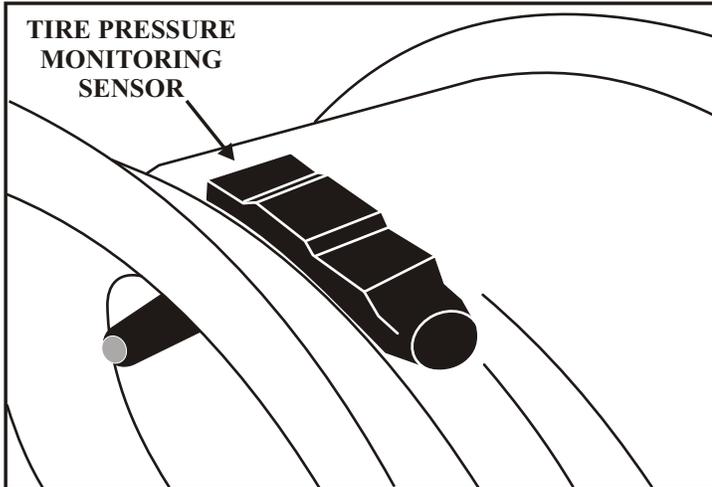
Figure 2

CAUSE: During the re-assembly of the vehicle, the left and right front wheels were switched to opposite sides. This action caused the Tire Pressure Monitoring System Sensors in each of those wheels (Refer to Figure 2) to alert the TPMS, turn on the warning lamp and store the above mentioned codes. This occurs because this is a Direct TPMS system, in other words it is a stand alone system whose only purpose is to monitor tire pressures.

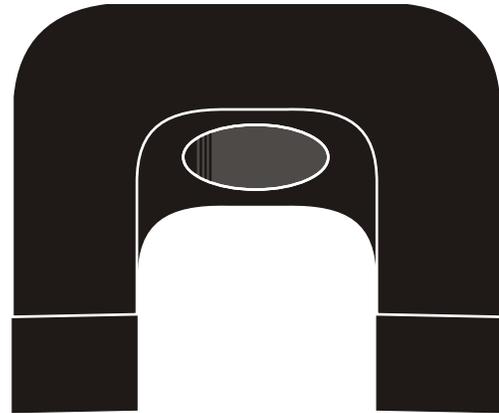
Figure 3

KENT-MOORE REPROGRAMMING TOOL J-41760

CORRECTION: Anytime wheels are rotated, tires changed, balanced or tire pressures are incorrect, the system must be reprogrammed. To reprogram, either a capable scan tool is required or the keyless entry key fob along with a magnet, which is Kent-Moore Tool J-41760 as shown in Figure 3, is needed to accomplish a manual reprogramming.
