FORD 4R70/75E TCC APPLICATION ON TOP OF 2ND GEAR

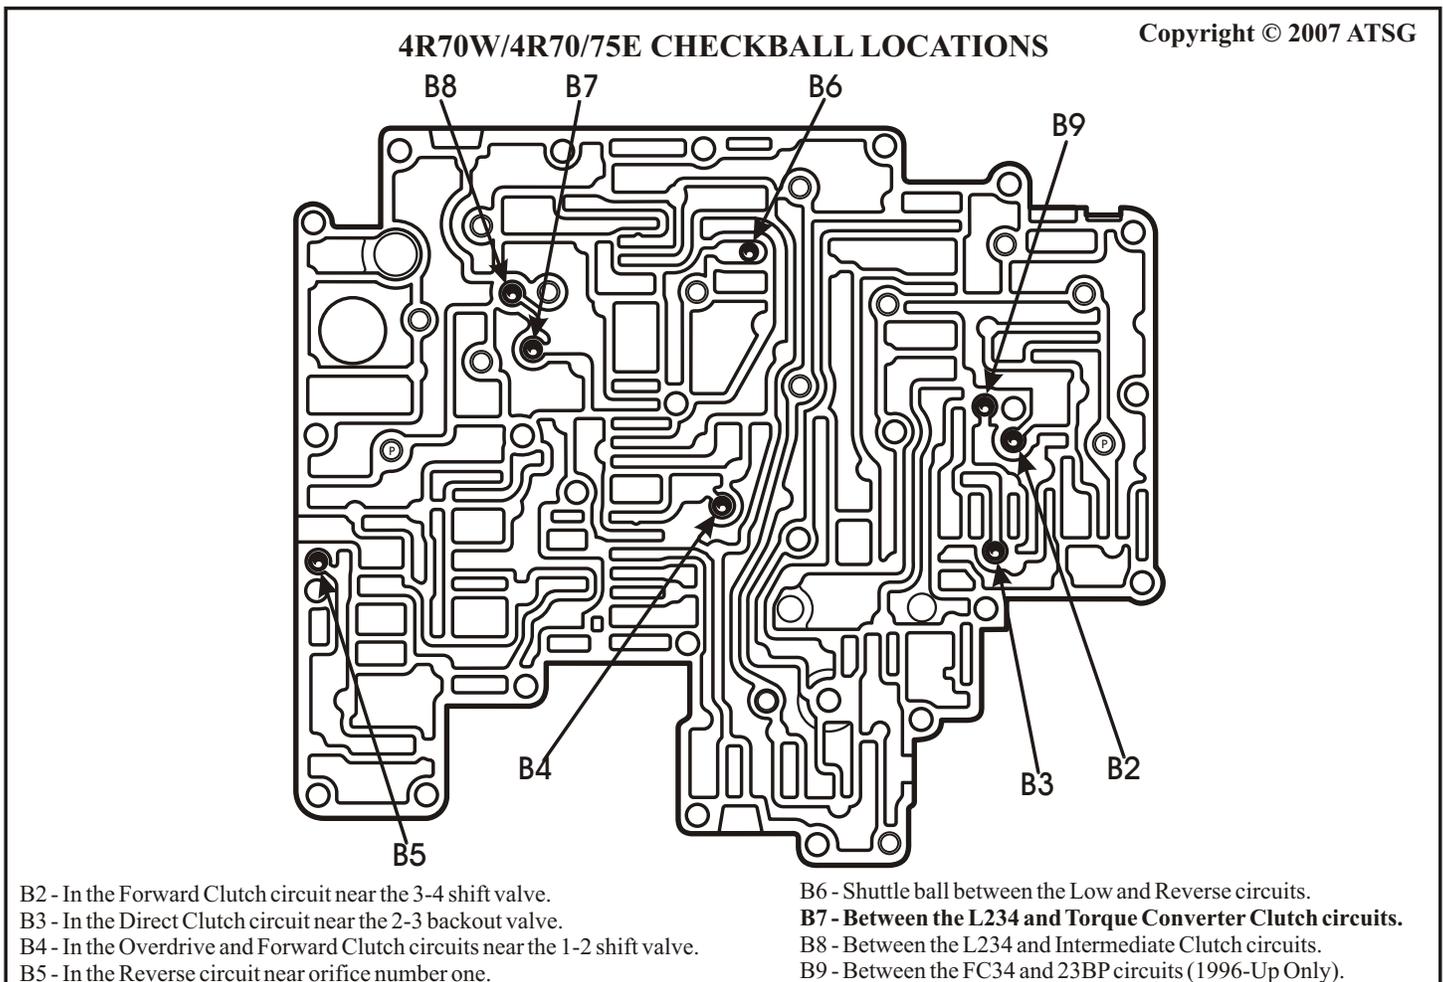
Figure 1

CAUSE: The #7 check ball in the valve body, (Refer to Figure 1), has become too small and is allowing line pressure from the 2-3 shift valve to stroke the Bypass Clutch Control Valve which will apply the converter clutch as soon as a 1-2 shift occurs as shown in the hydraulic diagram in Figure 2. The hydraulic diagram in Figure 3 illustrates how the TCC circuit should operate when the #7 check ball is the correct size.

CORRECTION: Although this bulletin refers to specific years and models, any 4R70W, 4R70/75E in any vehicle would have the same complaint should the #7 check ball become too small. Replacement of the #7 check ball will remove the complaint and restore TCC to computer control strategies.

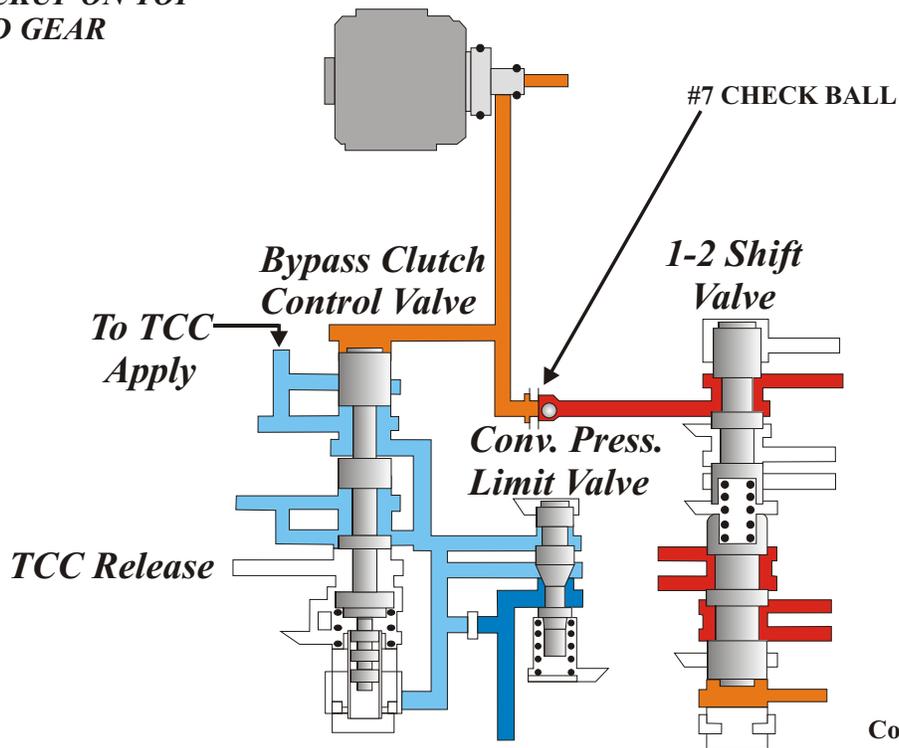
Figure 2

**#7 CHECK BALL IS TOO SMALL
ALLOWS LOCKUP ON TOP
OF 2ND GEAR**

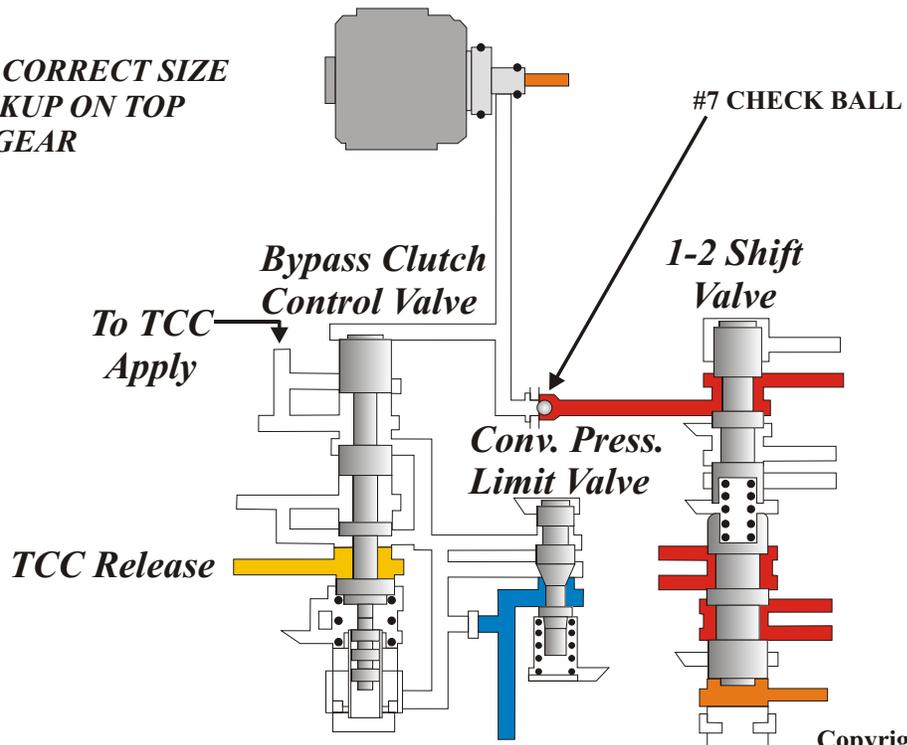
Figure 3

**#7 CHECK BALL IS CORRECT SIZE
PREVENTS LOCKUP ON TOP
OF 2ND GEAR**
