CHRYSLER 45RFE/55RFE BIND ON 3-4 OR 4-5 UPSHIFT

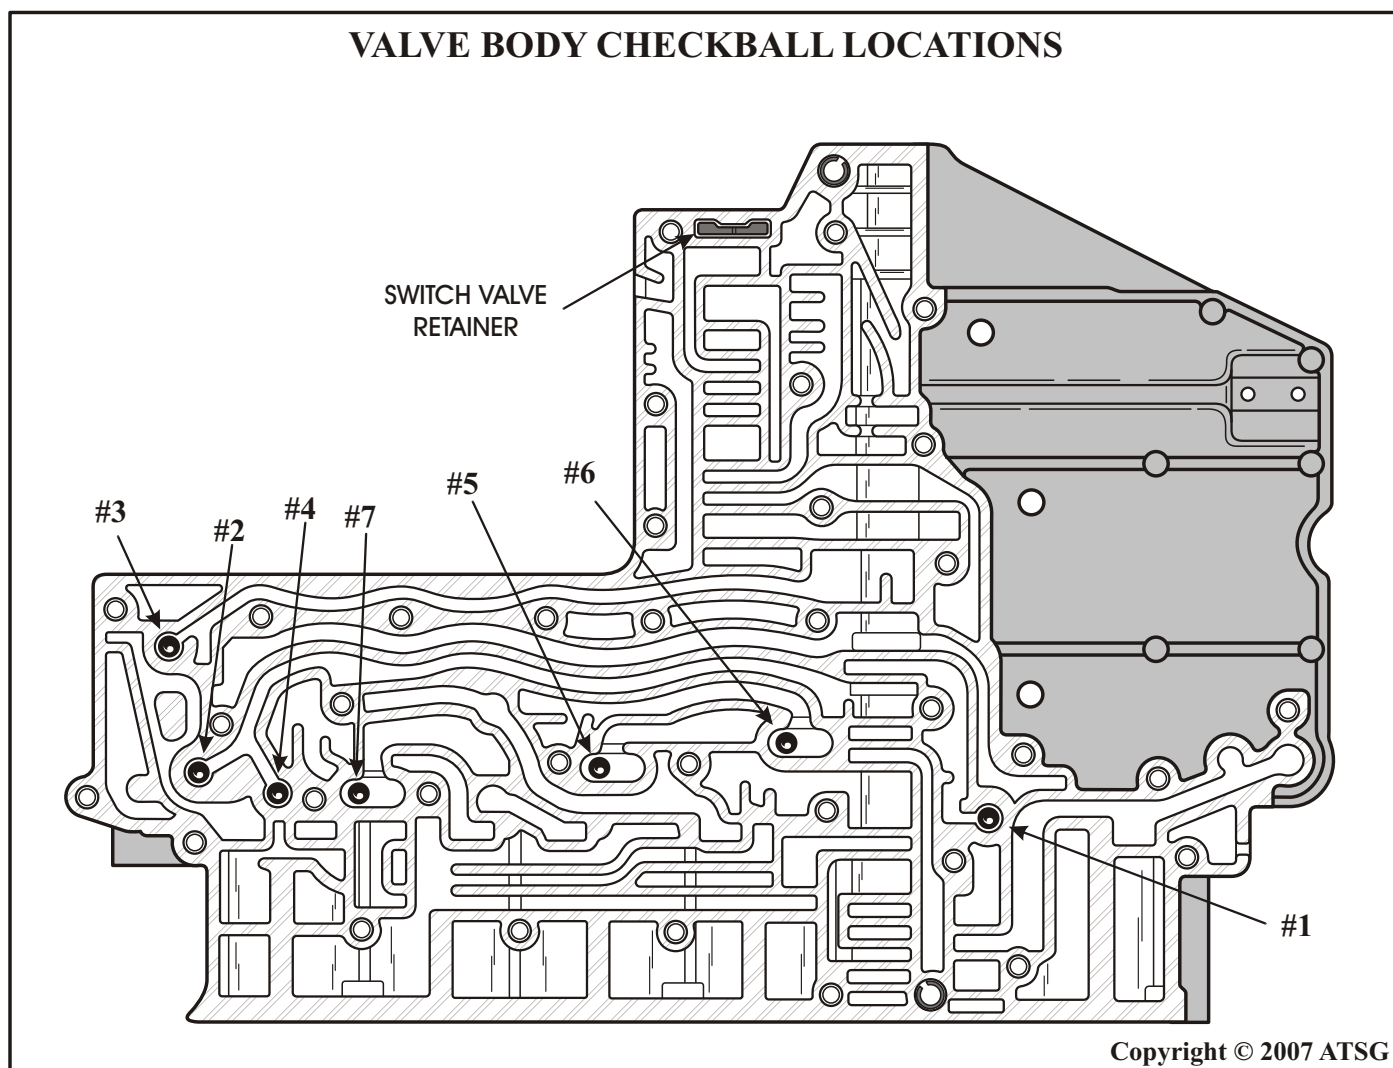
CAUSE: The cause may be that the #2 checkball, as shown in Figure 1 has partially disintegrated, allowing the underdrive clutch to be partially or fully applied when the 3-4 or 4-5 upshift occurs causing a bind-up.

CORRECTION: Replace the checkballs with new plastic checkballs available in aftermarket rebuild kits or from an O.E. supplier. For Valvebody Exploded views refer to Figures 2 and 3.
