# Technical Service Information

## HONDA CIVIC B4RA-M4RA-BMXA FAMILY WRONG GEAR STARTS-MULTIPLE SHIFT COMPLAINTS

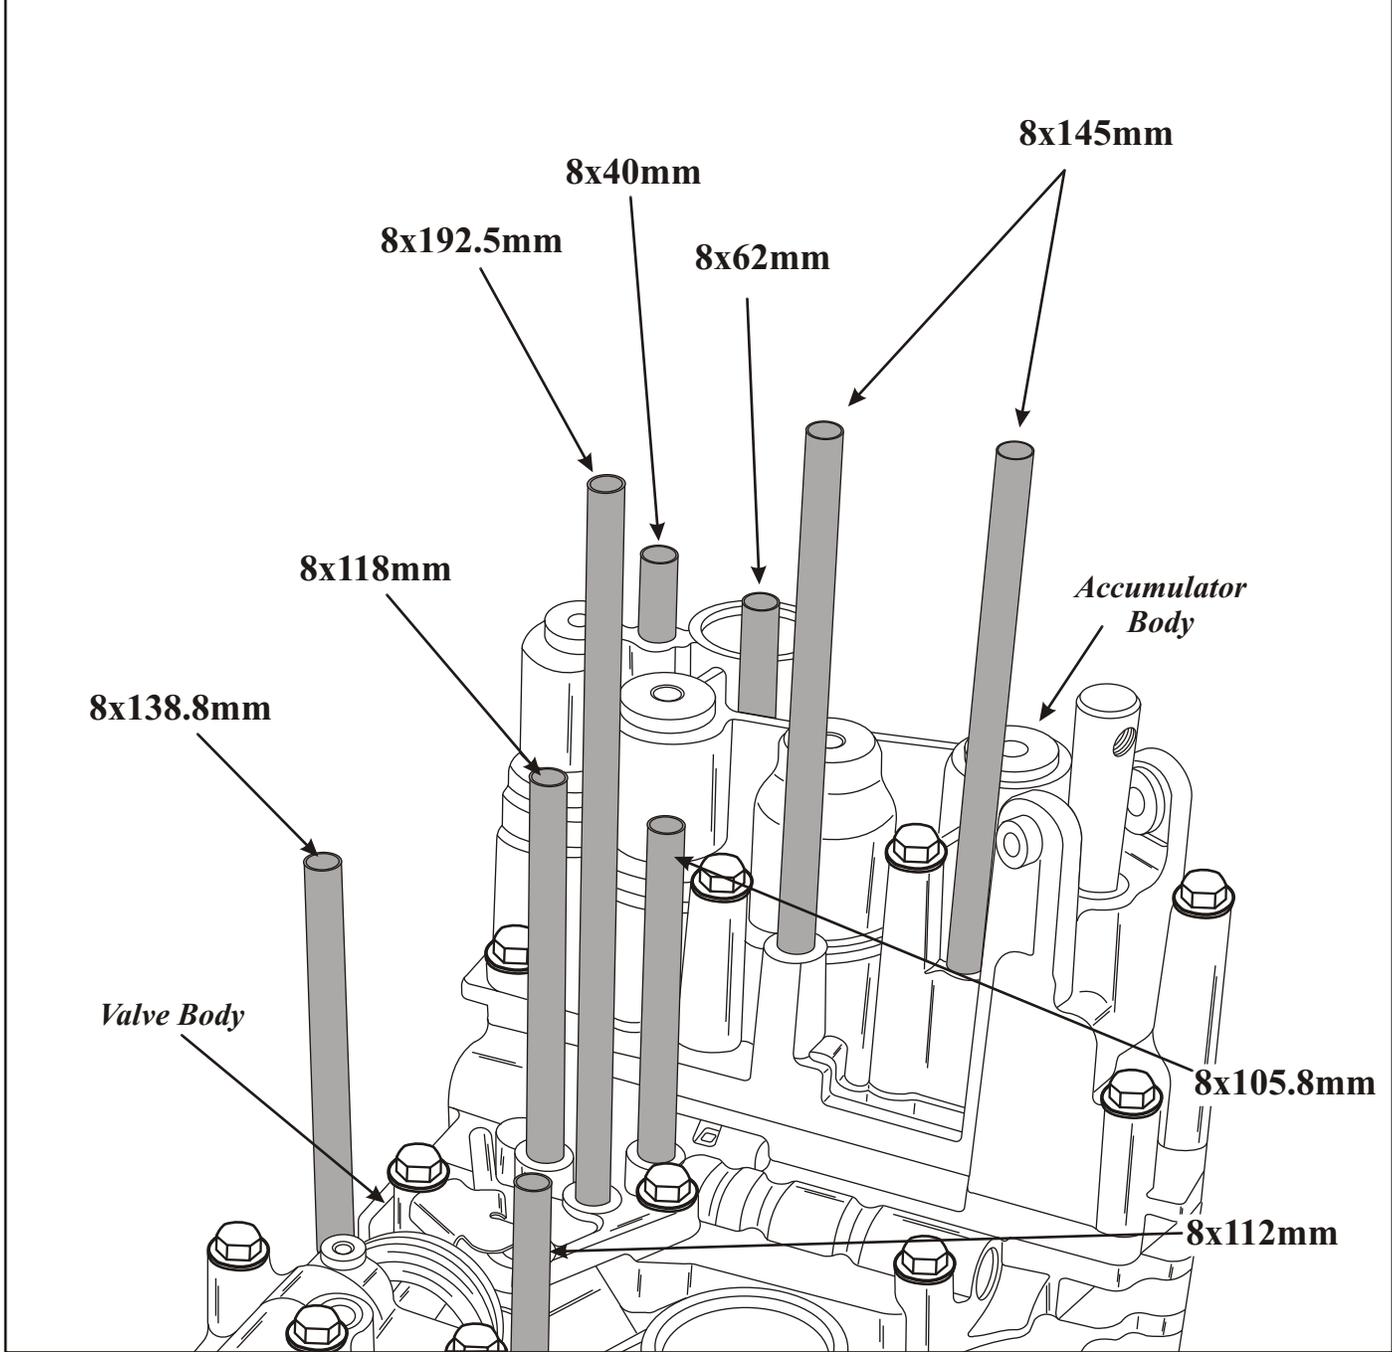
**CAUSE:** The cause may be, that during overhaul of the valve body and re-assembly one or more of the feed tubes were placed into the wrong hole on the accumulator body or valve body, causing low modulating pressure , which is solenoid feed and or low clutch apply pressure to one or more of the clutch packs.

### HONDA CIVIC B4RA-M4RA-BMXA FAMILY FEED TUBE LOCATIONS

**CORRECTION:**To correct this condition, refer to Figure 1 and measure the feed tube lengths to ensure that they are going into the correct locations on the accumulator body and valve body.
