Technical Service Information

FORD 5R55W

DELAYED ENGAGEMENT OR DTC P0705

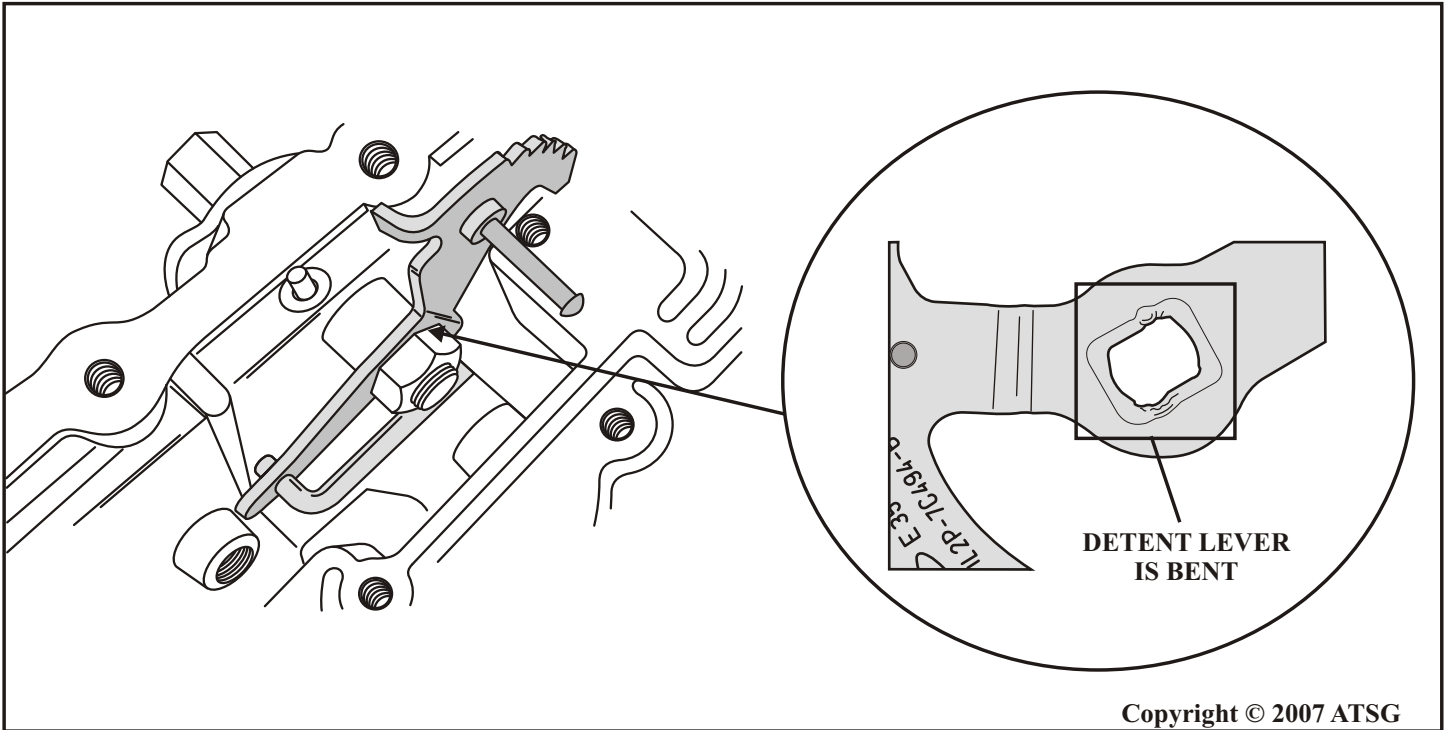
Figure 1

COMPLAINT: After overhaul, the transmission has delayed engagements on garage shifts and may even exhibit a 2-3 flared shift, which may also be accompanied by a DTC P0705, Digital Trans. Range Sensor Fault.

CAUSE: The internal linkage detent lever has been bent, (Refer to Figure 1), this causes a mis-alignment of the manual valve, and in some instances the manual valve may be bent as well.
The main cause of bending the internal linkage is the manual selector shaft nut. This nut has thread lock on it from the factory, this thread lock compound creates a situation where the nut that retains the manual selector shaft is so tight, that the technician has exerted enough force to bend internal linkage components. Note: If the Manual Linkage is out of alignment the Digital Range Sensor will not be aligned correctly as well.

SERVICE INFORMATION:
Detent Lever.....XW4Z-7A115-AA
Transmission Range Sensor.....1L2Z-7F293-AA
