Technical Service Information

FORD 4R75E EXCESSIVE SLIP IN FORWARD

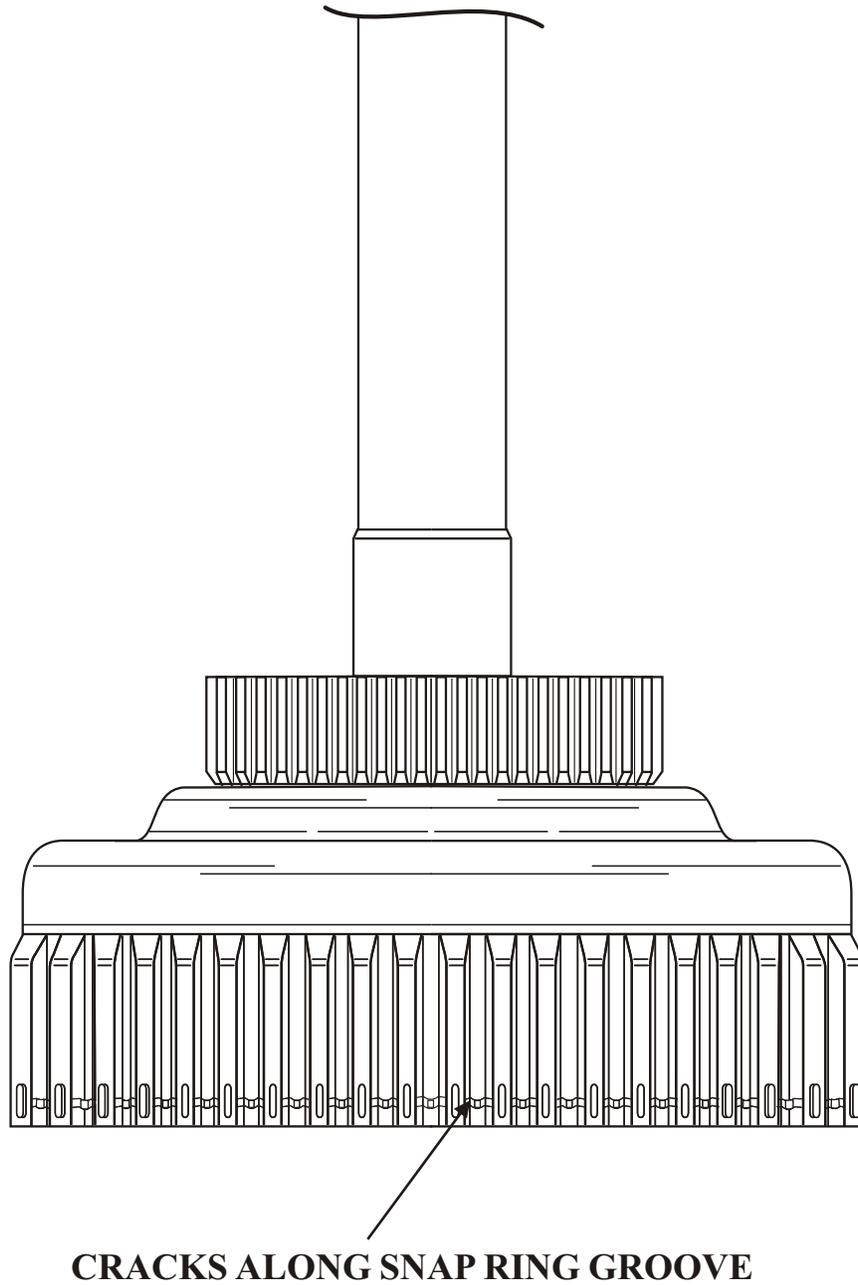
Figure 1

CAUSE: Cracked forward clutch drum, along the snap ring groove area as shown in figure 1. The metal debris found in the transmission sump is the result of the forward drum pressure plate hitting the inside area of the drive shell. Be aware that upon dis-assembly of a 4R75E if no debris is found in the sump, but the forward clutches are scorched. The crack along the snap ring groove may not be easily seen, check by placing a screw driver or scribe in the snap ring groove and slightly prying to reveal any failure in this area.

FORWARD CLUTCH DRUM

CORRECTION: 1. Replace Forward drum. 2 Re-calibrate the PCM with program # 06B06.

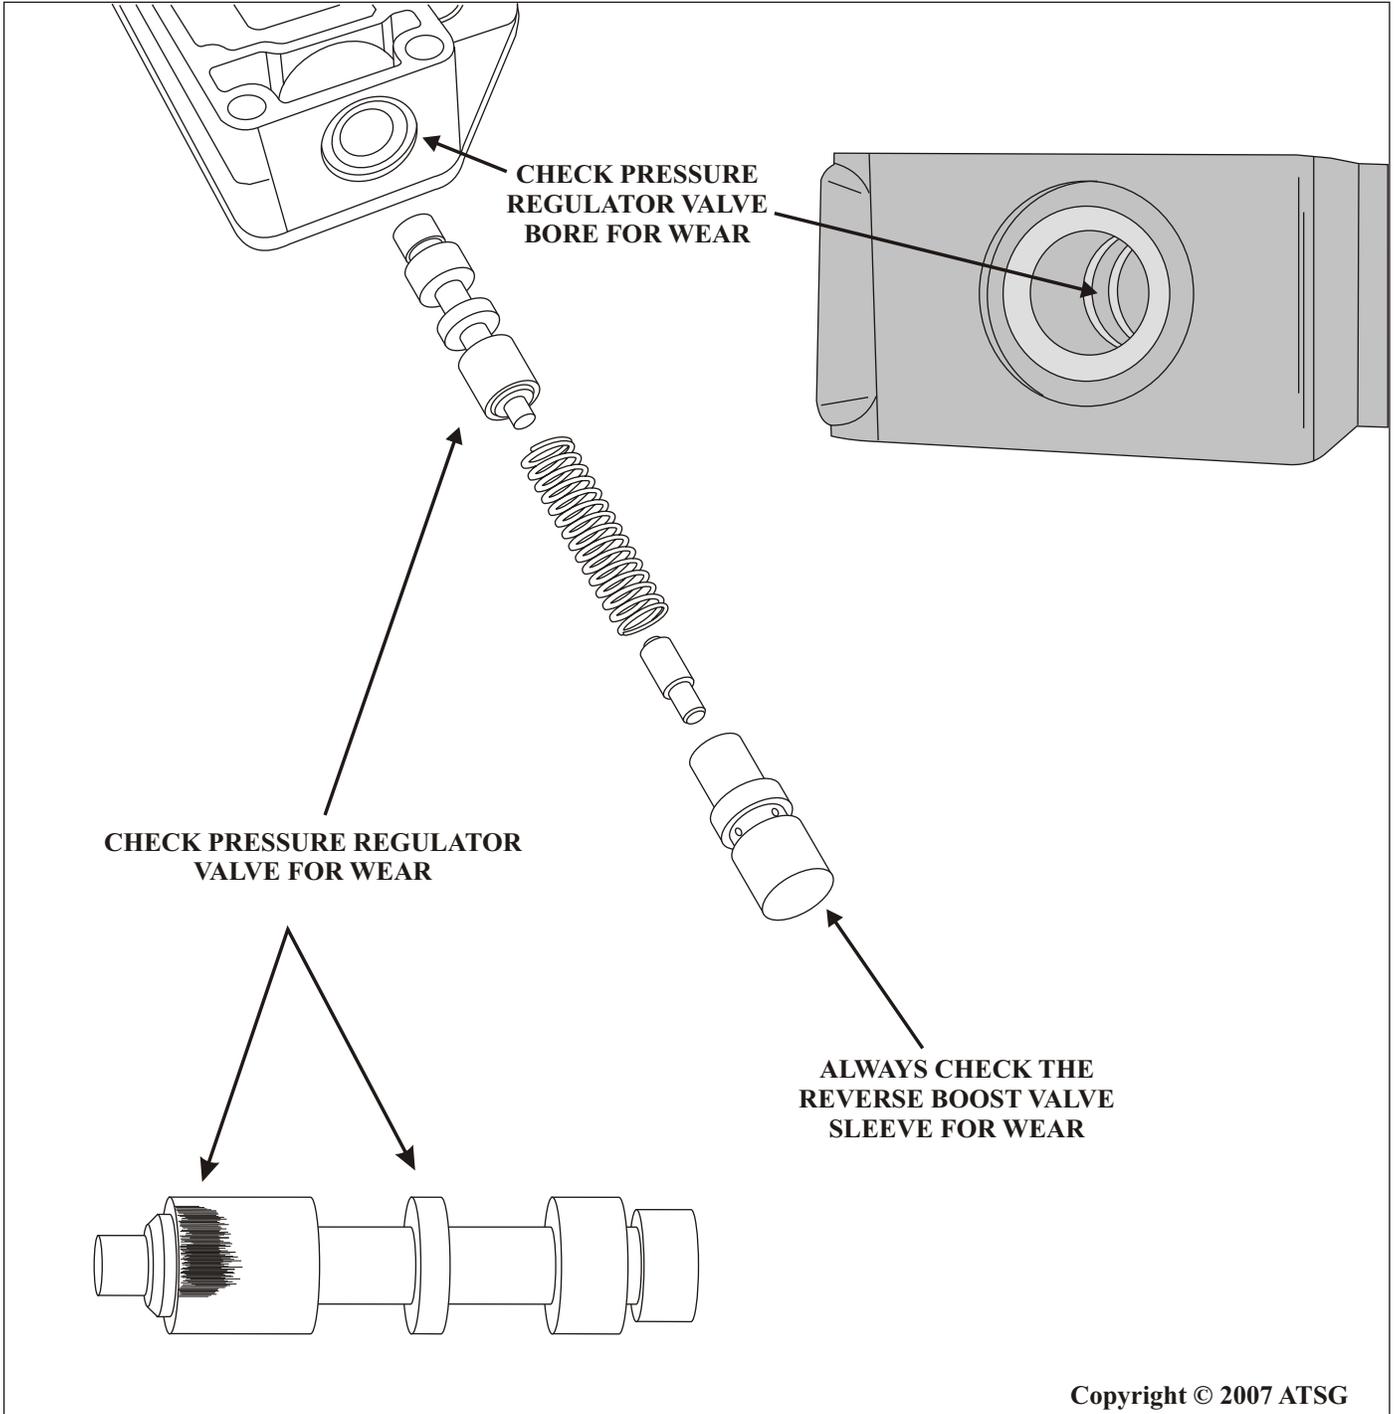
NOTE: ATSG has received several tech calls on vehicles that are not listed or covered under this Customer Satisfaction Program showing up in shops with the same failure of the forward clutch drum. We have also found on some of these vehicles with as little as 35,000 miles, the valve body would have severe wear in the Pressure Regulator Valve bore. This may also cause Forward drum failure due to pressure spikes. See Figure 2 .
