## FORD 4F27-E MAZDA FN4A-EL 1-2 FLARE AND 3-4 NEUTRAL

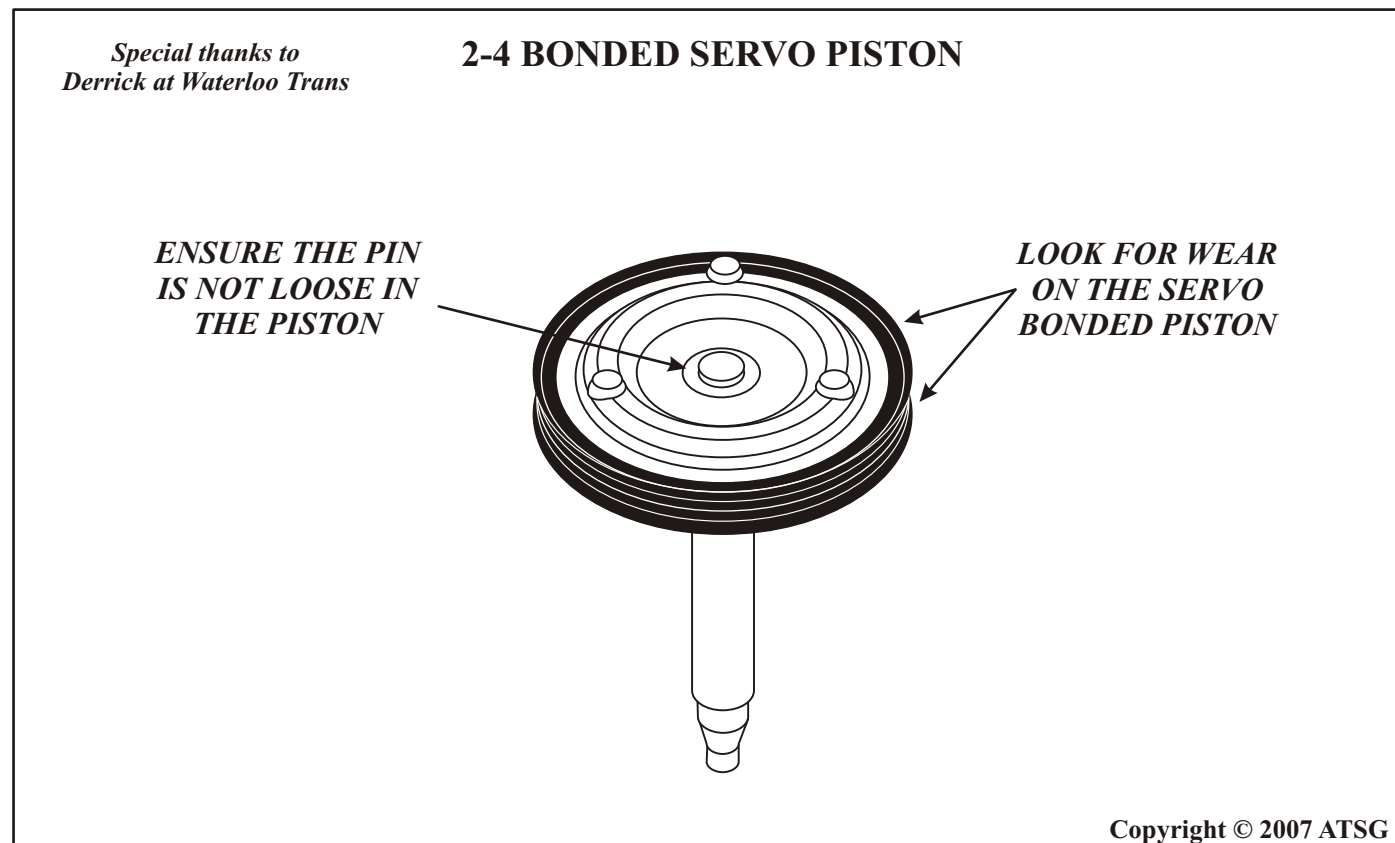
Figure 1

**CAUSE:** The cause may be, the bonded 2-4 servo piston is worn or the pin is loose from the piston, as shown in Figure 1. The cause for the piston being worn is because of a rough surface in the servo bore in the case.

**CORRECTION:** Replace the 2-4 servo piston, as shown in Figure 1. Using some fine sand paper or scotch-brite, lightly sand the bore of the case where the bonded rubber part of the servo rides, to ensure that is smooth. See Figure 2. Re-assemble the servo assembly back into the case as shown in Figure 3. **NOTE: If this repair is attempted in the vehicle, the linkage which is right over the 2-4 servo piston, will have to be removed, which means the mount bolts will have to be removed and the transmission lowered in the vehicle.**
