Technical Service Information

BMW/ISUZU 4L30E INADEQUATE LINE RISE

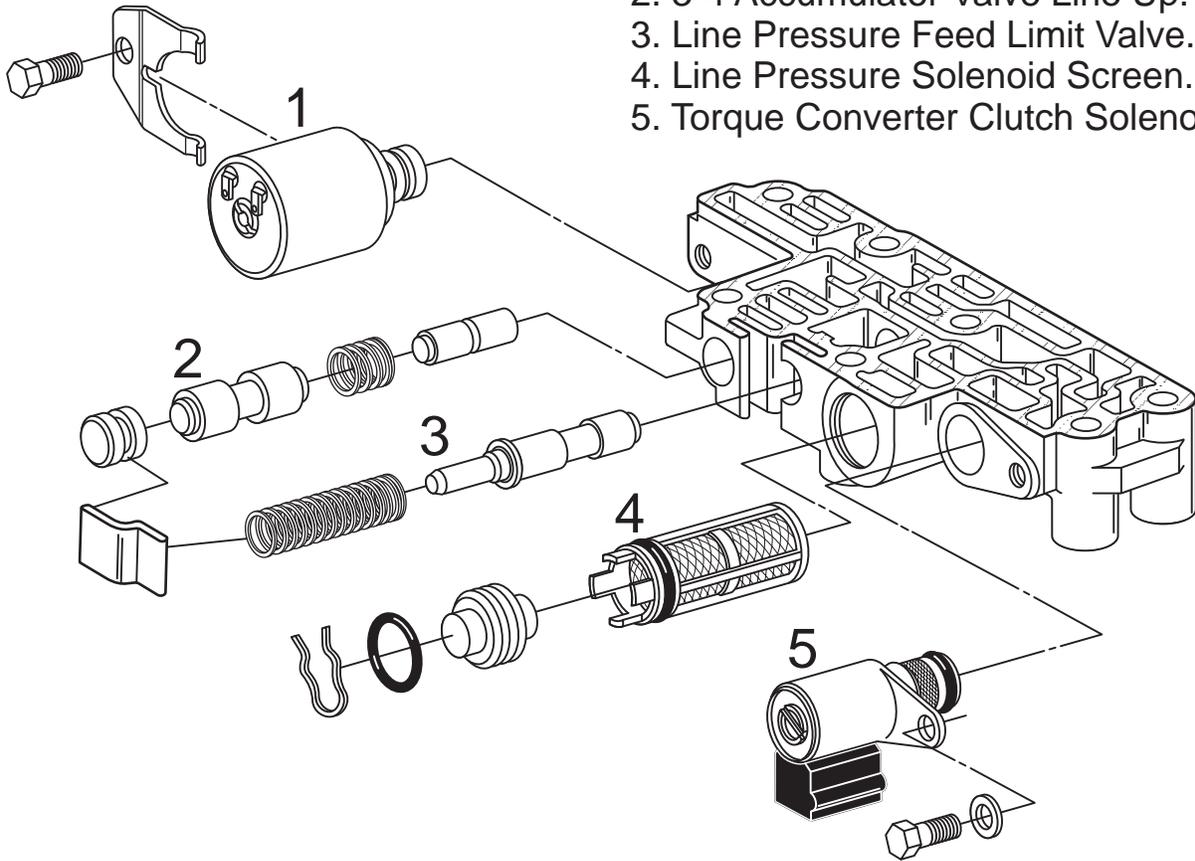
**ADAPTER CASE
VALVE BODY**

CAUSE: One cause may be a worn Feed Limit Valve bore in the Adapter Case Valve Body.

The responsibility of the Feed Limit Valve is to regulate line pressure before it is fed to the Force Motor/Pressure Control Solenoid. As the valve bore wears, the valve and spring will lose it's ability to regulate properly, as bore wear becomes more severe, excessive exhaust of line pressure occurs creating the soft or flared shifts, slipping and other complaints.

CORRECTION: Replace the Adapter Case Valve Body.

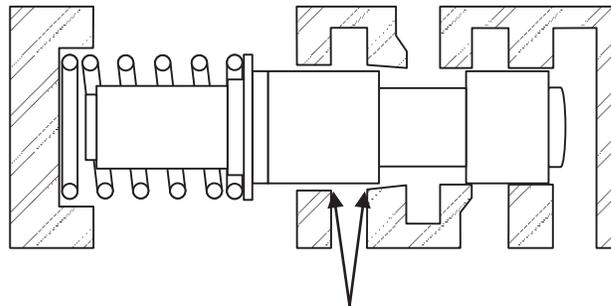
**PARTIAL CUTAWAY OF
FEED LIMIT VALVE BORE**

Valve body casting may wear in this location allowing line pressure to exhaust excessively.
