Technical Service Information

FORD AX4S **1-2 NEUTRAL 1999 & UP MODELS**

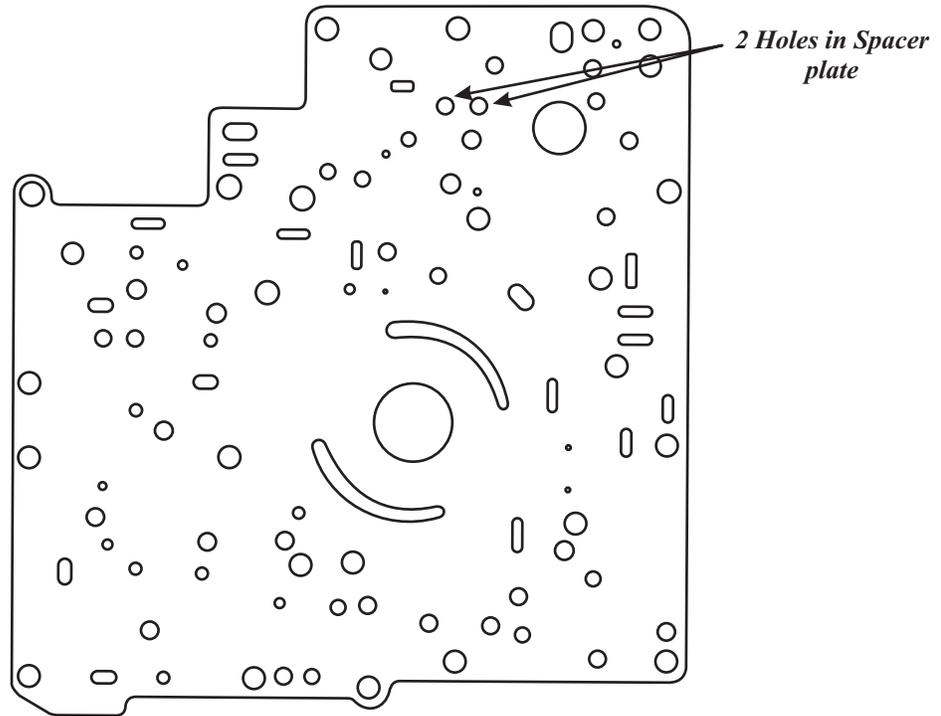
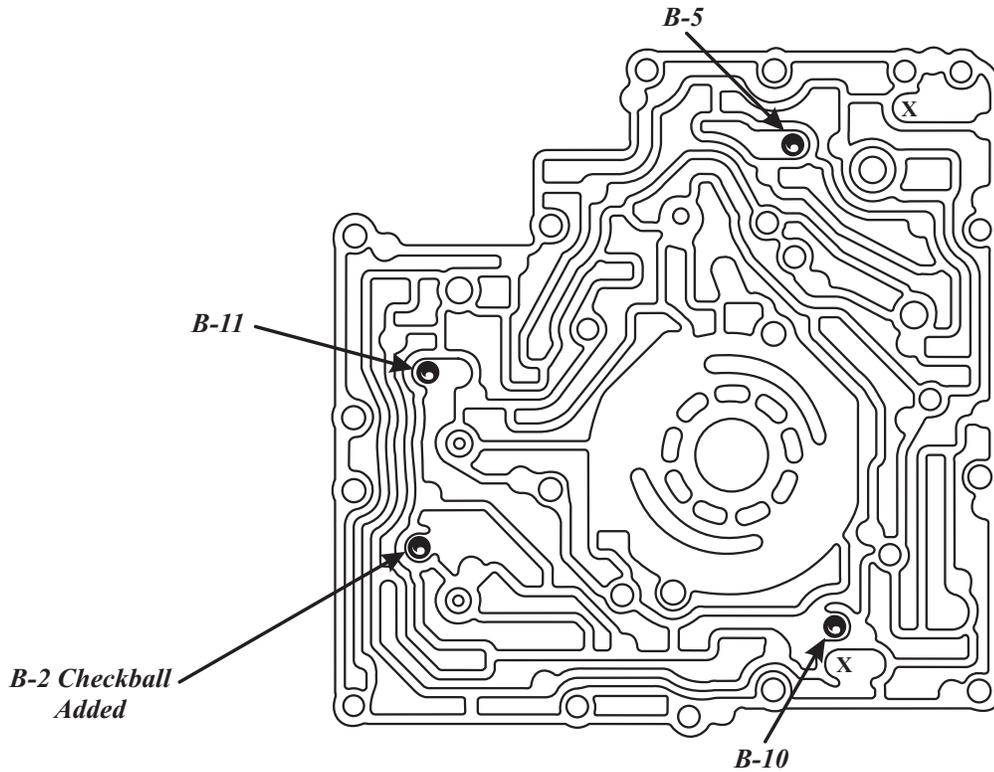
92-98 SPACER PLATE

CHECKBALL LOCATIONS 92-98 MODELS "ONLY"

CORRECTION: Refer to Figure 1 to identify the previous design Pump body and Pump spacer plate, and Refer to Figure 2 to identify the 1999 and Up design Pump body and Pump Spacer plate and ensure that the correct plate and checkball locations are used.

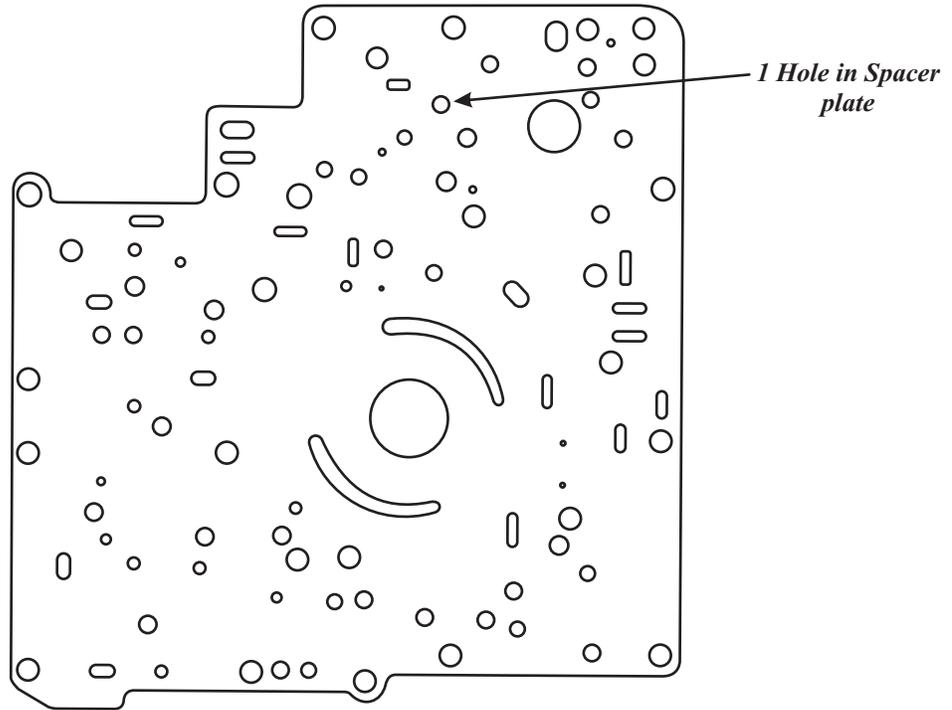
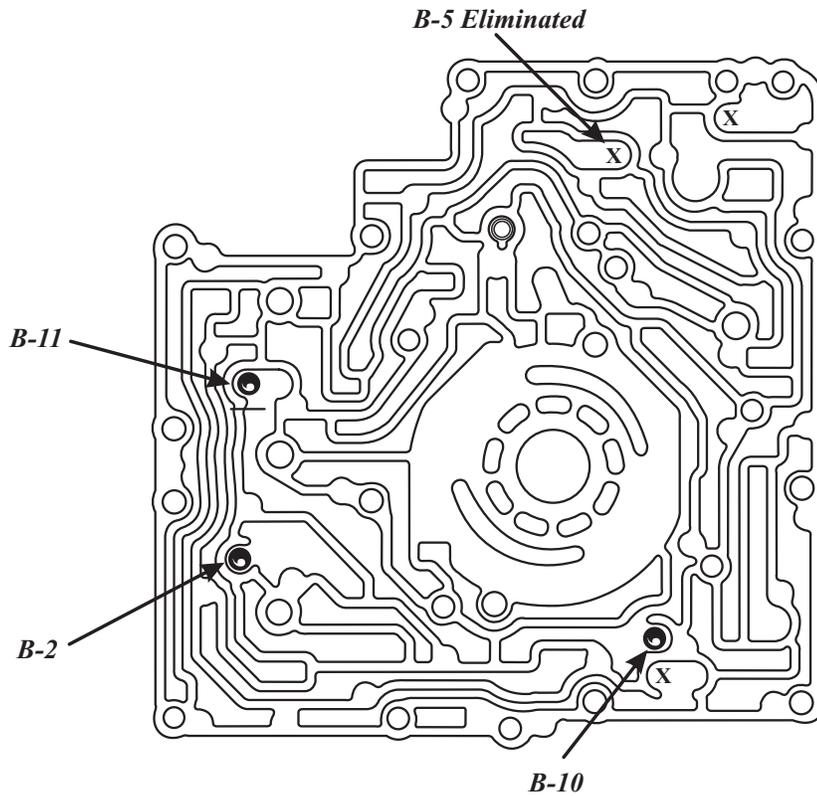
Figure 2

CAUSE: The cause may be, during overhaul, the pump had to be replaced, because of typical pump shaft bearing and rotor failure, and a replacement pump body with a 98 and earlier spacer plate was used. The 1999 and up pump plate requires 3 check balls, and when the B5 check ball is left out when using the previous design spacer plate, L12 pressure will be lost at the manual valve, thru the Reverse circuit.

1999 AND LATER SPACER PLATE

CHECKBALL LOCATIONS 1999 AND LATER "ONLY"
