Technical Service Information

SUBARU 4-AT DELAYED OR NO FORWARD ENGAGEMENT

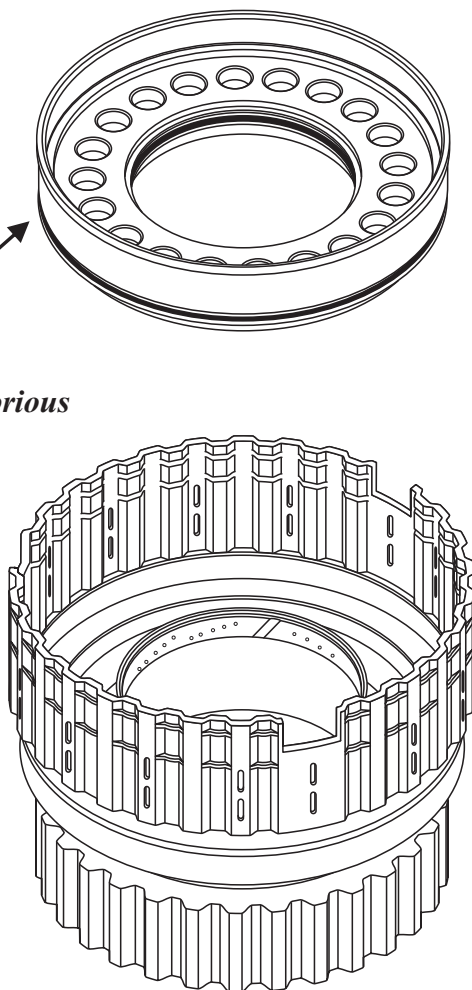
CAUSE: This condition may be caused by the outer piston seal of the Low clutch drum shrinking to the point it will no longer seal effectively. Refer to Figure 1 for identification of the Low drum and piston.

LOW CLUTCH PISTON AND HOUSING

*The outer piston seal is notorious
for shrinking*

CORRECTION: Replace the piston seals on the Low clutch piston.

*Transtec Part Number
26792 Inner "D" Ring
26793 Outer "D" Ring*
